# Pavement Data Collection and Pavement Management System Implementation for City of Crystal Lake, IL

Prepared for  
**City of Crystal Lake, Illinois**  
In Association with  
**Chicago Metropolitan Agency for Planning**

Prepared by  
**Applied Research Associates, Inc.**

## FINAL REPORT

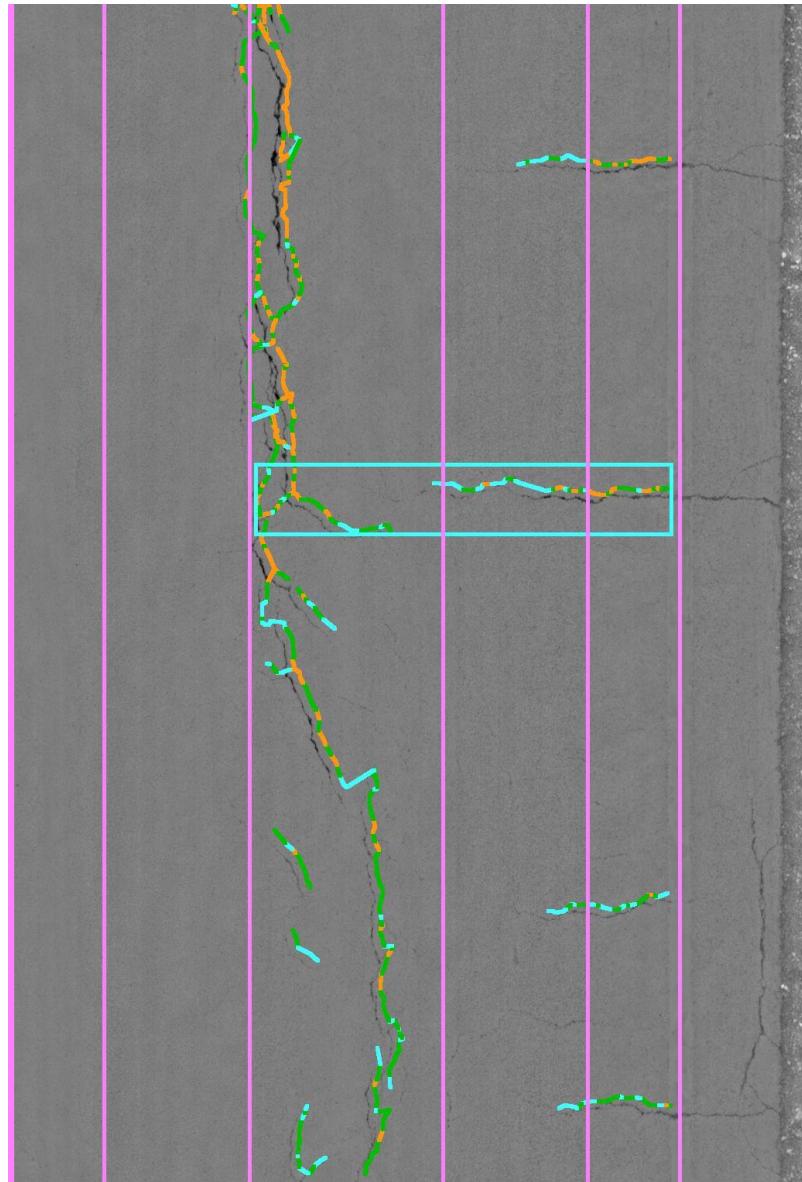
**Figure 6. Pavement distress detection using LCMS system.**

ARA's LCMS system identifies the pavement distresses and reports the type, severity, and extent of key pavement distresses, as shown in Figure 6. Some sample pavement surface images with representative PCI values are shown in Figure 7.

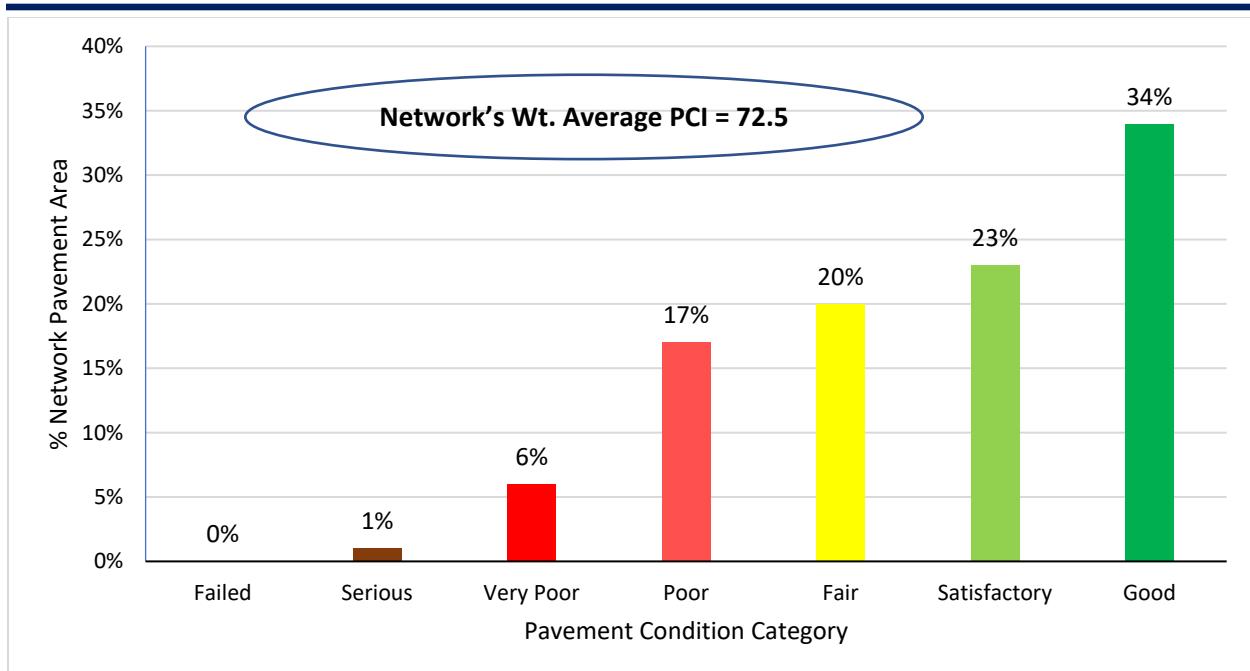
**Figure 8. Distribution of network pavement area based on pavement condition.**

Figure 8 shows the distribution of network pavement area based on pavement current conditions. In Figure 8, it can be observed that only 1% of the pavement network is in ‘serious’ condition. It is observed that about 23% of the network is in ‘poor’ or ‘very poor’ condition whereas about 57% of the network is in ‘satisfactory’ or ‘good’ condition. Figure 9 shows the detail distribution of pavement conditions based on the functional class of the streets.

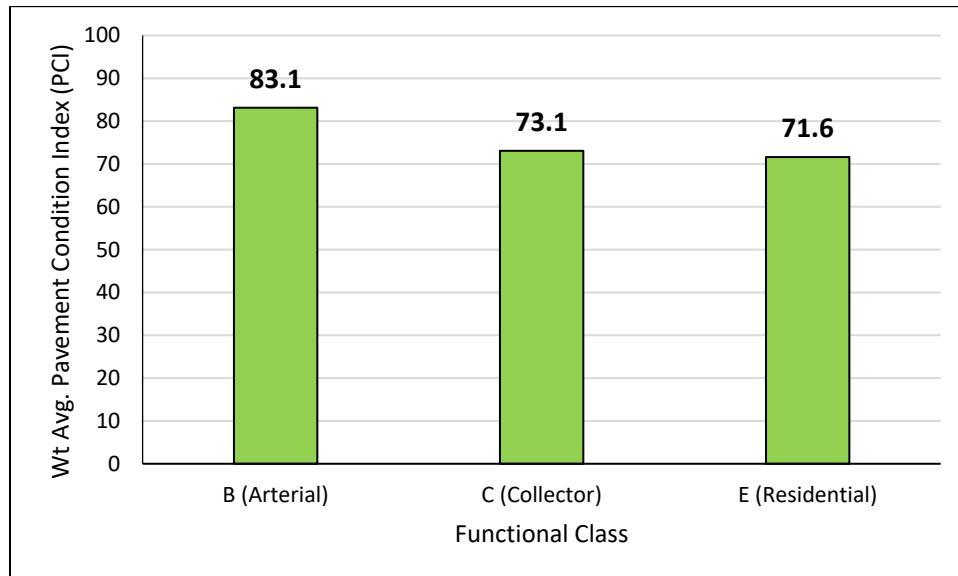
**Figure 10. Average pavement condition index (PCI) based on functional class.**

Figure 10 shows the average pavement condition based on functional class. The collector pavement sections comprise about 16.3% of the network by mileage and are in “satisfactory” condition with an average PCI value of 73.1. The arterial pavement sections comprise about 3.5% of the network by mileage and are in “satisfactory” condition with an average PCI value of 83.1. The major part (80.2% by mileage) of the network consists of residential streets and are on “Satisfactory” condition with an average PCI value of 71.6. A GIS map with PCI scores for all of the segments is shown in Figure 11.

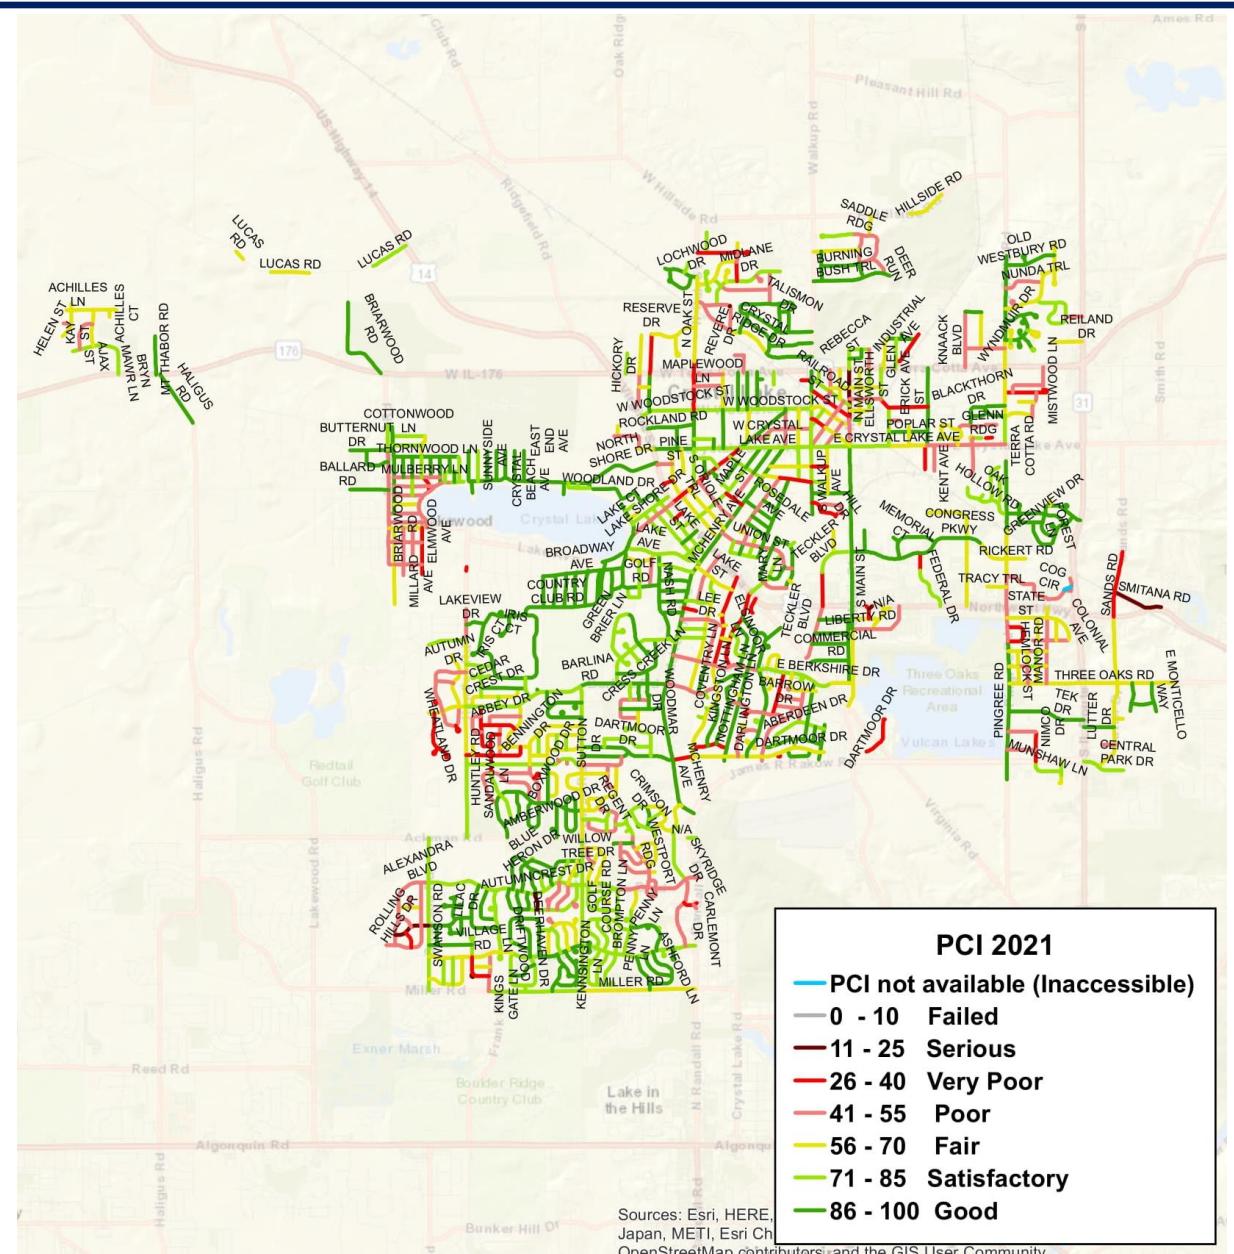
Figure 11. City of Crystal Lake's current pavement condition ratings.

Based on the April 2021 pavement condition survey, the weighted average PCI of the network is 72.5, which represents a pavement network is in “satisfactory” condition. ARA discussed the results of the PCI survey on June 29, 2021. Table 2 shows the pavement condition, percent area, number of sections, and number of sections by pavement surface type.
