2019 “State of the Streets”

Final Report

**Village of Dixmoor, Illinois &
Chicago Metropolitan Agency for Planning**

Gorrondona and Associates, Inc.
Pavement Engineering Division

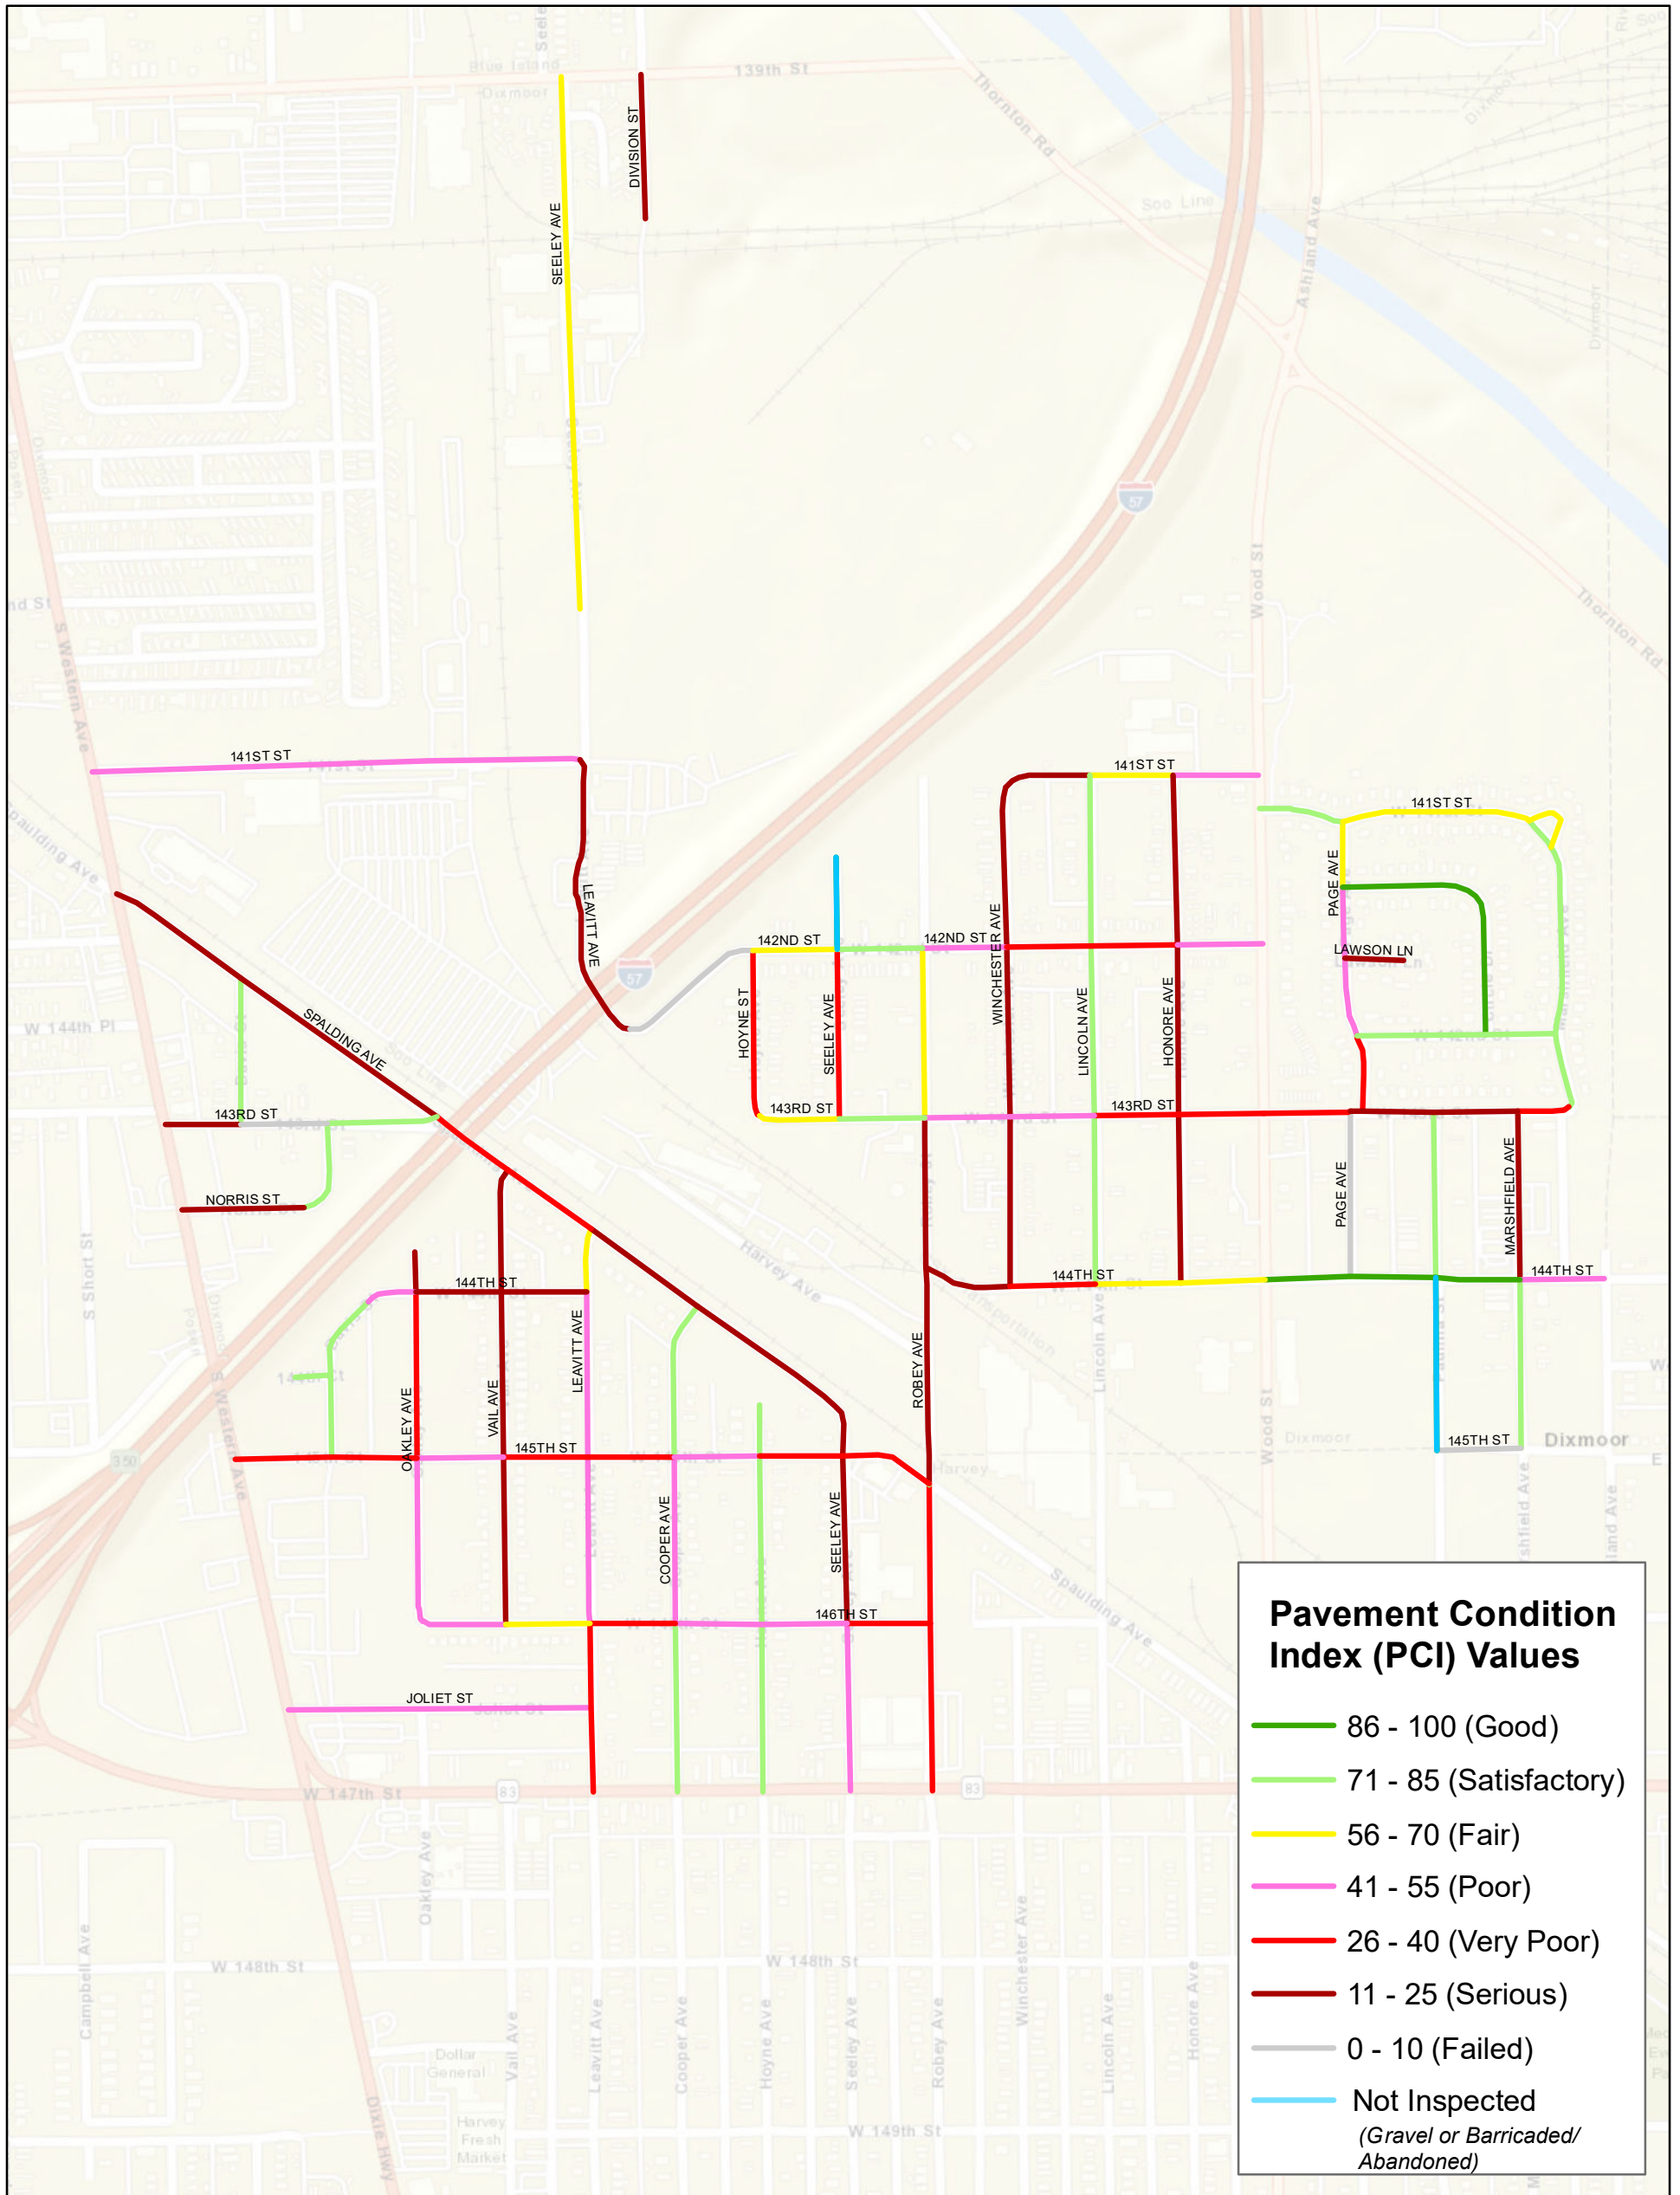
Map 1:
Pavement Condition Index
(PCI) Values

At the time of G&AI’s June 2019 inspection, the Village’s pavements were found to have an average PCI of 46, indicating that the Village’s roadways are in overall “poor” condition.

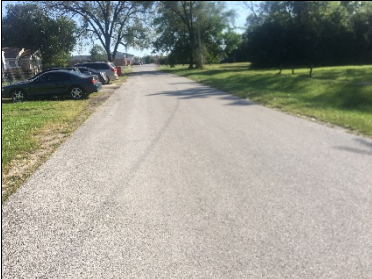
Location + History	PCI (IRI)	Recommended M&R Activity (Typical)
	Davis Ave. Near 144 th St. (Section 10) Last resurfacing date 2010	74 (319)	Preventive maintenance Seal joints between pavement and curb and gutter + surface treatment

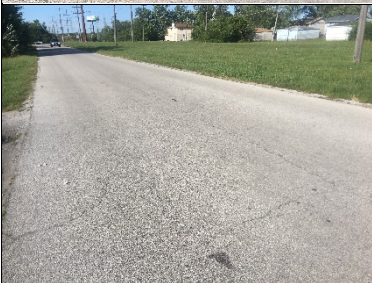
Robey Ave. Near 143 rd St. (Section 50) Last resurfacing date 2010	66 (193)	Preventive maintenance Seal cracks, paving lane joint and joints between pavement and curb and gutter + surface treatment

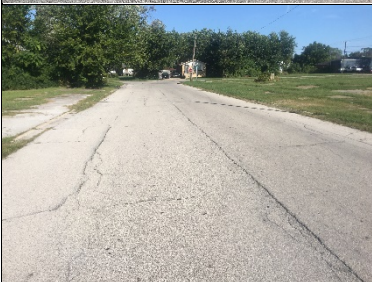
Joliet St. West of Leavitt Ave. (Section 10) Last resurfacing date unknown	55 (289)	Major M&R Localized patching + cold mill and overlay

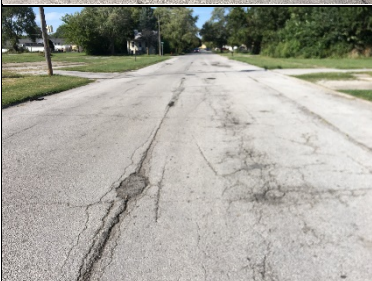
Leavitt Ave. Near W. 147 th St. (Section 30) Last resurfacing date unknown	53 (332)	Major M&R Localized structural patching + cold mill and overlay <u>or</u> reconstruction

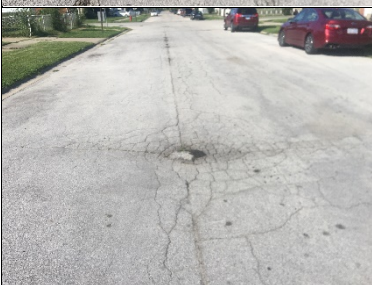
Vail Ave. South of 145 th St. (Section 10) Last resurfacing date unknown	19 (595)	Major M&R Localized structural patching + cold mill and overlay <u>or</u> reconstruction

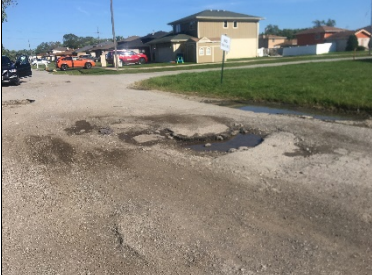
<p>142nd St. <i>Near Hoyne St. (Section 10)</i></p> <p><i>Last resurfacing date unknown</i></p>	<p>2 (>1,000)</p>	<p>Major M&R <i>Reconstruction</i></p>
---	---	---------------------------------	---
