Pavement Data Collection and Pavement Management System Implementation for Village of Dolton

Prepared for
Village of Dolton, Illinois
In Association with
Chicago Metropolitan Agency for Planning

FINAL REPORT

June 2020

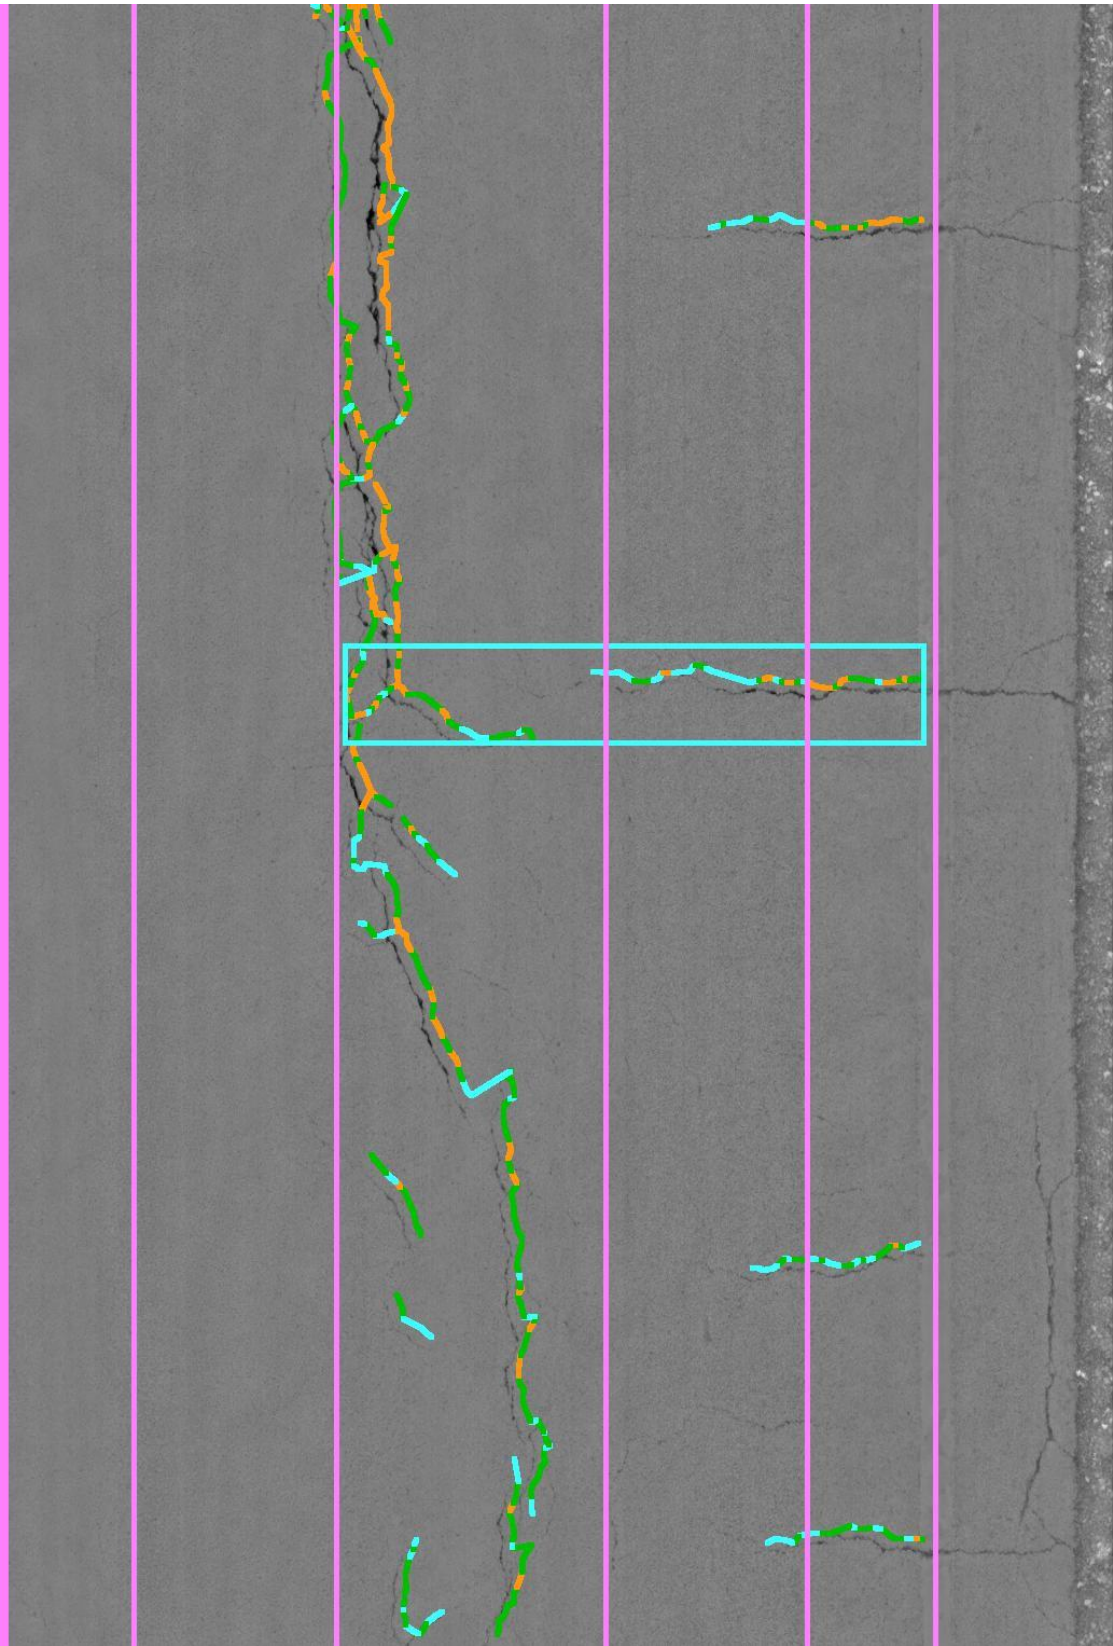
Figure 5. Pavement distress detection using LCMS system.

ARA’s LCMS system identifies the pavement distresses and reports the type, severity, and extent of key pavement distresses as shown in Figure 5. Some sample pavement surface images with representative PCI values are shown in Figure 6.

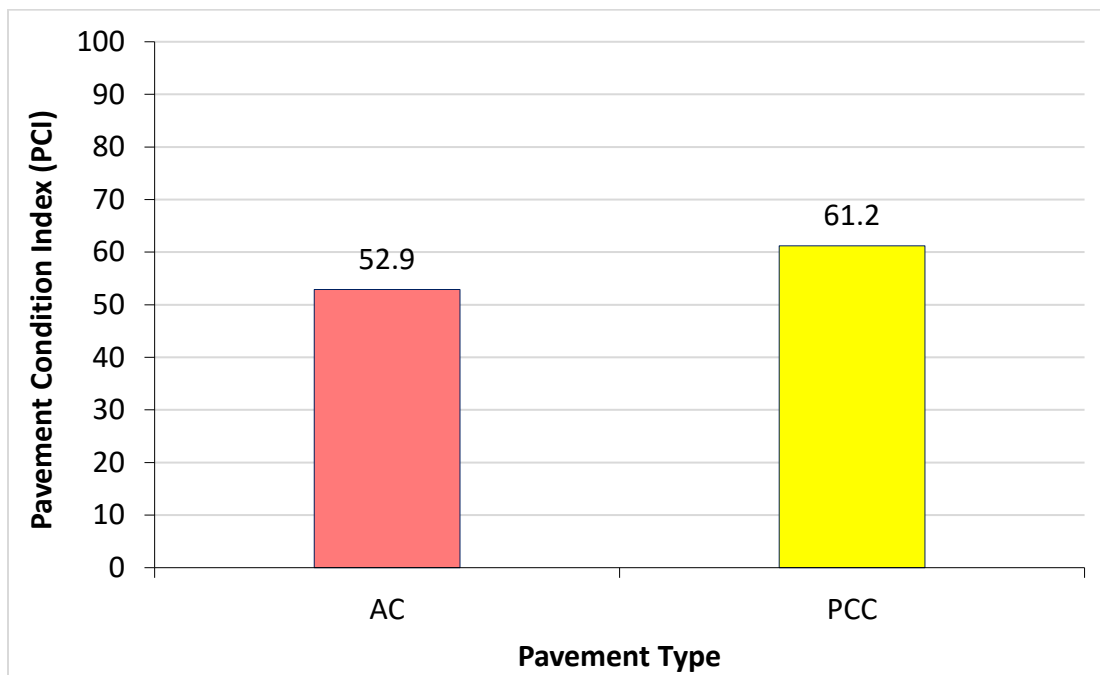
Figure 7. Average pavement condition by pavement surface type.

Table 2 shows the pavement condition, total pavement area, percent area, and the number of sections by pavement surface type. Figure 7 displays average pavement condition by pavement surface type. From Table 2, it can be seen that 99% of the pavement surface of the Village of Dolton network is built with asphalt concrete (AC). However, there are three Portland cement concrete (PCC) sections in the Village’s network.

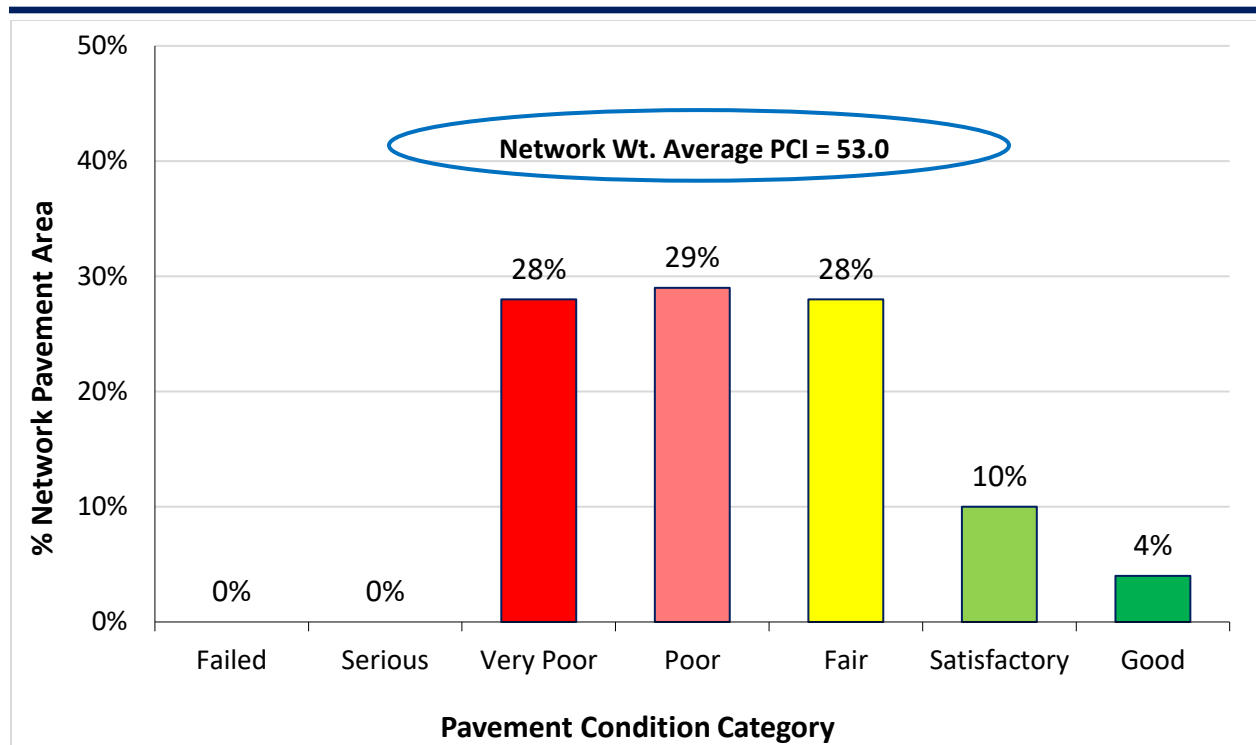
Figure 8. Distribution of network pavement area based on pavement condition.

Figure 8 shows the distribution of network pavement areas based on pavement current conditions. It can be noticed that no pavement section is in serious or failed condition as of August 2019.

In Figure 8, it can be observed that about 28% of the network pavement area is in ‘very poor’ condition. About 29% of the pavement area is in ‘poor’ condition. It can also be seen that about 28% of the network is in ‘fair’ condition, whereas about 14% of the network pavement area is in ‘satisfactory’ and ‘good’ condition.

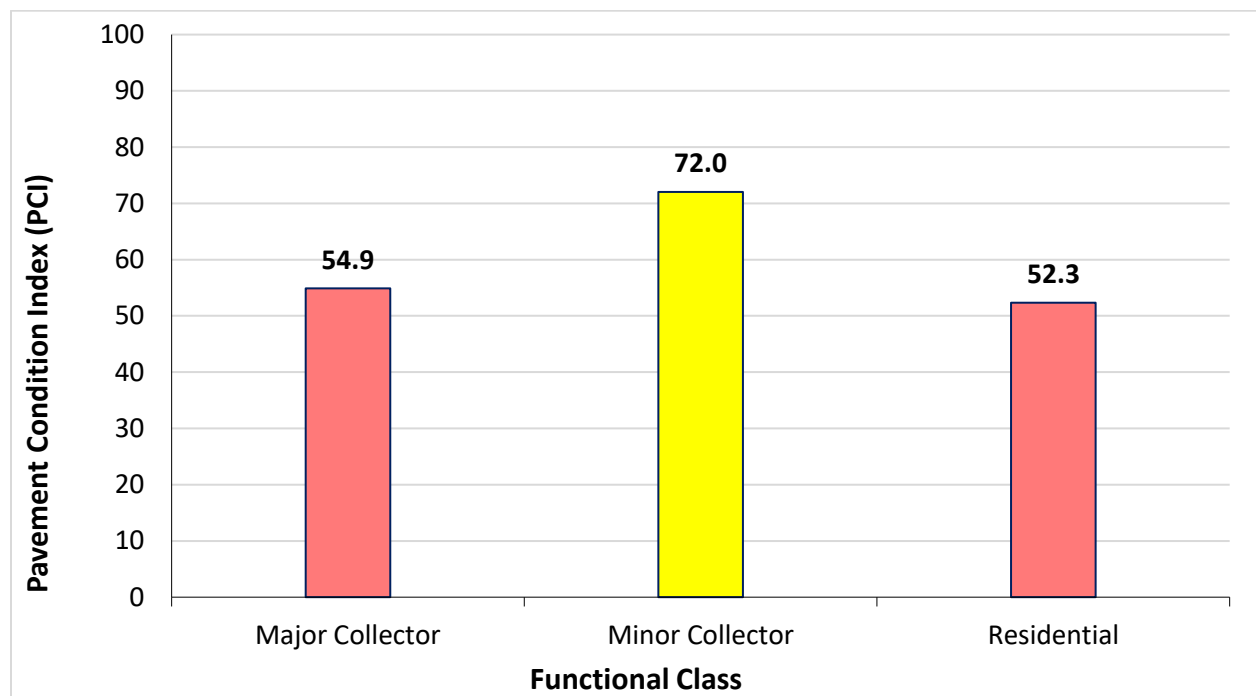
Figure 9. Weighted average pavement condition index (PCI) based on functional class.

Figure 9 displays the current pavement condition distributions based on the functional class. It can be seen that minor collector pavements are in fair condition whereas major collectors are transitioning from fair to poor condition. About 94% of the network consists of residential streets with an average PCI value of 52.3, which indicates poor condition.

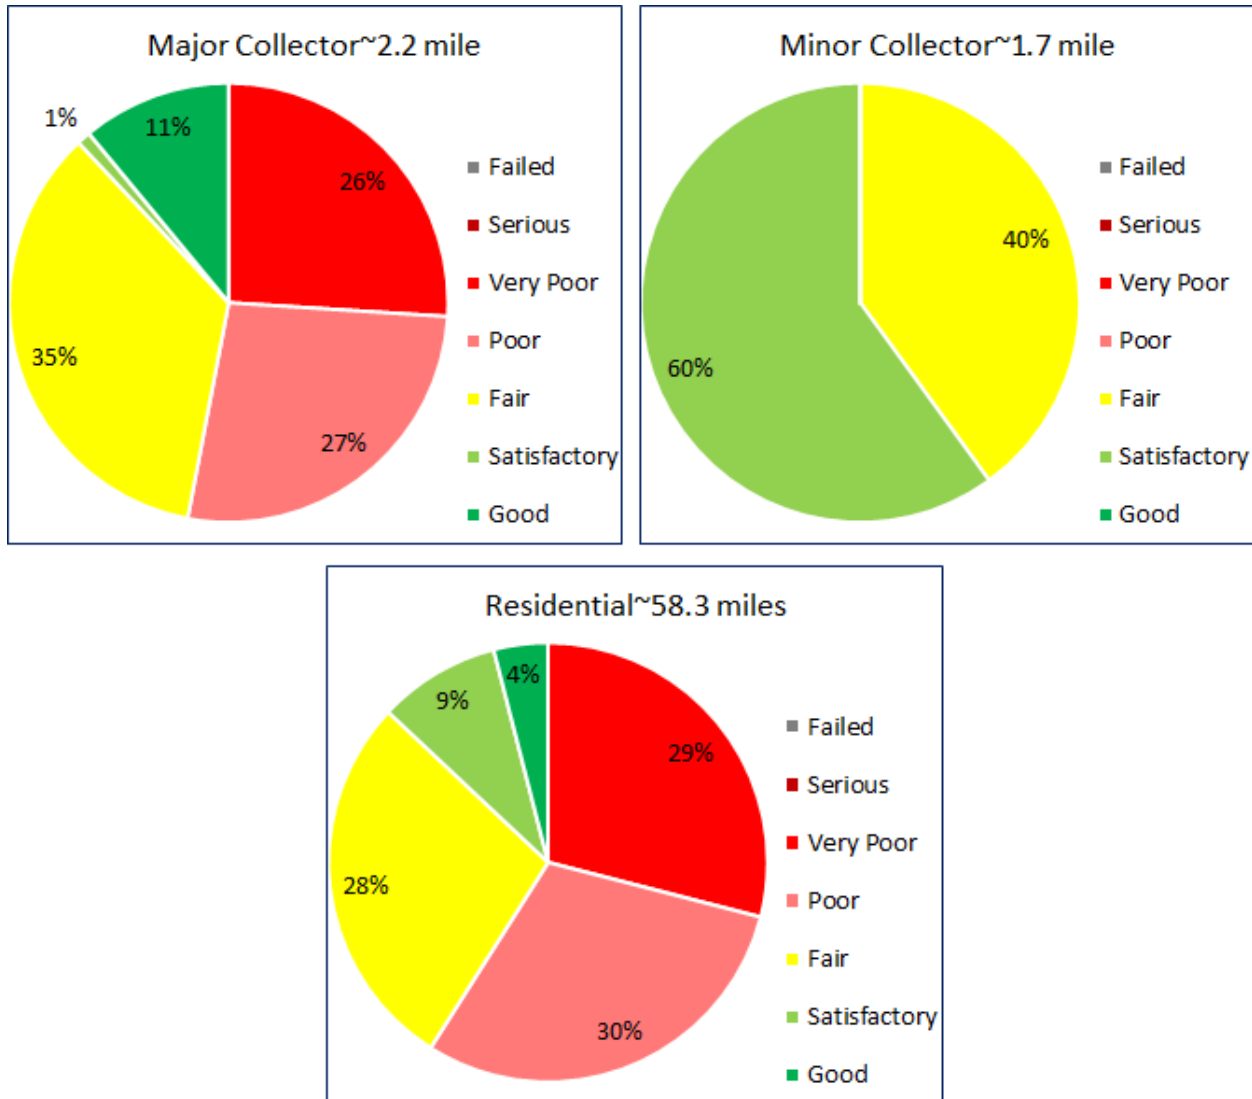
Figure 10. Details of the pavement condition distribution based on the functional class.

Figure 10 shows the detailed distribution of pavement conditions based on the functional class. It can be noticed that 59% of the residential pavements are in poor and very poor conditions.

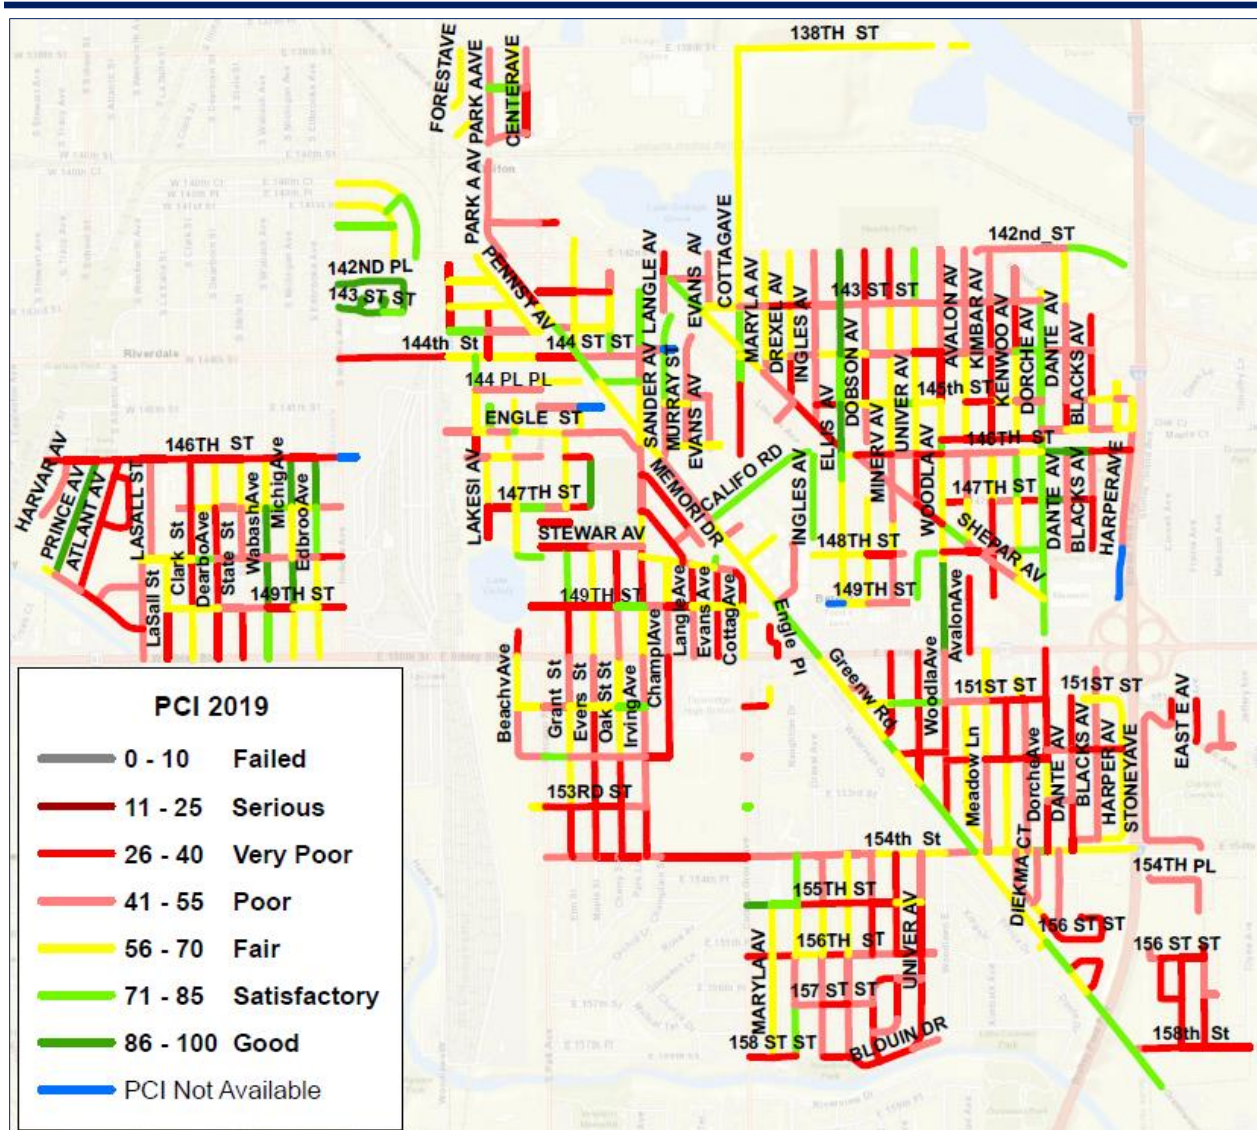
Figure 11. Village of Dolton’s current pavement condition ratings.

Figure 11 shows the pavement condition rating category for the Village of Dolton pavement sections. It can be noticed that major road such as a major part of the 154th St is in poor and very poor condition. It can also be seen that Cottage Grove Ave is in fair condition, whereas part of the 144th St is in very poor condition.
