2020 “State of the Streets”

Final Report

**Village of River Grove, Illinois &
Chicago Metropolitan Agency for Planning**

Gorrondona and Associates, Inc.
Pavement Engineering Division

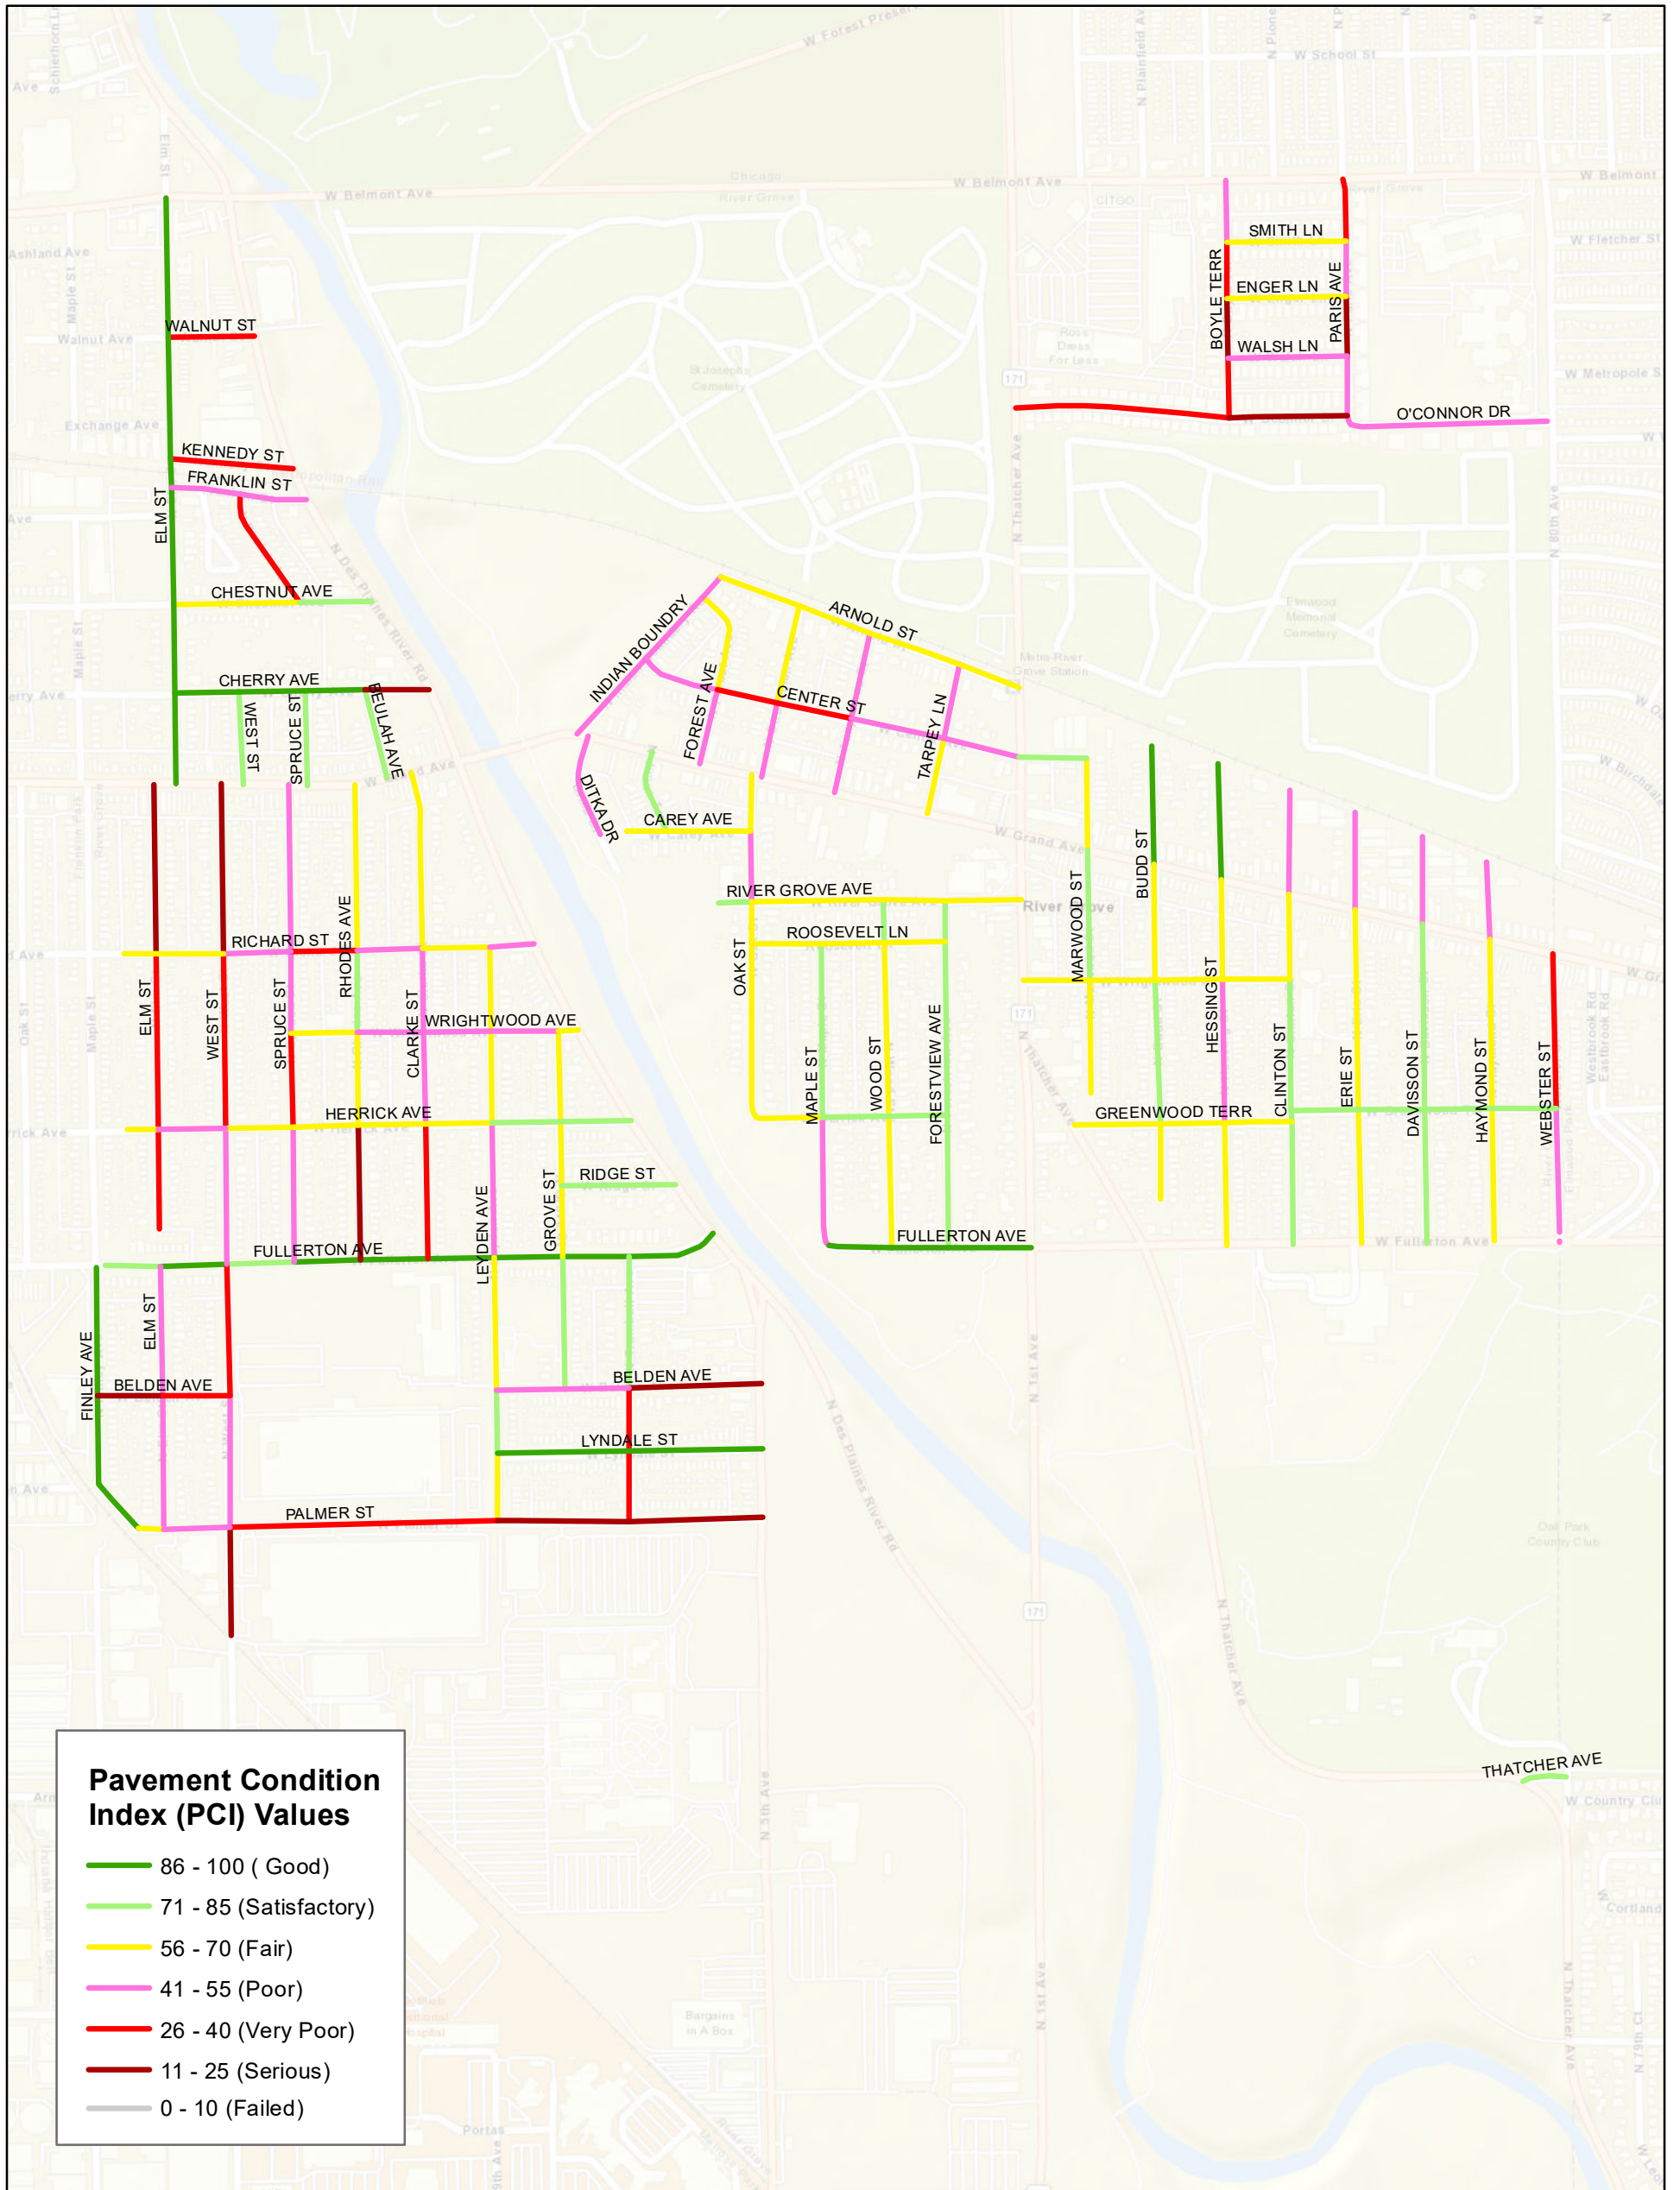
Map 1:
Pavement Condition Index
(PCI) Values

At the time of G&AI’s inspection, the Village’s pavements were found to have an average PCI of 60, indicating that the Village’s roadways are in overall “fair” condition.

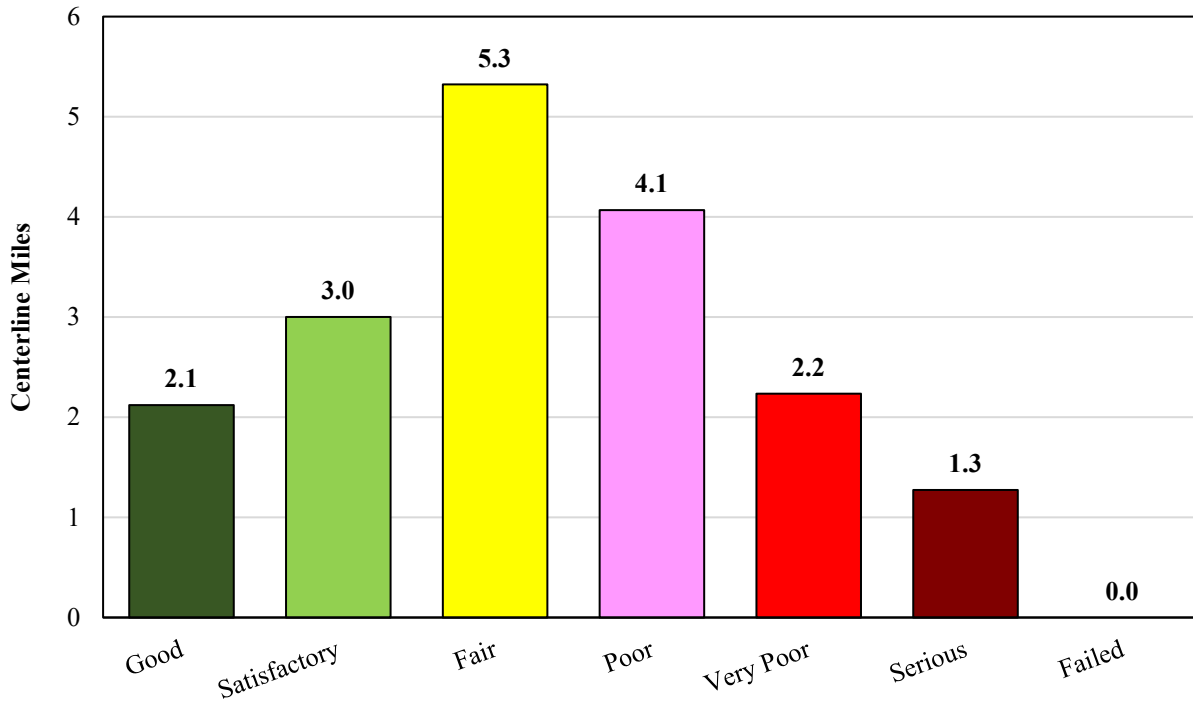
Figure 10. Village's roadway pavement condition distribution by PCI category.

At the time of G&AI’s inspection, the Village’s pavements were found to be in overall “fair” condition and have an average PCI of 60. The condition distribution of the Village’s pavements at the time of inspection is shown in Figure 10, and detailed condition maps can be found in Appendix A.

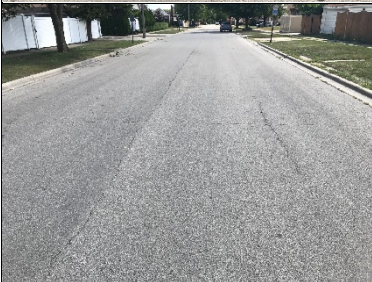
Trumbull Ave. (Section 30) Last resurfacing date 2010	75 (242)	Preventive maintenance Seal cracks as well as paving lane joint and joints between pavement and curb and gutter + surface treatment.

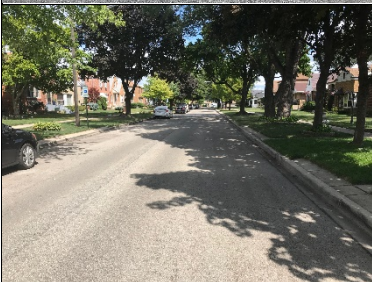
Herrick Ave. (Section 50) Last resurfacing date 2009	63 (275)	Preventive maintenance Seal cracks as well as paving lane joint and joints between pavement and curb and gutter + edge patching + surface treatment.

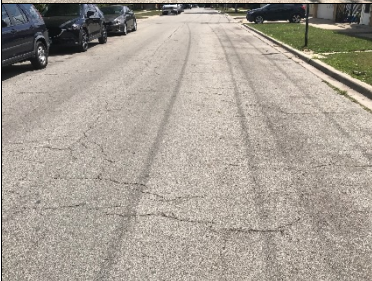
Spruce St. (Section 40) Last resurfacing date 2003	52 (229)	Major M&R Localized structural patching + cold mill and overlay <u>or</u> reconstruction

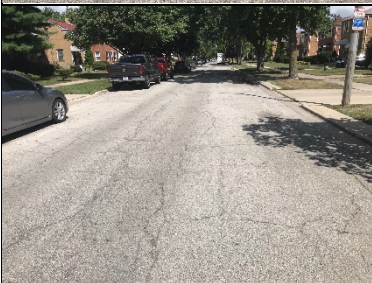
Wrightwood Ave. (Section 20) Last resurfacing date 2009	46 (288)	Major M&R Localized structural patching + cold mill and overlay

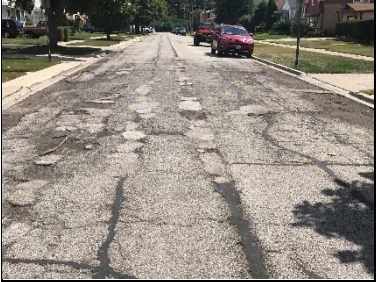
<p>Belden Ave. <i>(Section 50)</i> <i>Last resurfacing date 1992</i></p>	<p>25 <i>(397)</i></p>	<p>Major M&R <i>Reconstruction</i></p>

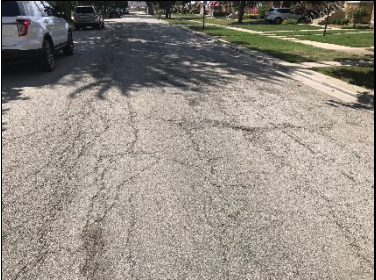
<p>Rhodes Ave. <i>(Section 10)</i> <i>Last resurfacing date 2009</i></p>	<p>23 <i>(358)</i></p>	<p>Major M&R <i>Reconstruction</i></p>
