Village of Downers Grove
Bicycle and Pedestrian Plan

Pedestrian Infrastructure Report

09.07.12

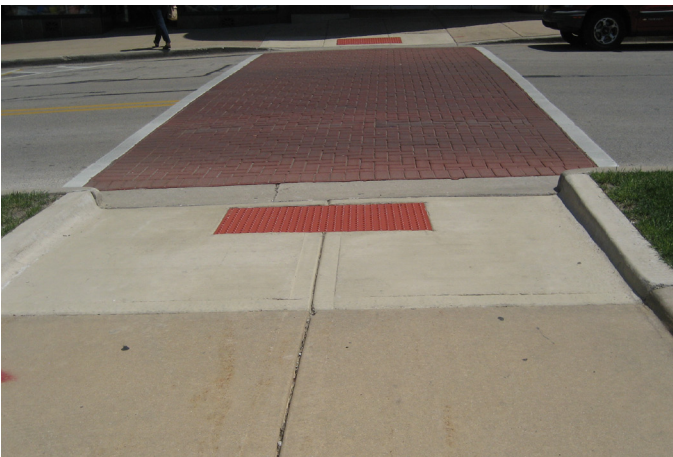
The most common violation among the curb ramps was missing detectable warning strips. Over half of the ramps were missing these, which serve to alert visually impaired pedestrians that they are about to enter into vehicle space. The survey only took note of the presence or absence of warning strip; however,

er, several locations were noted where the warning strip was included, but did not extend the full width of the ramp. It should be noted for future installations that the warning strip should extend the full width of the ramp or blended transition, according to PROWAG

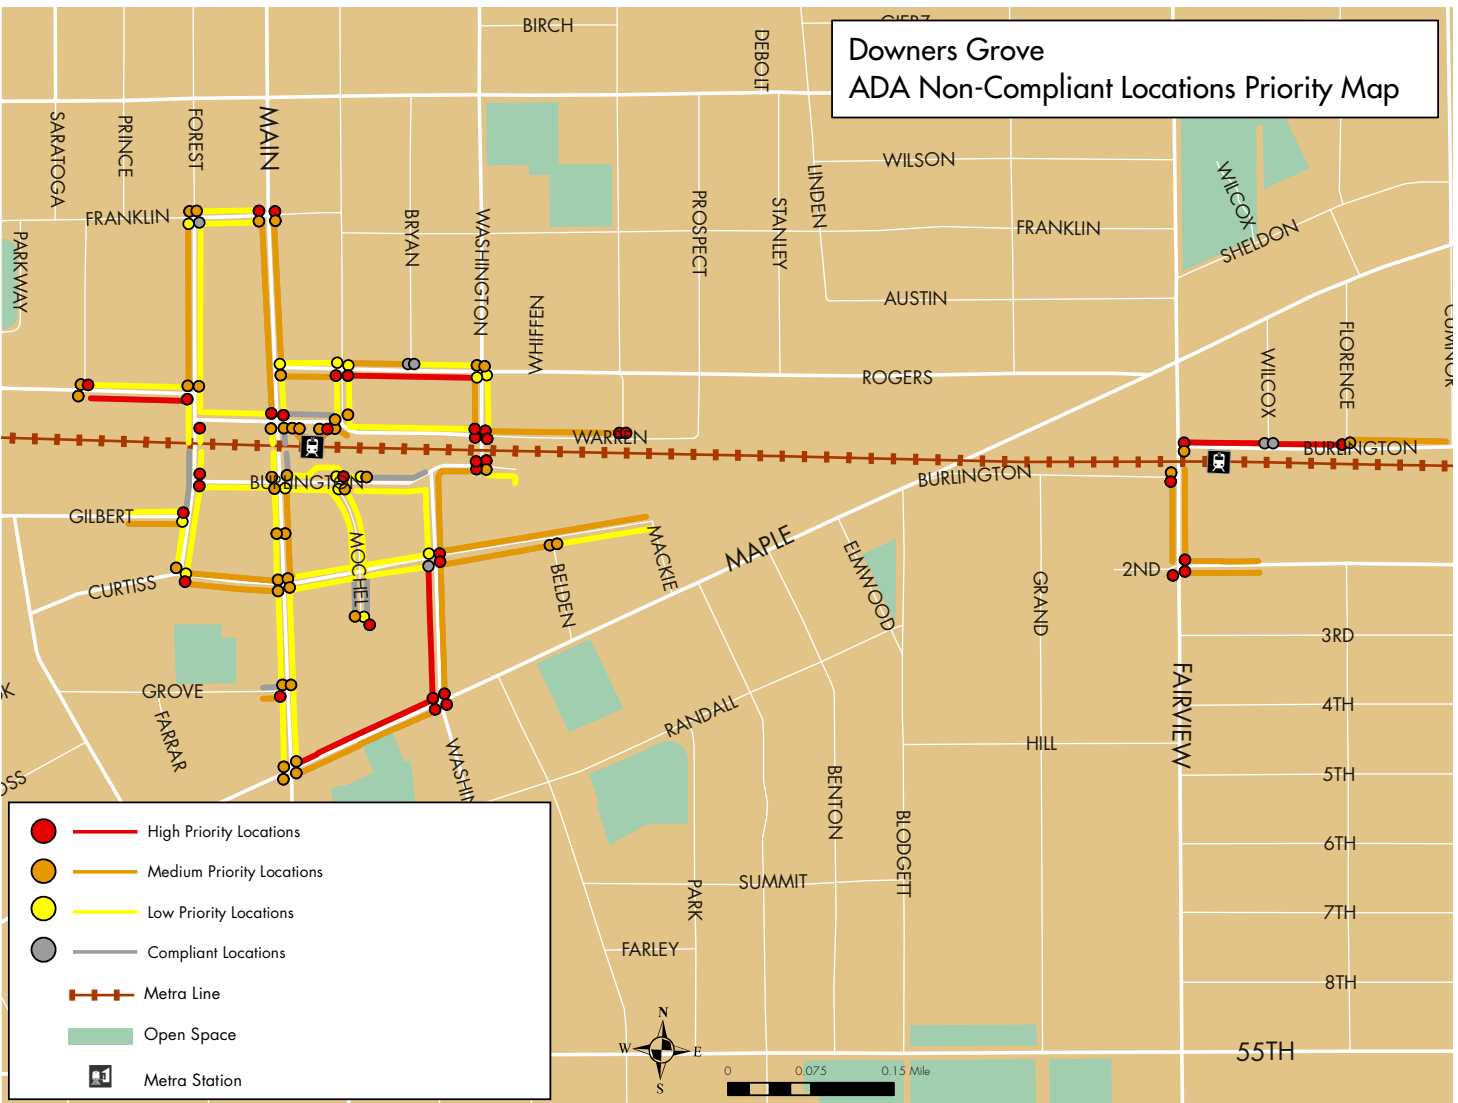
The following map suggests priorities for the physical improvements needed to comply with ADA requirements. The priorities were determined based on the following criteria:

High Priority – Blocks and intersections with two or more non-compliant elements needing more intensive renovation:

- Running slope or cross-slope is too high
- Tripping hazard >1”
- Fixed obstruction
- Narrow through width
- Missing detectable warning strip

Medium Priority – Blocks and intersections with one non-compliant element needing more intensive renovation.

Low Priority – Blocks and intersections with other non-compliant elements such as low tripping hazards, temporary obstructions, or pedestrian push buttons that are out of place.

- Develop a cost estimate for each type of improvement, i.e. curb ramp replacement, sidewalk re-grading, etc.
- Develop a schedule for physical changes. In some cases, the low priority items may require simple fixes at little or no cost and therefore may come before the higher-priority changes in the schedule.
- Submit the proposed changes and budget to the Village Board for approval.
- Re-evaluate the schedule annually or as new findings from additional evaluations are completed.
