Burlington, IL

Pavement Management Analysis Report

March, 2020

In 2019 IMS Infrastructure Management Services, LLC (IMS) was contracted by the Chicago Metropolitan Agency for Planning (CMAP) to conduct a pavement condition assessment and funding analysis for the Village of Burlington, IL on approximately 9.4 centerline miles of Village maintained asphalt roadways.

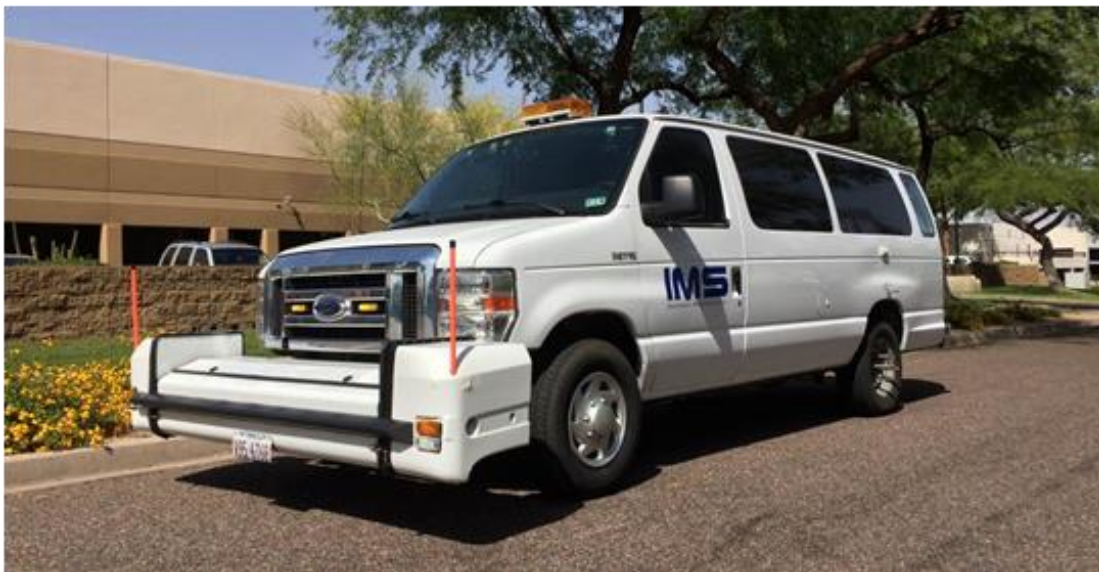
Figure 3 – Laser Road Surface Tester (RST)

Following a set of predefined assessment protocols matching ASTM D6433, a specialized piece of survey equipment – referred to as a Laser Road Surface Tester – is used to collect observations on the condition of the pavement surface, as well as collect high definition digital imagery and spatial coordinate information. The Laser RST surveys each local street from end to end in a single pass, while all other roadway classifications are completed in two passes.

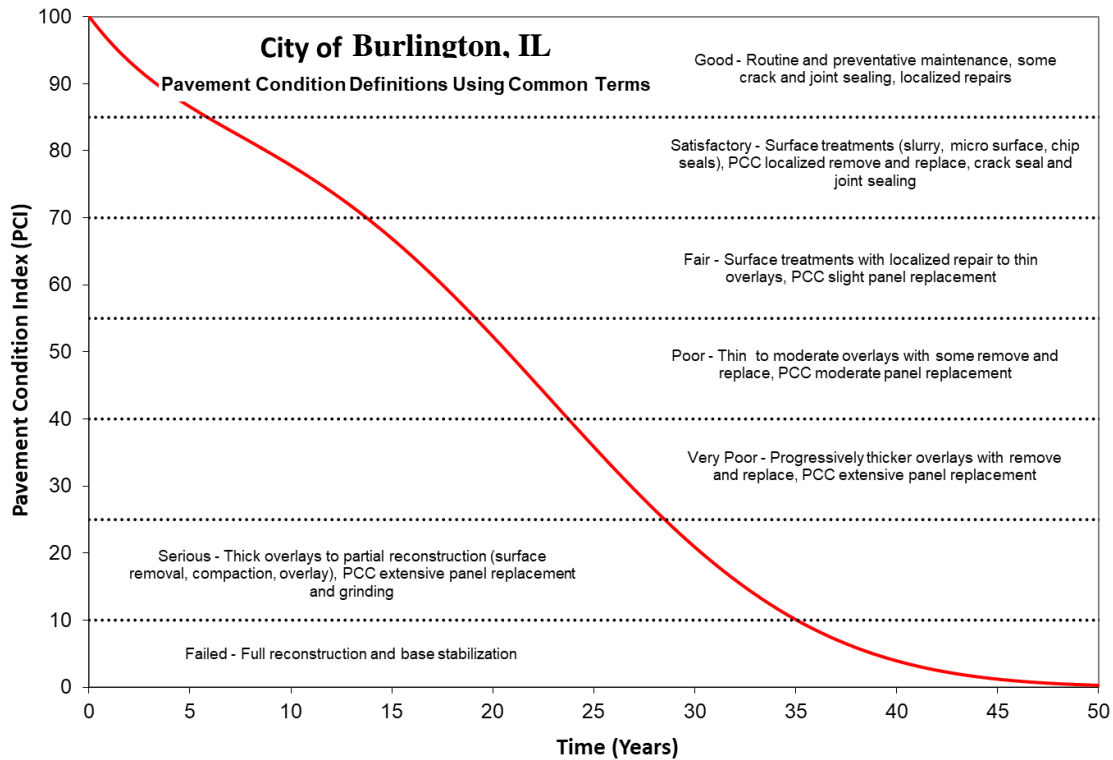
Figure 5 – Understanding the Pavement Condition Index (PCI) Score

The following compares the Pavement Condition Index (PCI) to commonly used descriptive terms. Divisions between the terms are not fixed, but are meant to reflect common perceptions of condition.

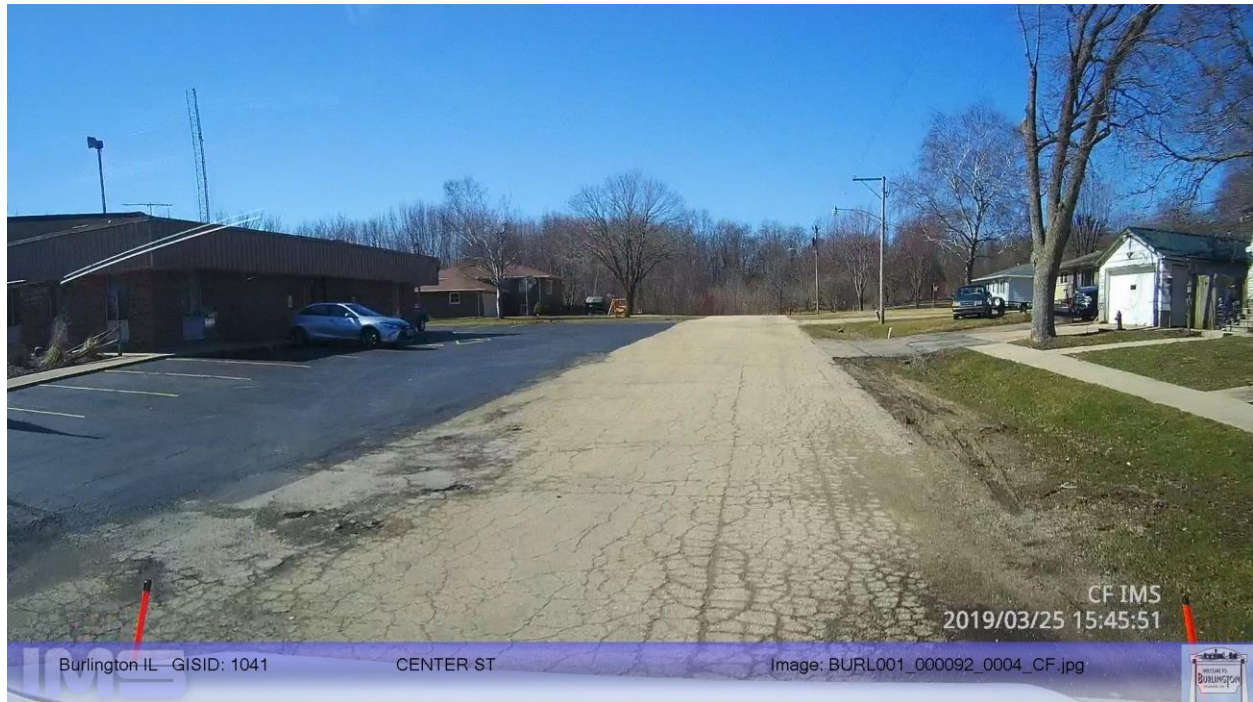
Center Street from West End to South Street (GISID 1041, PCI = 9) – Rated as Failed, this street displays spreading base failure as evidenced by the severe alligator cracking and patching. It is also worth noting that the patching along the left hand side of the street has severely deteriorated as evident by the amount loose material on the pavement surface. A mill and overlay on this street would not be suitable as the base has failed and would not meet an extended service life of at least 15 years. This street requires a full reconstruction and should be carefully monitored.

Deferral of reconstruction of streets rated as Failed will not cause a substantial decrease in pavement quality as the streets have passed the opportunity for overlay-based strategies. Due to the high cost of reconstruction, Failed streets are often deferred until full funding is available in favor of completing more streets that can be rehabilitated at lower costs, resulting in a greater net benefit to the Village. This strategy however must be sensitive to citizen complaints forcing the street to be selected earlier. In addition, this type of street can pose a safety hazard for motorists, since severe potholes and distortions may develop. It is important to consistently monitor these streets and check for potholes or other structural deficiencies until the street is eventually rebuilt.

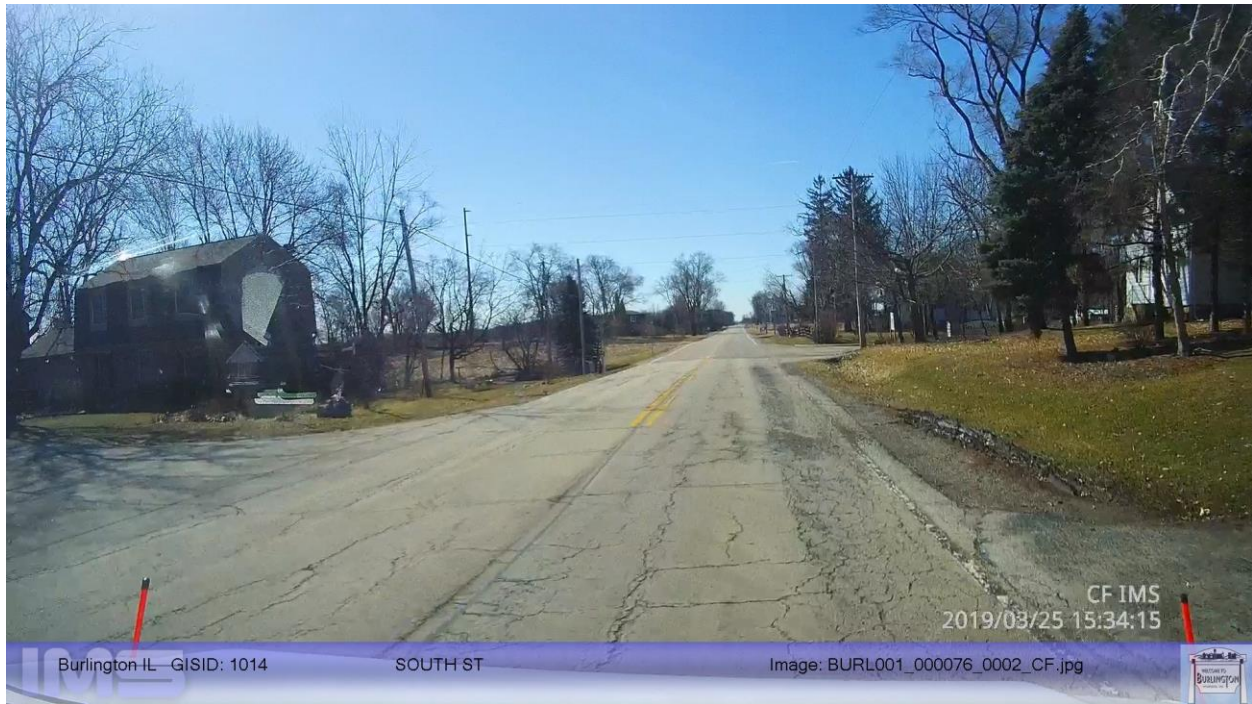
South Street from Deutsch Road to Rolling Oaks Drive (GISID 1014, PCI = 22) – Rated as Serious, this segment still has some remaining life before it becomes a critical reconstruction need. On this street, the base is showing signs of failure in areas exhibiting alligator/fatigue cracking. If left untreated, within a short period of time, a full reconstruction would be required.

On arterial roadways, Serious streets often require partial to full reconstruction – that is removal of the pavement surface and base down to the subgrade and rebuilding from there. On local roadways, they require removal of the pavement surface through grinding or excavation, base repairs, restoration of the curb line and drainage, and then placement of a new surface.

In general, the service life of Serious streets is such that if deferred for too long, it would require a more costly reconstruction. Streets rated as Serious are typically selected first for rehabilitation as they provide the greatest cost/benefit to the Village – that is the greatest increase in life per rehabilitation dollar spent.

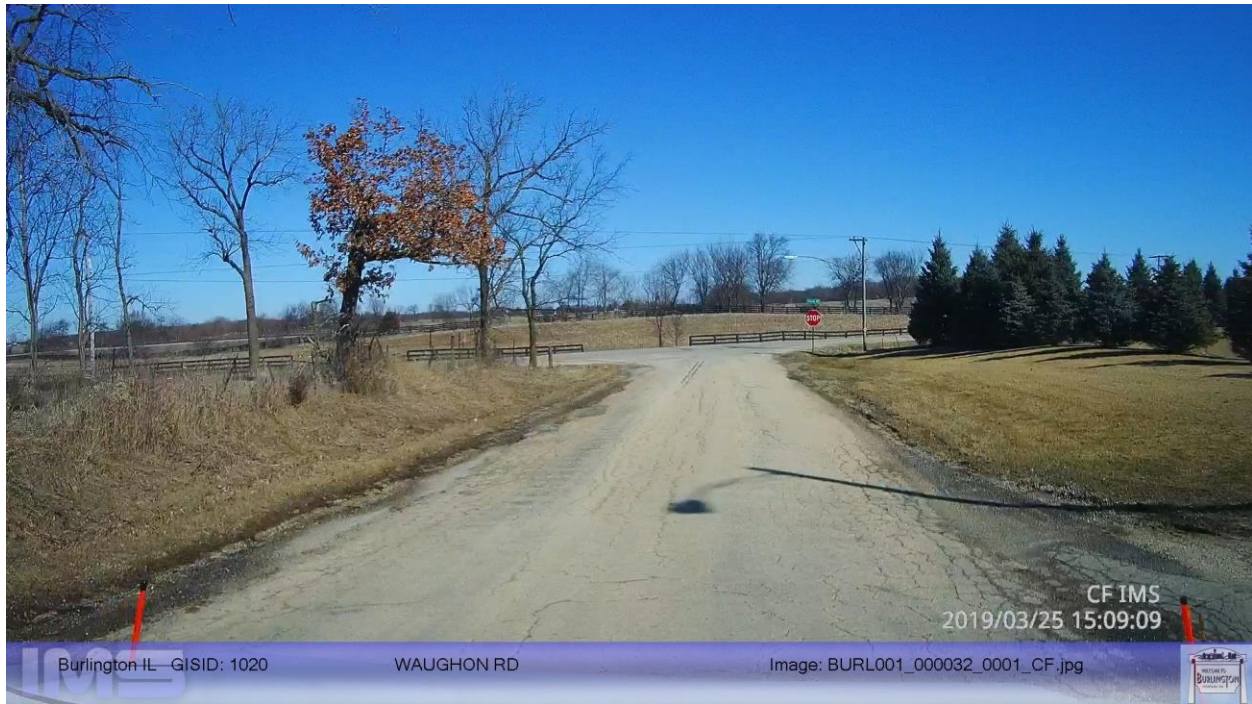
Waughon Road from Plank Road to Meadow View (GISID 1020, PCI = 32) – Very Poor streets have distresses that tend to be localized and moderate in nature – that is they do not extend the full length of the segment and can be readily dug out and repaired. This street segment highlights this characteristic as the failed area does not quite extend the full length or width of the roadway and is still serviceable.

However, it also highlights the relationship between base and pavement quality. Placing an overlay on this street without repairing the base would not achieve a full 15 year life as the failure would continue to occur over time. Structural patching of the failed areas along localized rehabs would permit a full width grind and inlay on this street segment and return it to full service.

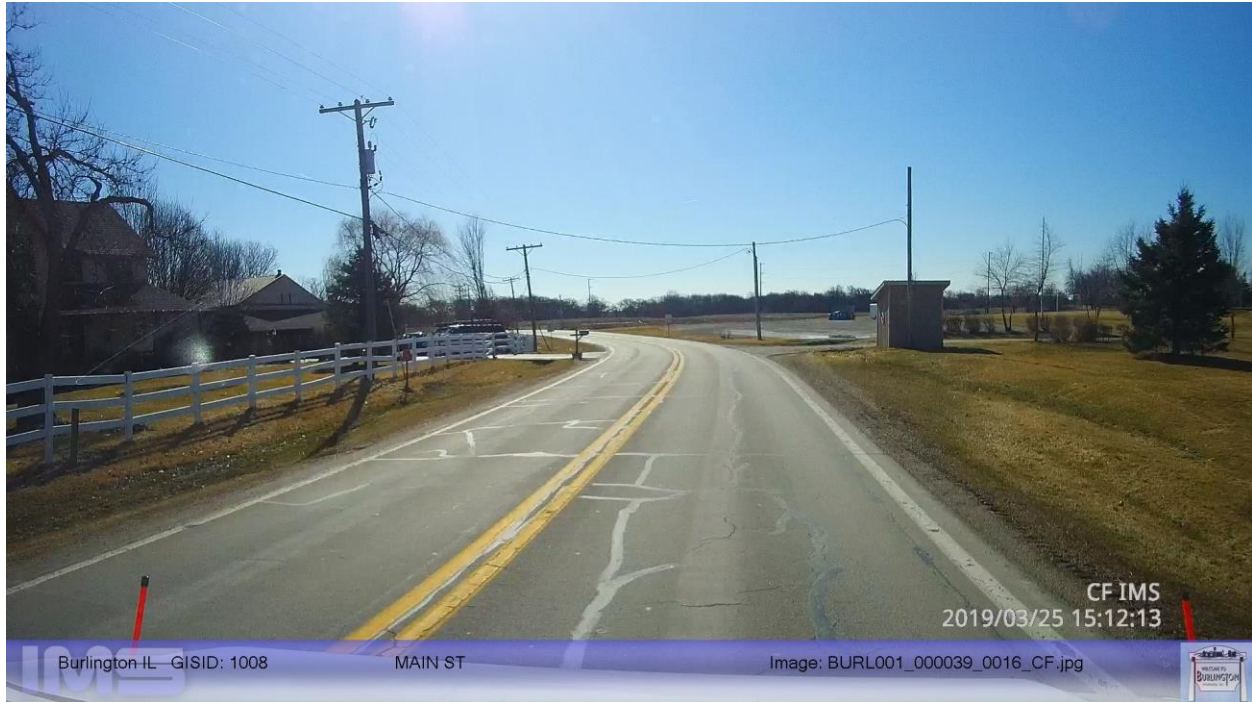
Main Street from Railroad Street to South Village Limit (GISID 1008, PCI = 49) – Rated in the poor category, these streets require thicker overlays. Several distresses are present, but tend to be more localized, moderate in severity, and less load related (longitudinal and transverse cracking and raveling). *Asphalt streets rated as poor tend to receive a higher priority as they are just below the common point for critical PCI. These streets tending to accelerate in deterioration more quickly and will become a greater burden to the budget if left untreated.*

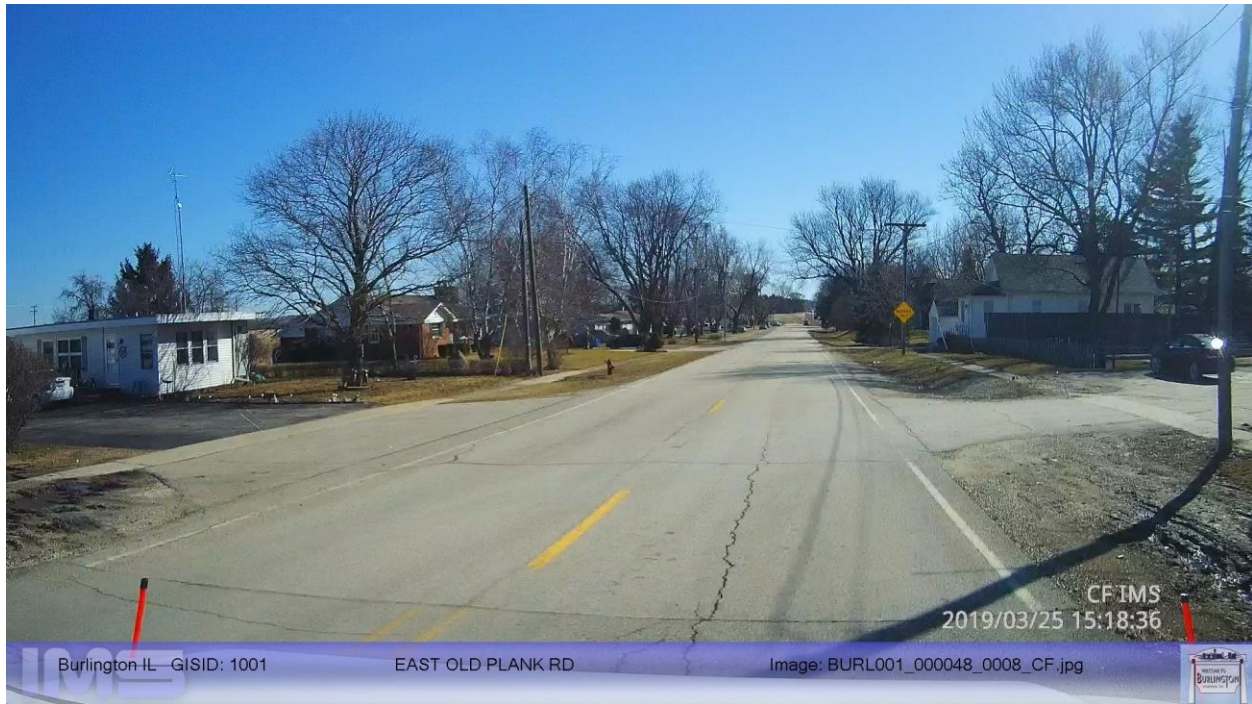
East Old Plank Road from Main Street to Center Street (GISID 1001, PCI = 58) – Rated as Fair with the primary cause of deterioration the transverse and longitudinal cracking. It also displays small amounts of load associated distresses that can easily be removed to restore the visual appearance of the roadway. The existing cracks should be sealed and the pavement surface restored, with a heavier surface treatment such as microsurfacing or double slurry to fully waterproof the pavement and cover the crack sealant. The occasional dig out and replacement may be required to correct localized deficiencies. Alternatively, depending on the extent of the distressed areas, base strength and drainage, a thin overlay may be applied.

Asphalt streets rated as Fair are ideal candidates for thinner surface-based rehabilitations and local repairs. Depending on the amount of localized failures, a thin edge mill and overlay, or possibly a surface treatment, would be a suitable rehabilitation strategy for streets rated as Fair. Streets that fall in the high

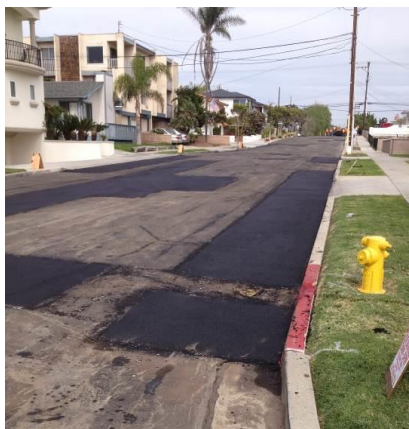
60 - low 70 PCI range provide the greatest opportunity for extending pavement life at the lowest possible cost, thus applying the principles of the perpetual life cycle approach to pavement maintenance. The adjacent photo is a great example of a street segment (not a Burlington Road) that displayed low load associated distresses and thus, high structural characteristics, and once the distressed areas were replaced, a slurry seal was applied. The patching accounted for less than 5 to 10% of the total area and resulted in a good looking, watertight final surface at a much lower cost than an overlay with less disruption to the neighborhood and curb line. The patches were paver laid and roller compacted.

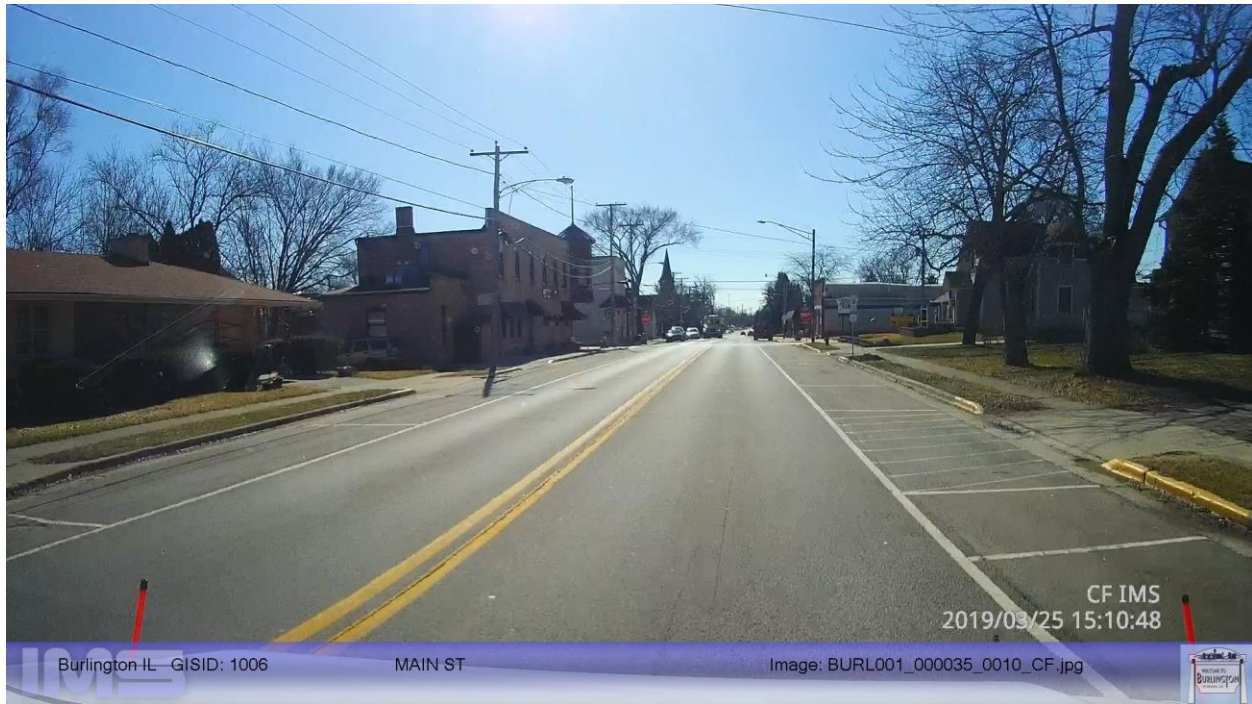
Main Street from East Old Plank Road to Center Street (GISID 1006, PCI = 80) – Rated as Satisfactory, this road displays minor amounts of transverse cracking and patching. The surface is non-weathered, and the base is still strong. This street is an example of a candidate for preventative maintenance and light weight surface treatments to extend the life of a roadway.

Asphalt streets rated as Satisfactory generally need lightweight surface-based treatments such as surface seals, slurries, chip seals or microsurfacing. Routine maintenance such as crack sealing and localized repairs often precede surface treatments. The concept is to keep the cracks as waterproof as possible through crack sealing and the application of a surface treatment. By keeping water out of the base layers, the pavement life is extended without the need for thicker rehabilitations such as overlays or reconstruction. Surface treatments also tend to increase surface friction and visual appearance of the pavement surface but do not add structure or increase smoothness.

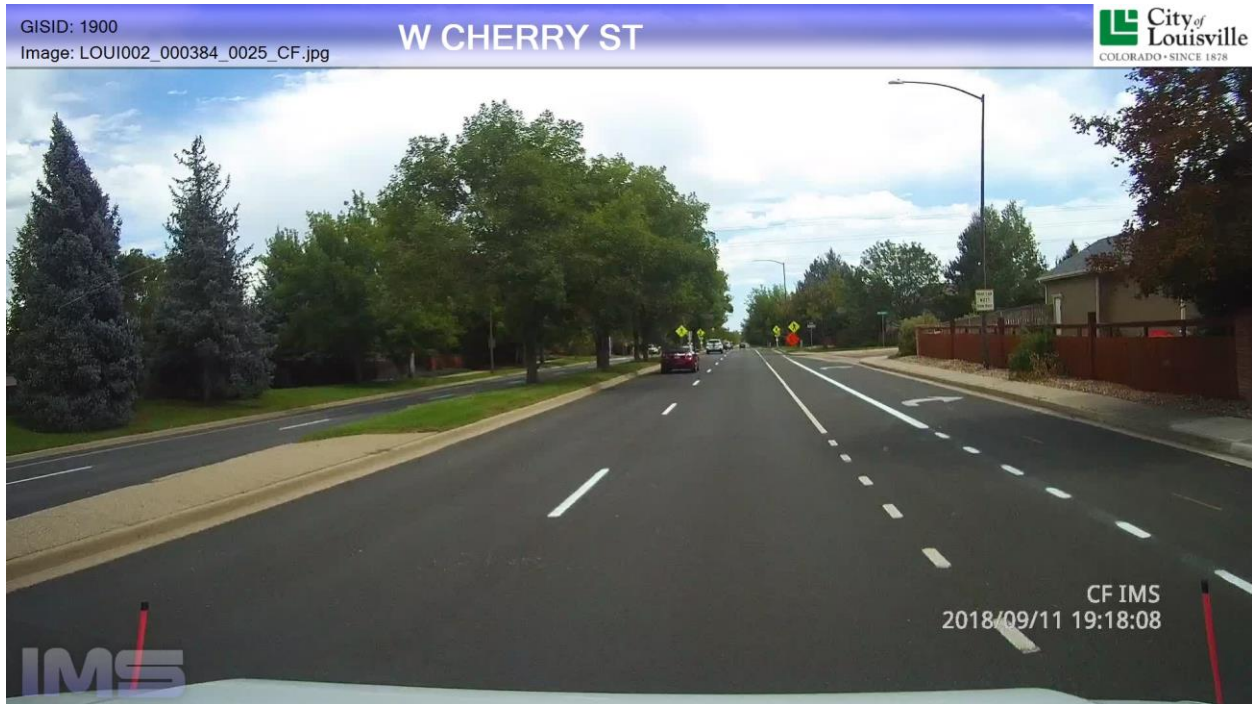
(Not a Burlington street) PCI = 97 – Rated as Excellent, displaying little to no surface distresses. The ride is smooth and the surface is non-weathered and the base is strong. In a couple of years, this street segment would be an ideal candidate for routine maintenance activities such as crack sealant rehabilitation.

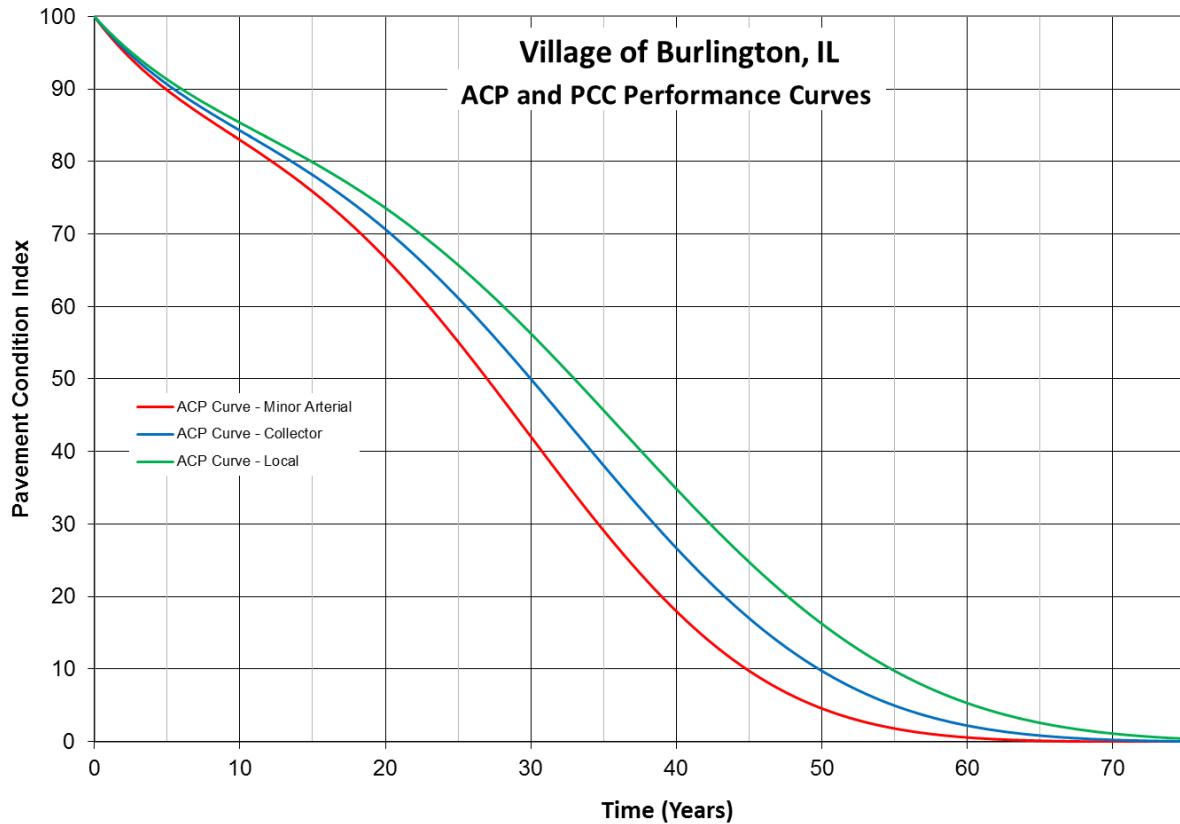
Figure 8 – Performance Curves

- Pavement performance curves that are used to predict future pavement condition. Paver allows for historical data to be used to build deterioration models that reflect actual pavement condition over time. This gives an agency the ability to group streets into families that share similar characteristics which play a part in deterioration. Examples include functional class, pavement type, AADT, soil properties, heavy vehicle traffic, test pavement, construction method. For the current project, there was no historical data available to build these curves. As a substitute, IMS created curves based on data from decades of surface surveys which the Village can use until sufficient data is available to build custom curves. **Figure 8** below illustrates these curves.

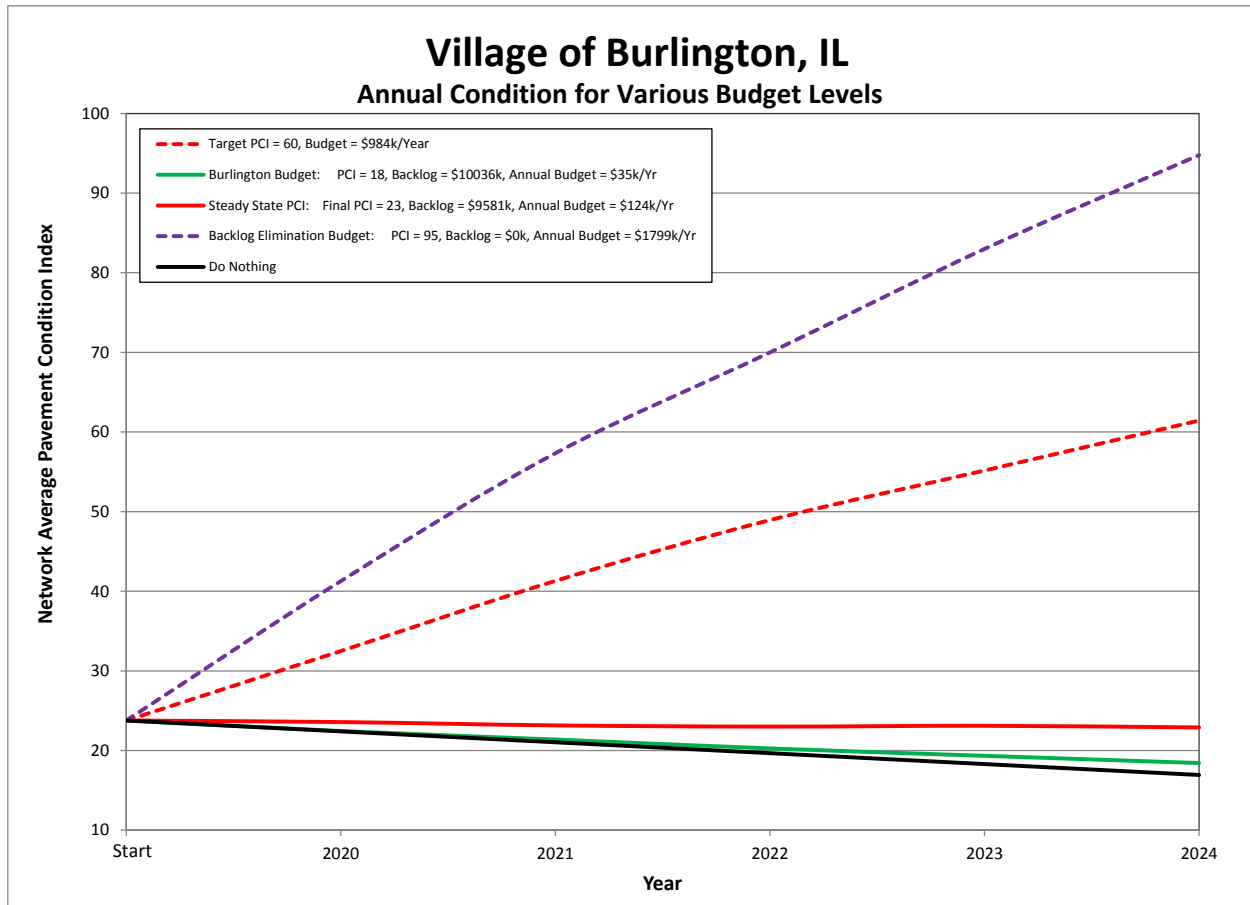
Figure 9 – 5 Year Annual PCI

Figure 9 presents the analysis results on an annual basis. This shows that if the budget falls below \$124k/year (Steady State Budget), over time the overall condition of the roads will deteriorate as backlog continues to grow.

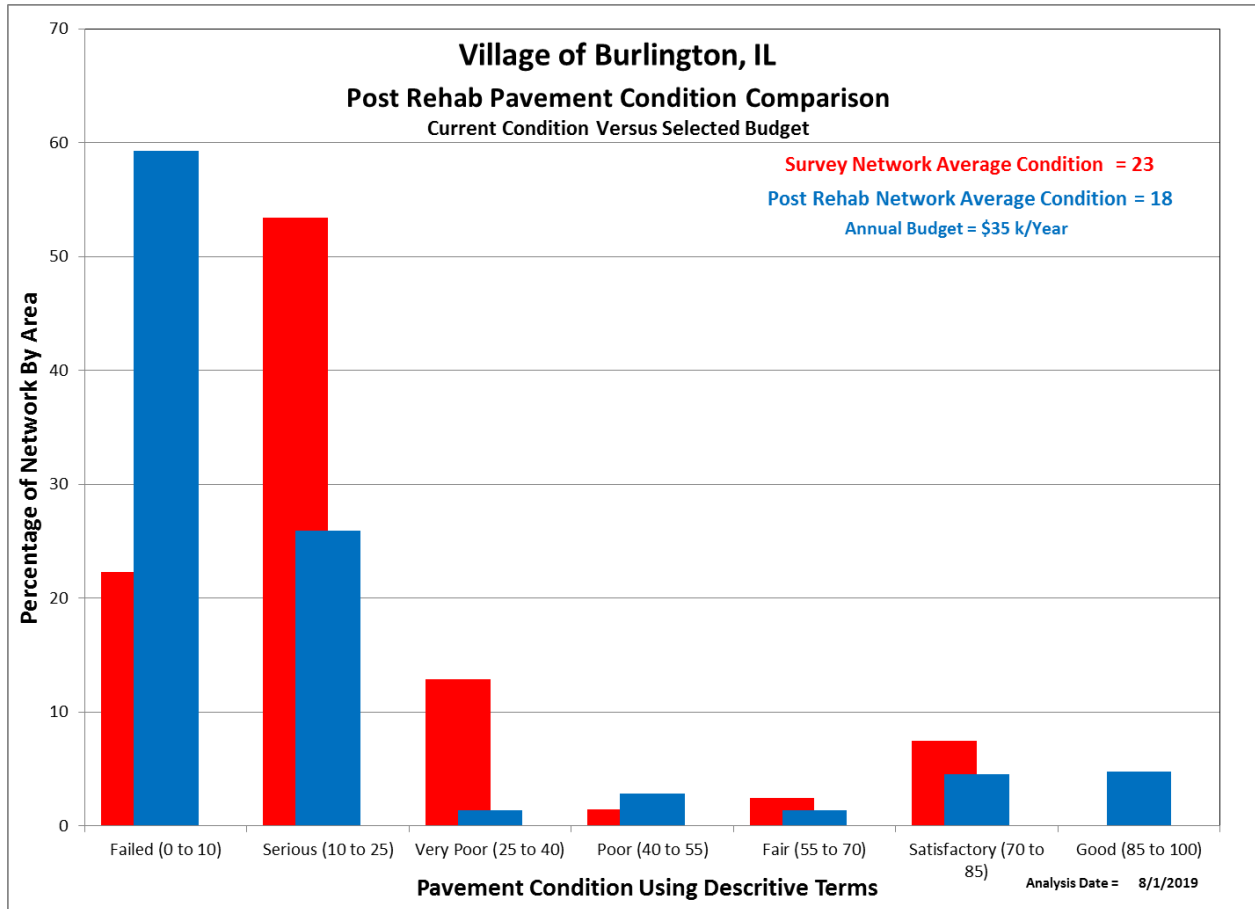
Figure 12 – Five-Year Post Rehabilitation Condition Distribution

The following figure (**Figure 12**) compares the current network condition distribution (red) against the 5-year post rehabilitation distribution would be at with a budget of \$35k/year (blue). As can be seen in the plot, the current Burlington budget will allow the overall network's PCI average to decrease.
