Pavement Data Collection and Pavement Management System Implementation for City of Markham

Prepared for
City of Markham, Illinois
In Association with
Chicago Metropolitan Agency for Planning

FINAL REPORT

June 2020

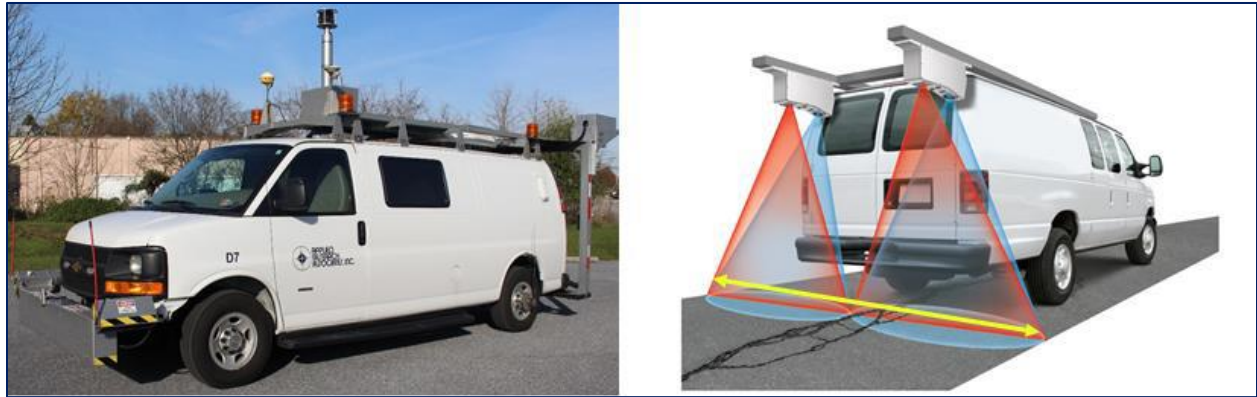
Figure 3. ARA's laser crack measurement system.

ARA collected geo-referenced images of the entire City of Markham roadway network using the DSV on July 2-6, 2019. ARA’s DSV equipped with the Laser Crack Measurement System (LCMS), shown in Figure 3, captures images at 20-ft intervals. Each image is linearly referenced with the DSV’s onboard distance measuring instrument (DMI) and associated global positioning system (GPS) coordinates. For two-lane City highways, ARA collected images in a single direction. In four-lane pavement sections, data was collected in the outermost lane in both directions.

The LCMS captures enhanced right-of-way images using a 360° camera system. The images were used to assess the surface condition of the pavement using the Pavement Condition Index (PCI) methodology in accordance with ASTM D6433. In addition to the images, sensor data was collected including the International Roughness Index (IRI) and rutting for all the segments. The weighted average IRI value of the City network is 298 inch/mile, which indicates the network is in 'unacceptable' condition in terms of pavement roughness (see Appendix A for full scale of IRI values). IRI is an index to express pavement roughness, which is an expression of the irregularities in a pavement surface that adversely affect the ride quality of a vehicle.

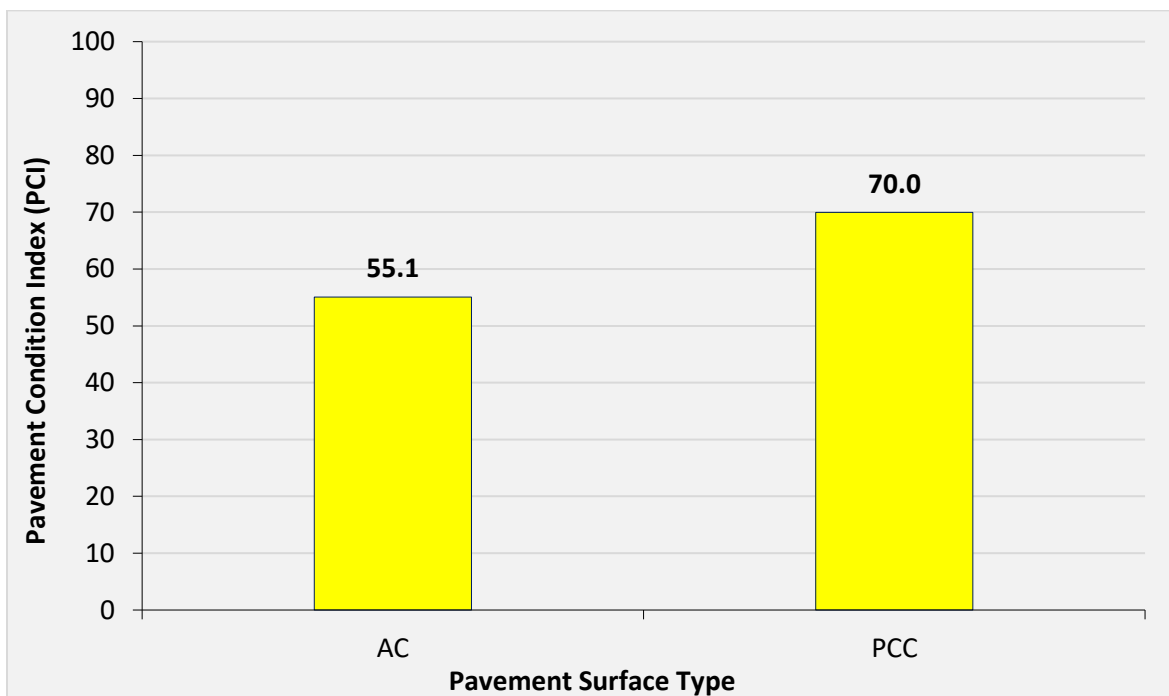
Figure 7. Average pavement condition by pavement surface type.

Table 2 shows the pavement condition, percent area, number of sections, and number of sections by pavement surface type. Figure 7 displays average pavement condition by pavement surface type. From Table 2, it can be seen that 99% of the pavement surface of City of Markham network is built with asphalt concrete (AC). However, there are four Portland cement concrete (PCC) sections in the City’s network.

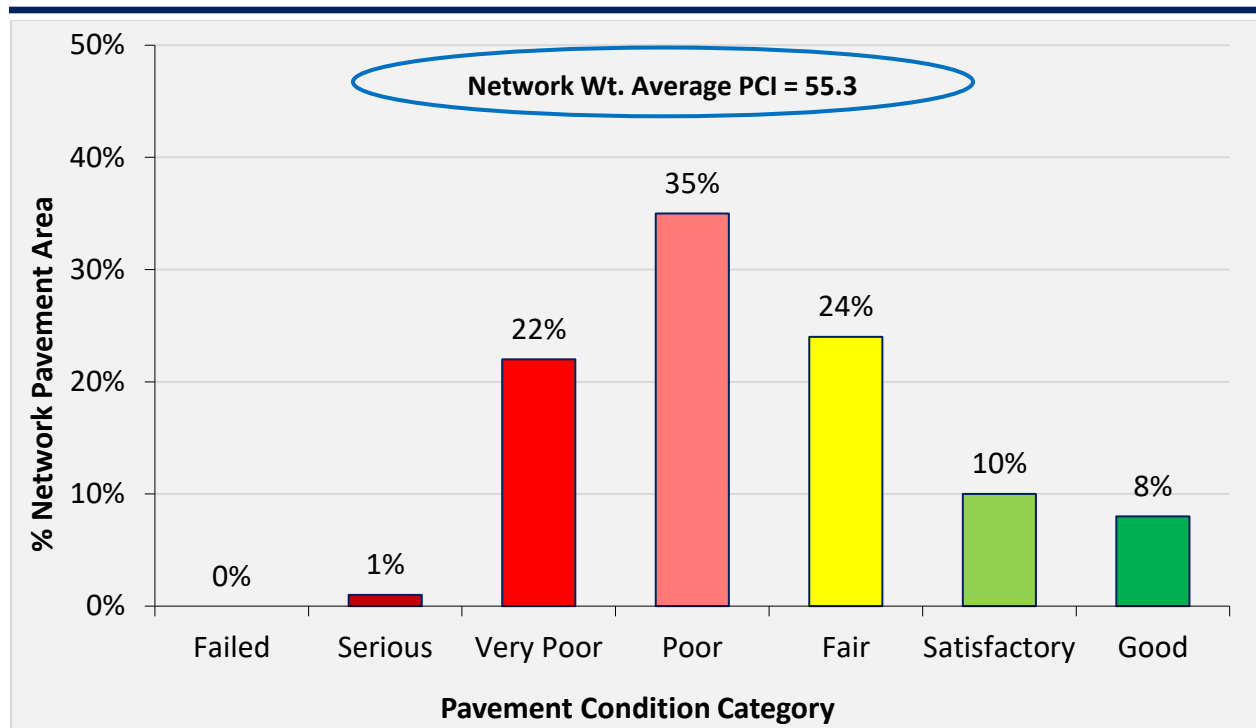
Figure 8. Distribution of network pavement area based on pavement condition.

Figure 8 shows the distribution of network pavement areas based on pavement current conditions. It can be noticed that no pavement section is in failed condition as of August 2019.

In Figure 8, it can be observed that about 1% of the network pavement area is in ‘serious’ condition. About 22% of the pavement area is in ‘very poor’ condition. It can also be seen that about 35% of the network is in ‘poor’ condition whereas about 24% of the network is in ‘fair’ condition. Only 18% of the network pavement area is in ‘satisfactory’ and ‘good’ condition.

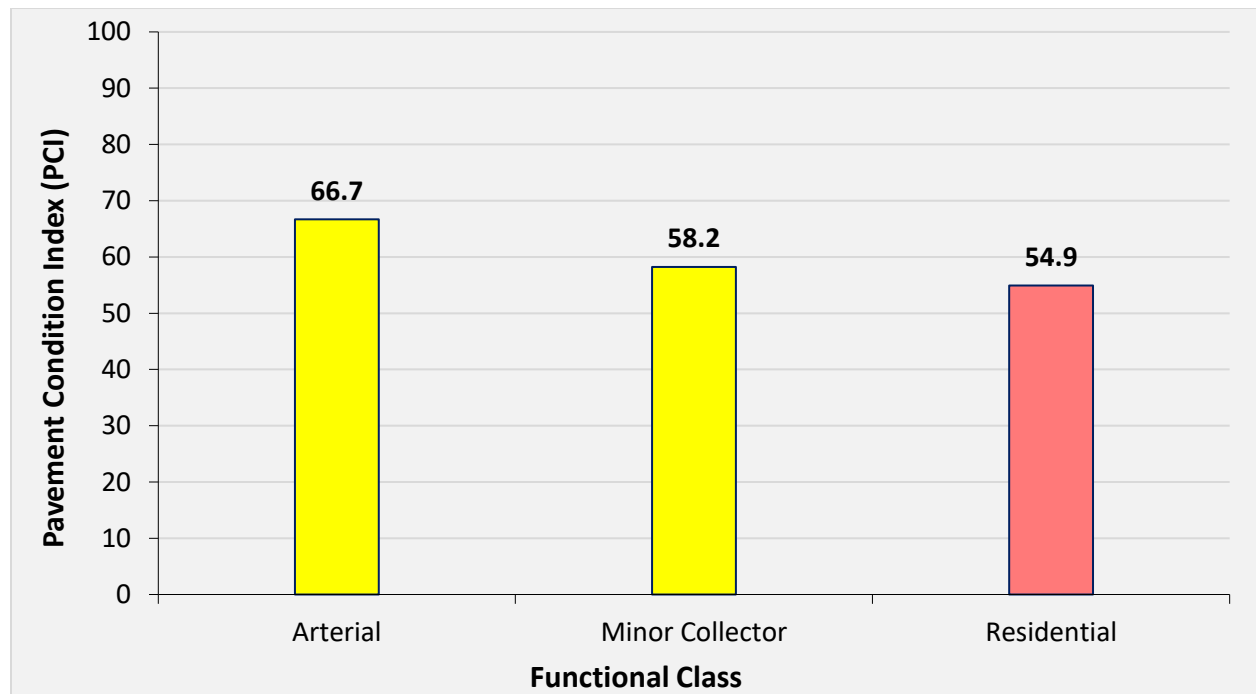
Figure 9. Weighted average pavement condition index (PCI) based on functional class.

Figure 9 displays the current pavement condition distributions based on the functional class. It can be seen that both arterial and minor collectors are in fair condition whereas residential pavements are in poor condition.

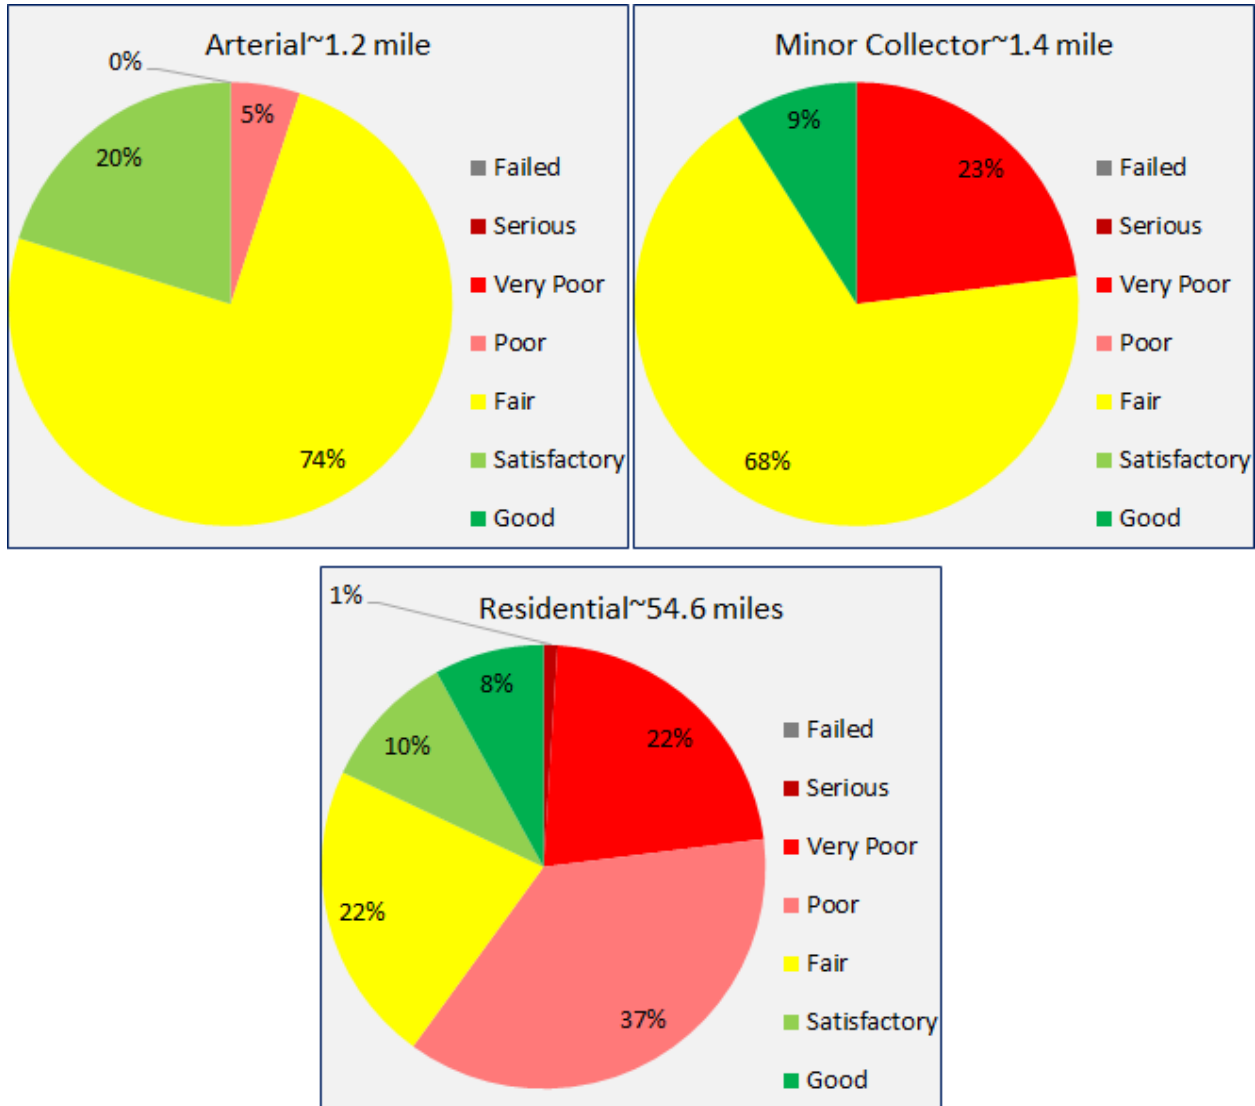
Figure 10. Details of the pavement condition distribution based on the functional class.

Figure 10 shows detail distribution of pavement condition based on the functional class. It can be noticed that 60% of the residential pavements are in poor, very poor, and serious conditions.

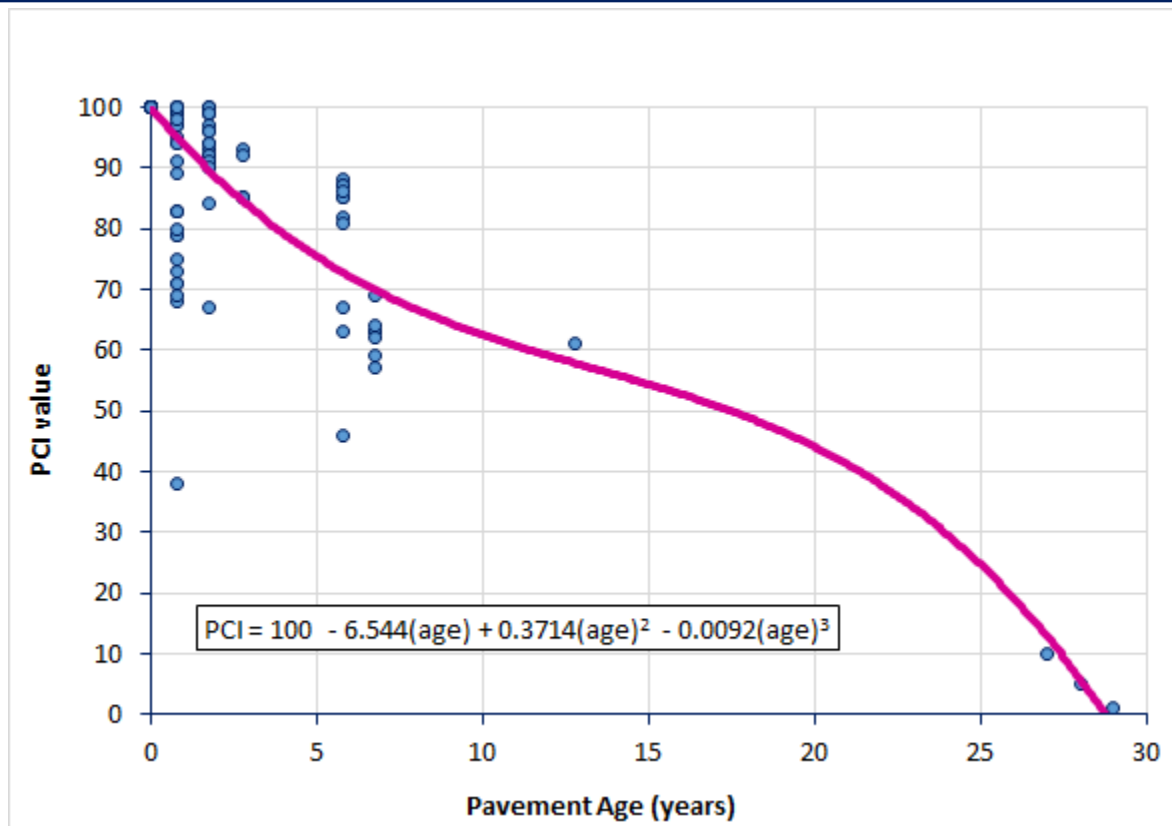
Figure 13. A pavement performance model for the asphalt pavements.

Pavement age data was not available; therefore, the pavement performance model from a neighbor city with comparable condition has been used, as shown in Figure 13. All asphalt surfaced pavements were assigned to this model. There are only four pavement sections in the City of Markham network with a concrete surface. Therefore, a default pavement performance model from the PAVER™ has been used for the concrete pavement.

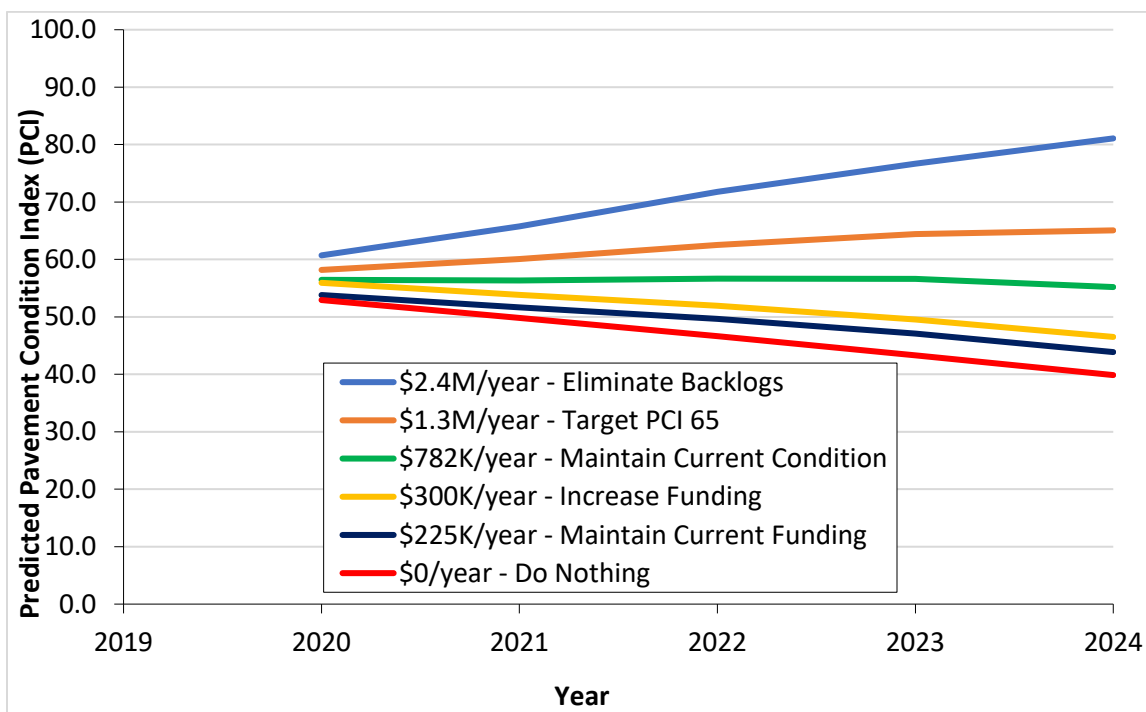
Figure 14. Effect of funding levels on the City's pavement condition.

Using the M&R Working Plans module and based on the recommendation, the funding level scenarios were generated for a five-year period for only major M&R activities. For the current funding level (\$300K/year), it was assumed that \$75K/year would be allocated for stopgap and localized preventive distress maintenance, whereas \$225K/year would be spent for major M&R activities. Table 5 and Figure 14 display the effect of different funding levels required for the different funding and network PCI value scenarios. From Figure 14, it can be seen that the current funding is insufficient to maintain the current condition over the next five years. Providing budget to eliminate backlogs results in an average PCI value

of 81.1 after five years, while not spending any funds on the M&R program will deteriorate the network to an average PCI of 39.9 after five years. In maintaining the current condition (PCI=55.3) plan, it is required to invest about \$782K/year over the next five years. In the 'Target PCI 65' plan, the network average PCI increases to 65.1 in 2024 and requires \$1.3M/year over the next five years. Table 6 shows the predicted number of mileages can be improved by the funding scenarios.

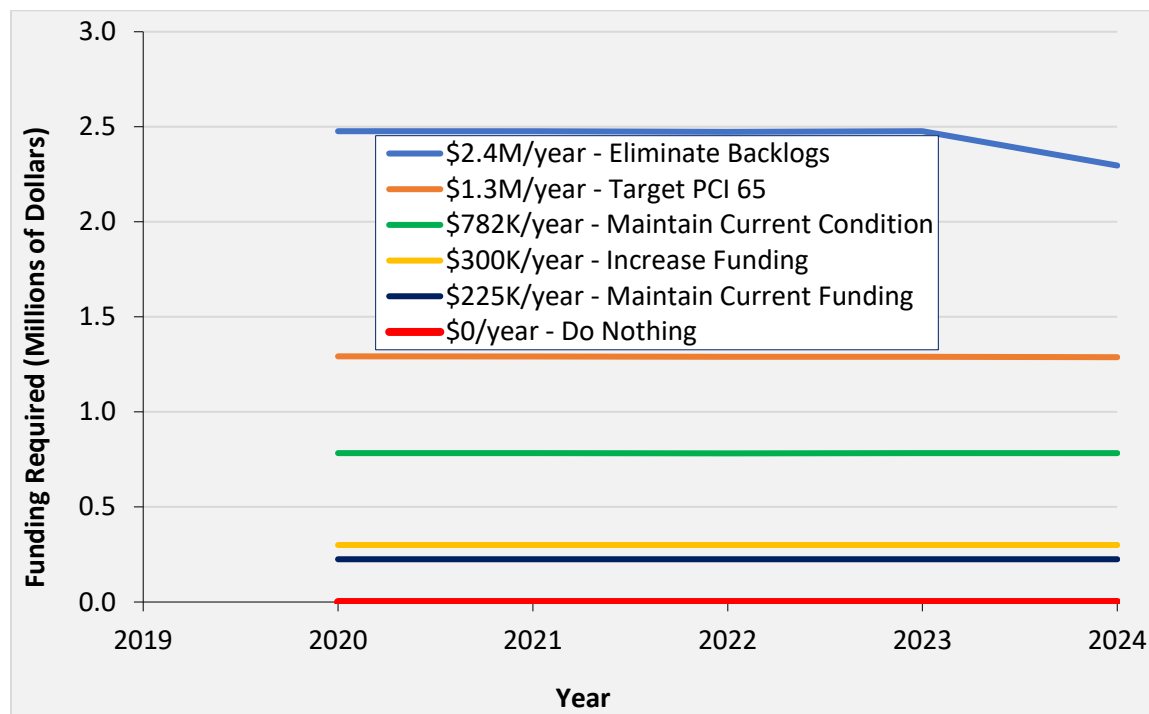
Figure 15. Required funding per year to achieve different condition targets.

Table 7 and Figure 15 show the amount of funding required to achieve target PCI values for the various funding scenarios. To eliminate backlogs, it is required to invest about \$2.4M/year for the major M&R over the next five years. To achieve an average network PCI of 65, the required investment is approximately \$1.3M/year for the major M&R over the next five years, whereas it requires about \$782K/year for the major M&R to maintain current conditions over the next five years.

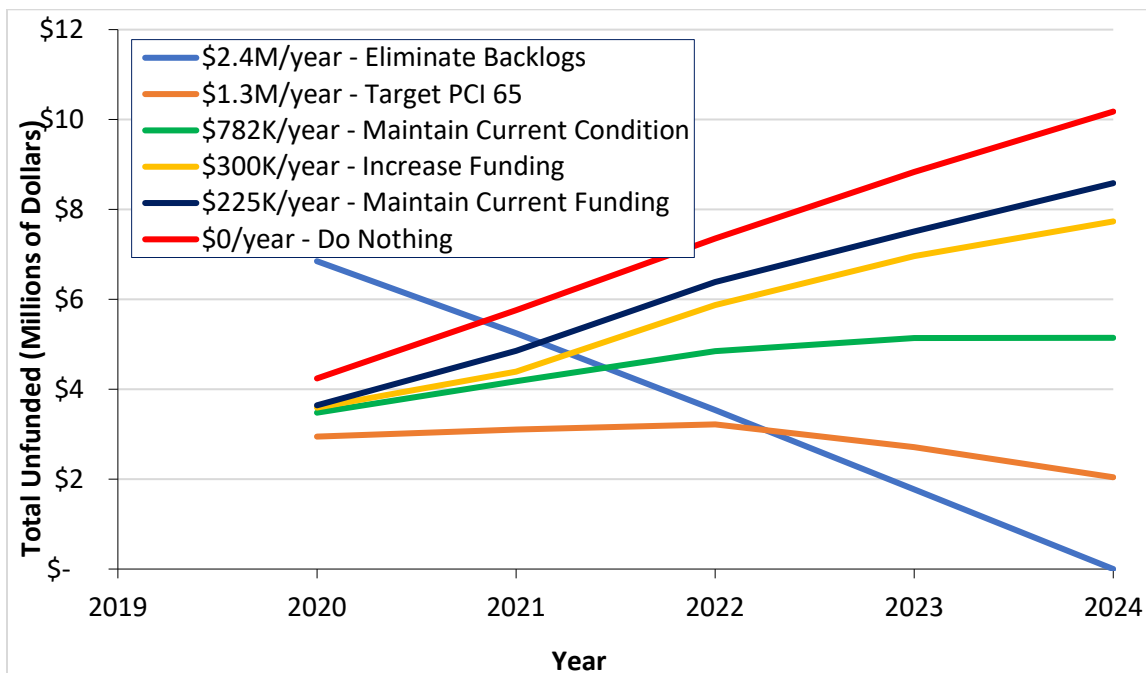
Figure 16. Total unfunded budget per year based on funding scenarios.

Table 8 and Figure 16 show the unfunded budget based on the funding scenarios. It can be seen that it requires about \$6.8M in 2020 to eliminate the backlogs, while doing nothing will generate a backlog of \$10.2M by 2024. Current major M&R funding will sustain a backlog of \$3.6M-\$8.6M.

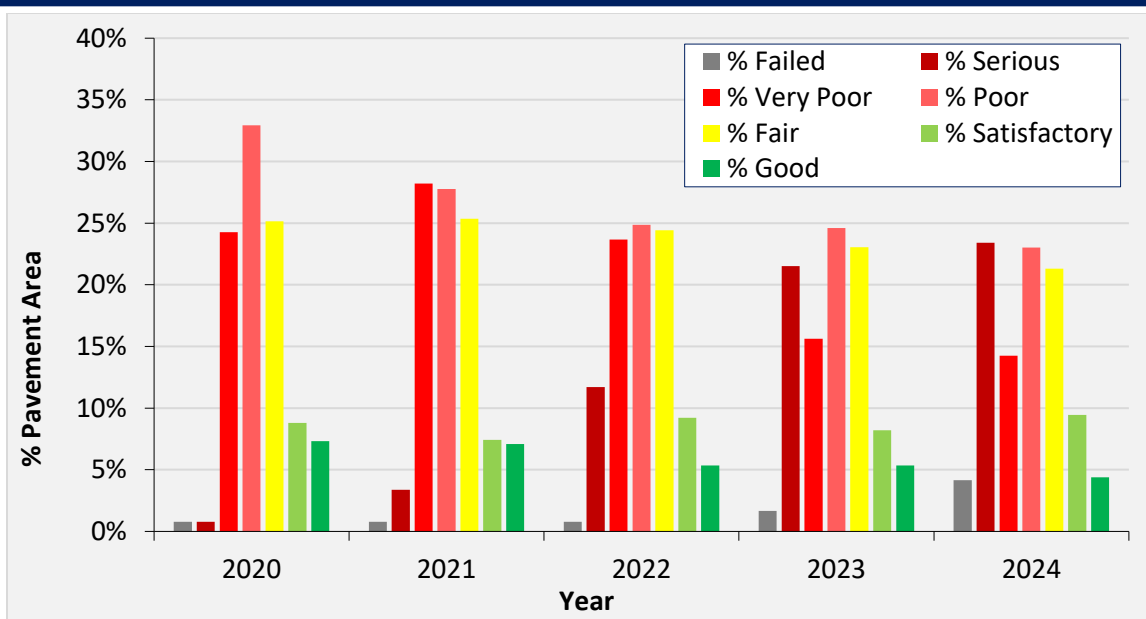
Figure 17. City’s pavement condition by year with the current major M&R funding (\$225K/Year).

A 5-Year major M&R plan based on current funding and 2020 localized distress M&R plan are provided in Appendix A. Figure 17 shows the network condition distribution for the next five years with the current funding level. Figure 8 shows that currently about 23% of the pavement network is in ‘serious’ and ‘very poor’ condition, and this would keep increasing over the next five years. By 2024, about 42% network would be in ‘failed’, ‘serious’ and ‘very poor’ condition. However, the average PCI of the network is expected to be 43.9 in 2024 with the current funding level; a decrease of 11.4 PCI points from the 2019 average PCI.

Currently, about 23% of network area is in 'serious' and 'very poor' condition which will increase to 41% by 2024. It is recommended to increase the funding level to maintain current condition and improve the condition. It is also recommended that the City should focus on applying routine preventive maintenance to pavement sections in 'satisfactory' and 'good' condition so that it would delay the transition to the 'fair' condition. Preventive maintenance activities, such as crack sealing and localized patching, can cost-effectively extend the life of a pavement.
