2020 “State of the Streets”

Final Report

**Village of Merrionette Park, Illinois &
Chicago Metropolitan Agency for Planning**

Gorrondona and Associates, Inc.
Pavement Engineering Division

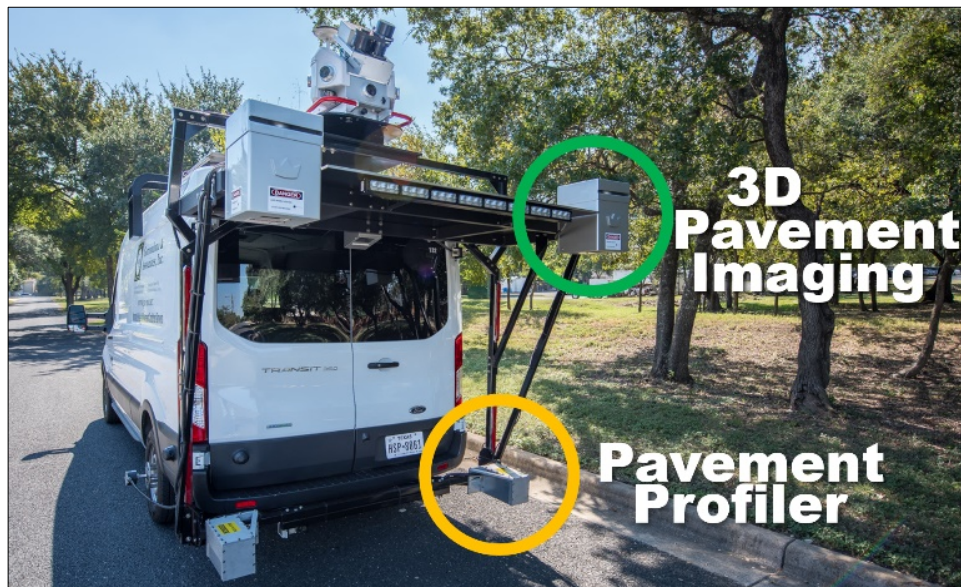
G&AI deployed a state-of-the-art PathRunner pavement data collection system to capture high-resolution pavement imagery and surface data necessary to assess the condition of the Village’s roadways. The PathRunner system is shown in Figure 8.

Figure 8. PathRunner pavement condition data collection system.

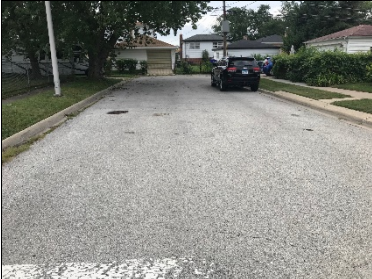
Figure 11. Pavement conditions observed during PCI inspection.

Figure 11 illustrates a variety of pavement conditions observed throughout the Village during the pavement condition survey. The figure includes PCI and IRI values for each pavement section along with observed distress types and recommended M&R.

Location + History	PCI (IRI)	Recommended M&R Activity (Typical)

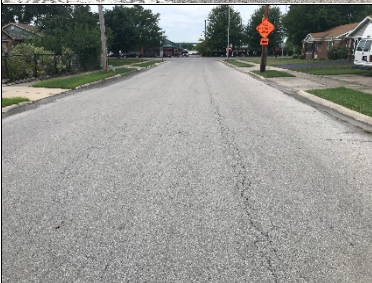
H. J. Rogowski <i>(Section 10)</i> Last resurfacing date 2007	72 (549)	Preventive maintenance <i>Seal cracks as well as paving lane joint and joints between pavement and curb and gutter + surface treatment.</i>

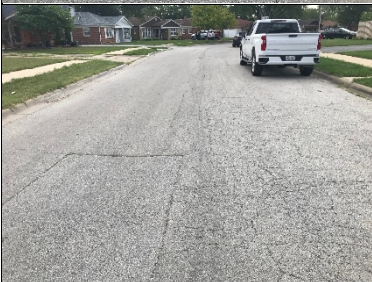
116 th Pl. <i>(Section 10)</i> Last resurfacing date 2007	58 (426)	Preventive maintenance <i>Seal cracks as well as paving lane joint and joints between pavement and curb and gutter + surface treatment.</i>

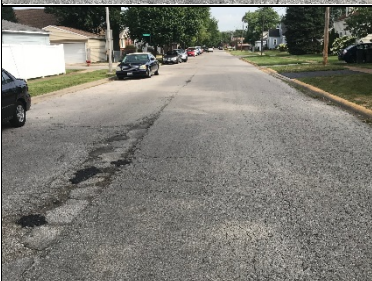
Meadow Ln. <i>(Section 50)</i> Last resurfacing date 2007	49 (354)	Major M&R <i>Localized structural patching + cold mill and overlay.</i>

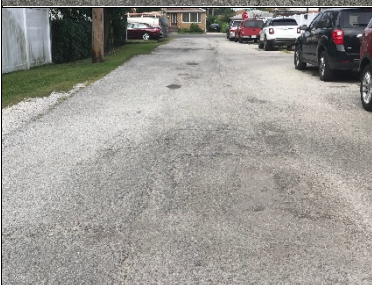
Troy Ave. <i>(Section 20)</i> Last resurfacing date 2000	28 (523)	Major M&R <i>Localized structural patching + cold mill and overlay <u>or</u> reconstruction</i>

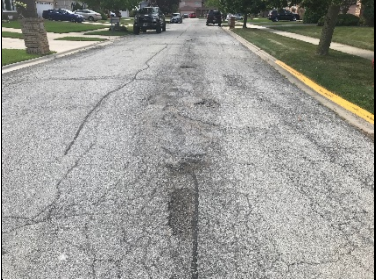
<p>Merrion Ln. <i>(Section 10)</i></p> <p><i>Last resurfacing date 1986</i></p>	<p>24 <i>(493)</i></p>	<p>Major M&R <i>Reconstruction</i></p>
---	---	-----------------------------	---

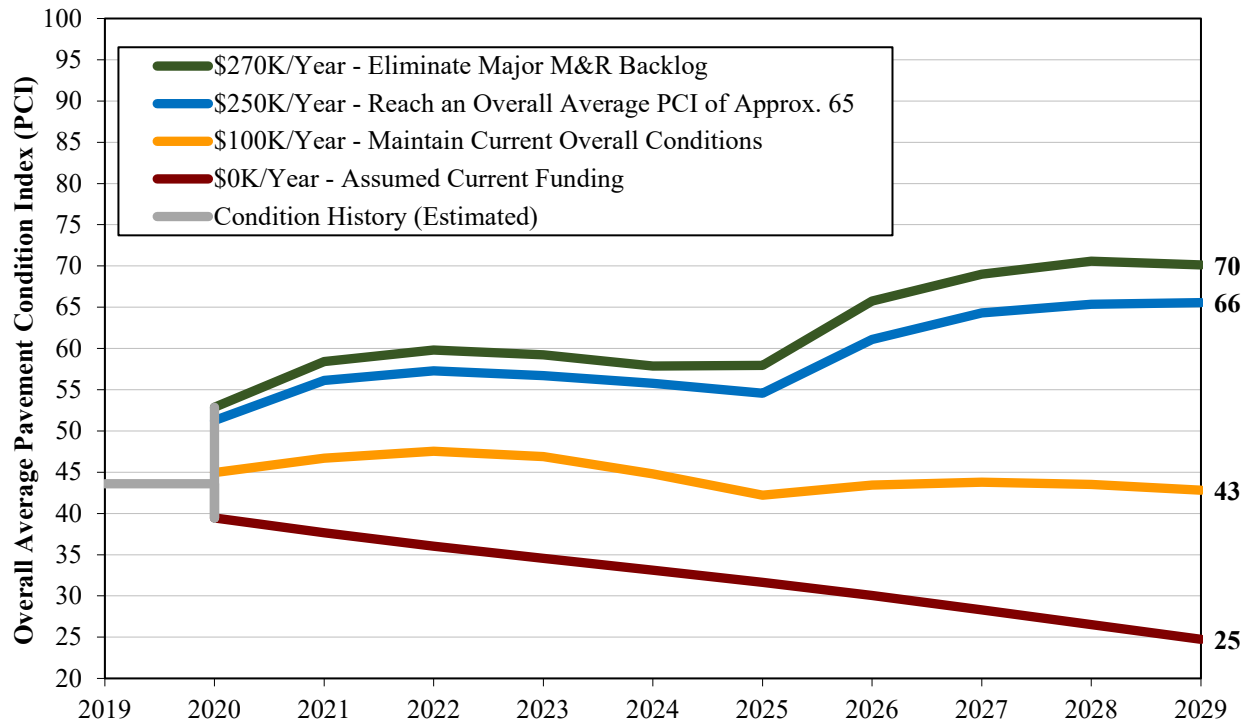
The results of the PAVER M&R analyses are shown in the following two figures. Figure 12 illustrates the estimated ten-year change in pavement condition resulting from the analyzed funding scenarios, and Figure 13 depicts the estimated change in the Village’s major M&R backlog for each funding scenario.

Figure 12: Impact of funding levels on overall pavement conditions by year.

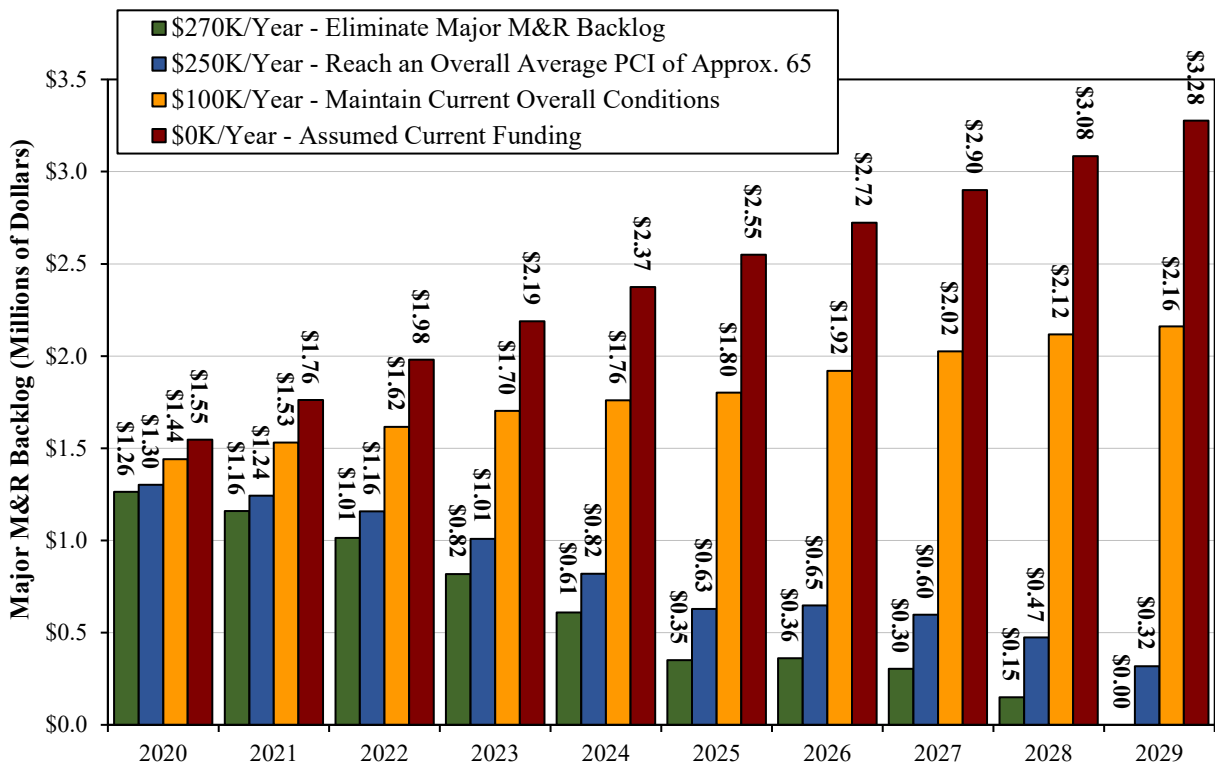
Figure 13: Impact of funding levels on major M&R backlog by year.
