# **2018 “State of the Streets”**

## ***Final Report – 5/22/2019***

**Village of Niles, Illinois +**  
***Chicago Metropolitan Agency for Planning***

**Gorrondona and Associates, Inc.**  
Pavement Engineering and Management Division  
4201 West Parmer Lane, Building A, Suite 150 | Austin, Texas 78727  
(512) 719-9933 | [www.ga-inc.net](http://www.ga-inc.net)

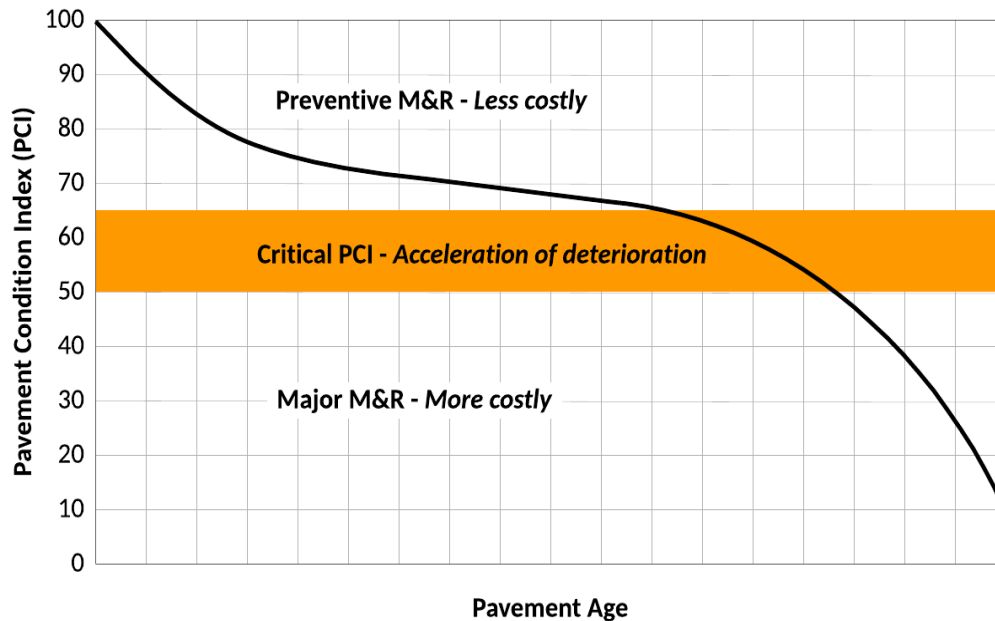
**Figure 1. Correct timing of preventive and major M&R relative to the Critical PCI.**

The “Critical PCI” value for a pavement is the PCI value below which cost-effective preventive maintenance is no longer a viable option, and more significant rehabilitation and sometimes reconstruction. As shown in Figure 1, the primary objective of pavement management is to preserve pavements in good condition above the Critical PCI value rather than wait for them to deteriorate below the Critical PCI value, resulting in the need for significant rehabilitation or reconstruction.

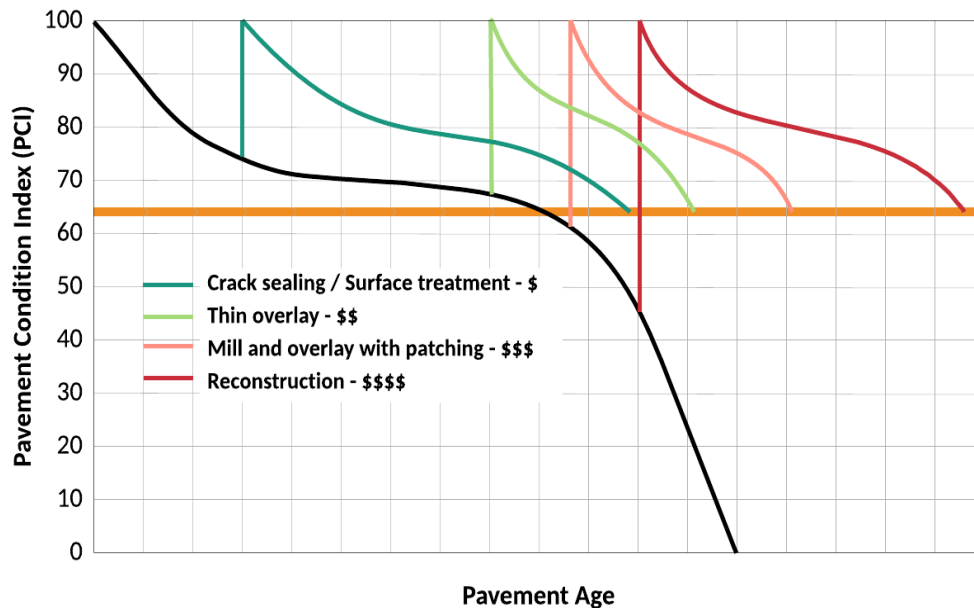
**Figure 2. Increasing price and decreasing benefit of M&R.**

When the appropriate preventive maintenance treatments (e.g., crack sealing, seal coats, patching, etc.) are undertaken at the correct times during a pavement’s service life, these relatively inexpensive preventive M&R treatments can extend the service life of the pavement, as shown in Figure 2.

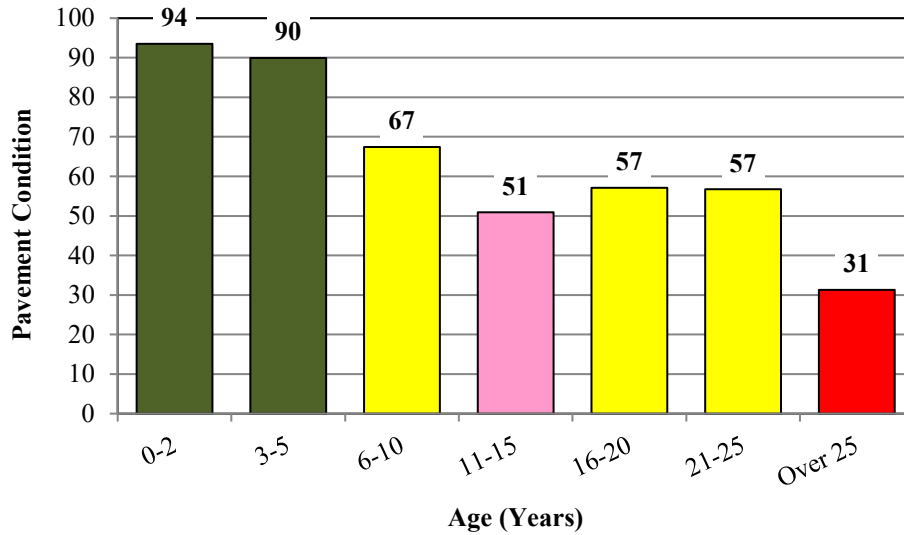
**Figure 3. Pavement condition by age.**  
(Note: Pavements with ages over 25 years may be missing historical construction data.)

Figure 3 shows the distribution of the Village’s roadway pavement condition by age.

The overall condition of the Village’s pavements is typical, with older pavements in worse condition. As shown in Figure 3, pavements between the ages of 16 and 25 years are in relatively similar condition. This stabilization of condition is due to localized maintenance activities targeted to provide temporary repairs to address the more severe pavement distresses.

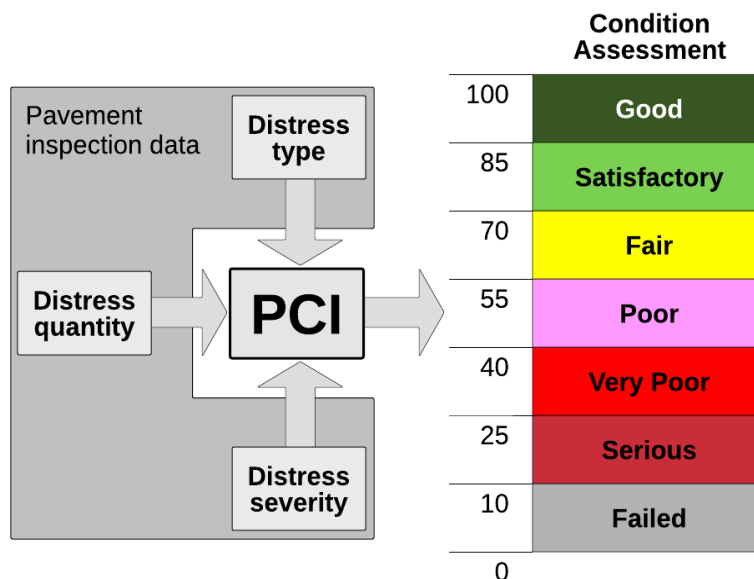
**Figure 4. PCI inputs and the Village’s condition assessment scale.**

The pavement condition survey was performed following a modified approach of the PCI method described in ASTM D 6433. The PCI procedure is an objective and repeatable method for determining existing pavement condition. A PCI value provides an indication of the structural integrity and operational condition for a pavement section. The PCI procedure consists of a routine (typically triennial) visual inspection, during which pavement distress types, severity levels, and quantities are identified and recorded. These data are then input into the PCI algorithm to calculate a PCI value that ranges from 0 to 100, as shown in Figure 4.

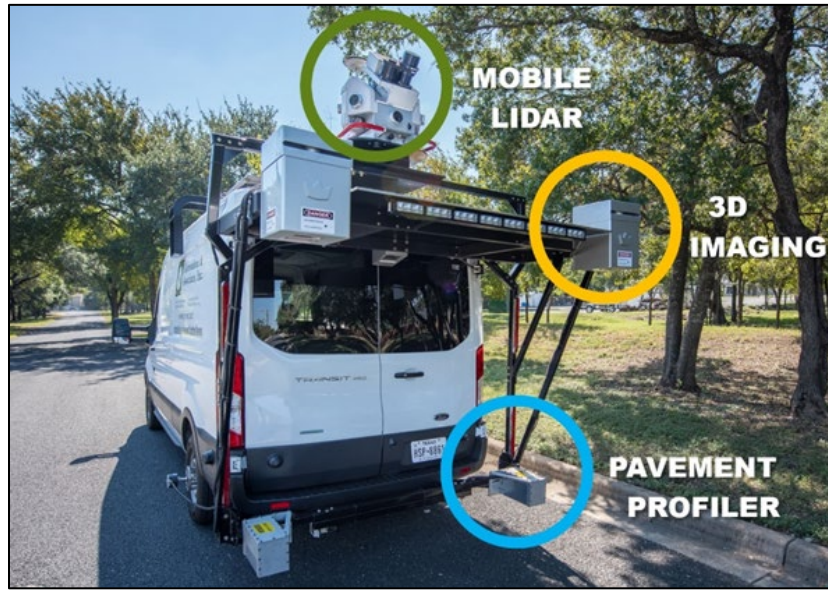
Figure 5: G&AI’s PathRunner pavement data collection system.

G&AI’s PathRunner survey team collected all pavement condition data, including:

- High-resolution 3D downward images for detecting cracking,
- Rutting measurements, and
- High-resolution, forward-facing, right-of-way images.

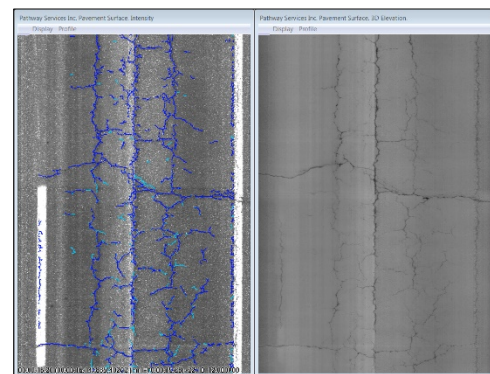
Steps 1 and 2: *Initial Automated Crack Detection and Rutting Analysis*

1. **AutoCrack™ Software** – This software detects cracking in the pavement imagery.
2. **AutoClass™ Software** – This software classifies the type of cracking detected.
3. **Manual image rating** – This step involves G&AI’s team of trained and experienced raters evaluating the imagery and identifying any distress types that the automated crack detection and classification software did not observe or incorrectly identified.
4. **QC/QA rating** – This step involves G&AI’s team of raters and project engineers reviewing the rated data prior to import into PAVER.

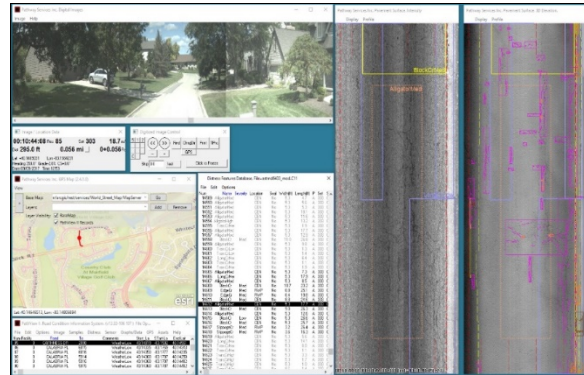
**Steps 3 and 4: Manual Rating + QC/QA using PathView™**

The QC/QA rating is the single most important step in the project. The G&AI team uses the PathView™ software for evaluating distresses using both automated algorithms and manual supplemental rating. All QC/QA is performed using PathView™. The same software system has been used for more than 25 state DOTs and several municipal agency pavement condition survey projects.

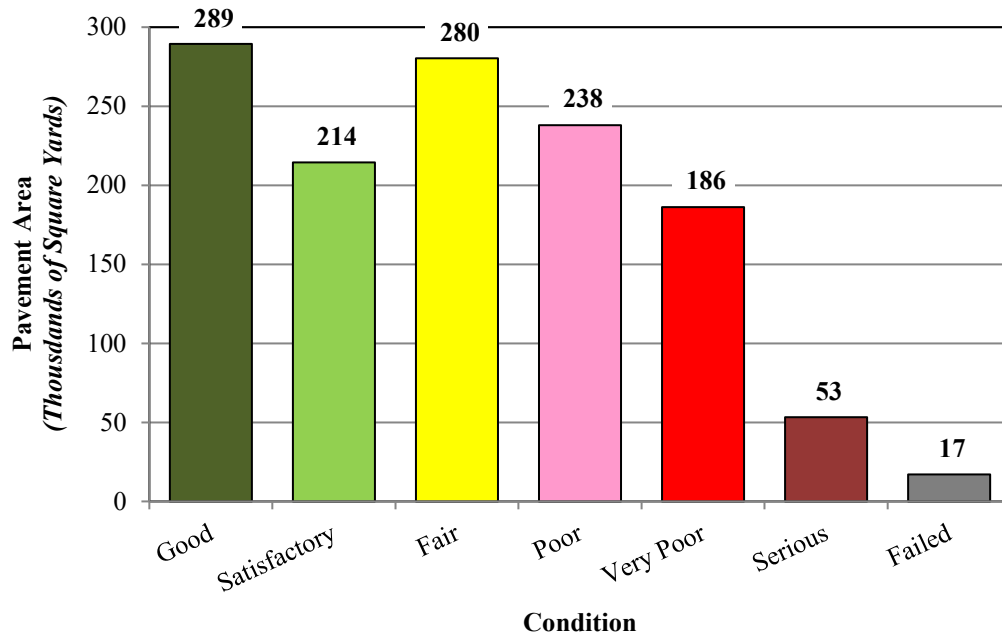
**Figure 6. Overall pavement conditions by area.**

At the time of G&AI’s November 2018 inspection, the Village’s pavements were found to be in overall “Fair” condition, with an average PCI of 63. The condition distribution of the Village’s pavements at the time of inspection is shown in Figure 6, and detailed condition maps can be found in Appendix A.

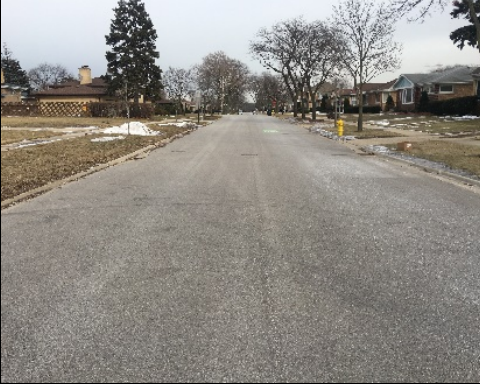
Cleveland Street  <i>Cold mill and overlay in 2016</i>	95	Preventive maintenance  <i>Seal joints between pavement and curb and gutter</i>

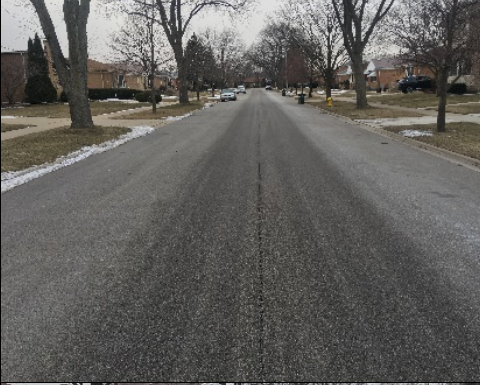
West Conrad Avenue  <i>Cold mill and overlay in 2016</i>	93	Preventive maintenance  <i>Seal paving lane seam</i>

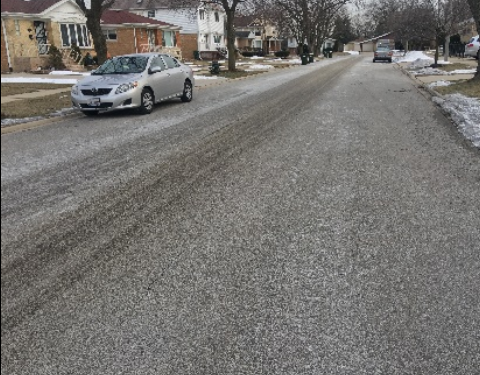
North National Avenue  <i>Cold mill and overlay in 2013</i>	90	Preventive maintenance  <i>Seal cracks (early stage alligator) and joints between pavement and curb and gutter</i>

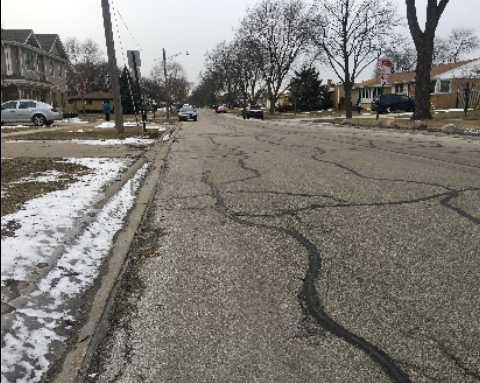
<p>Main Street  <i>(West of Harlem Avenue)</i></p> <p><i>Cold mill and overlay in 2008</i></p>	<p>61</p>	<p>Major M&amp;R</p> <p><i>Localized structural patching + cold mill and overlay</i></p>

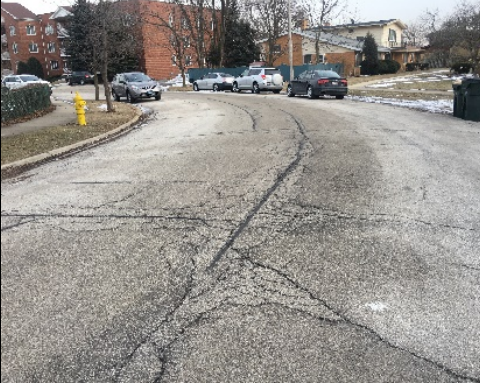
<p>West Carol Court</p> <p><i>Cold mill and overlay in 1997</i></p>	<p>55</p>	<p>Major M&amp;R</p> <p><i>Localized structural patching + cold mill and overlay <u>or</u> reconstruction</i></p>

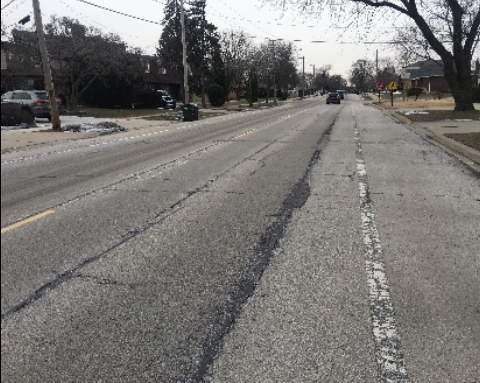
<p>Shermer Road</p> <p><i>Cold mill and overlay in 1997</i></p>	<p>45</p>	<p>Major M&amp;R</p> <p><i>Localized structural patching + cold mill and overlay <u>or</u> reconstruction</i></p>

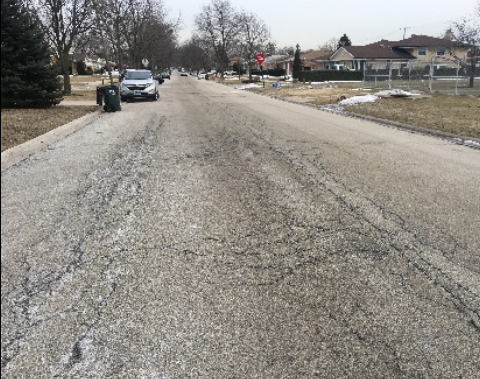
<p>North Oriole Avenue</p> <p><i>Cold mill and overlay in 2000</i></p>	<p>41</p>	<p>Major M&amp;R</p> <p><i>Localized structural patching + cold mill and overlay <u>or</u> reconstruction</i></p>

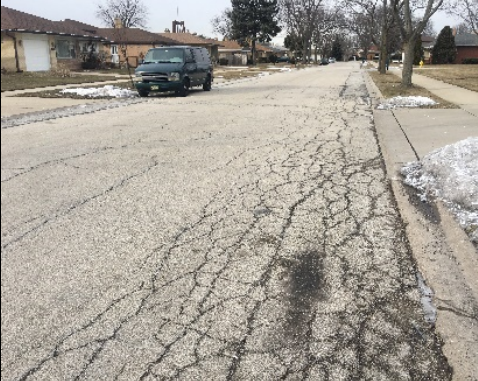
<p>Neva Avenue <i>Cold mill and overlay in 1997</i></p>	<p>30</p>	<p>Major M&amp;R <i>Localized structural patching + cold mill and overlay <u>or</u> reconstruction</i></p>

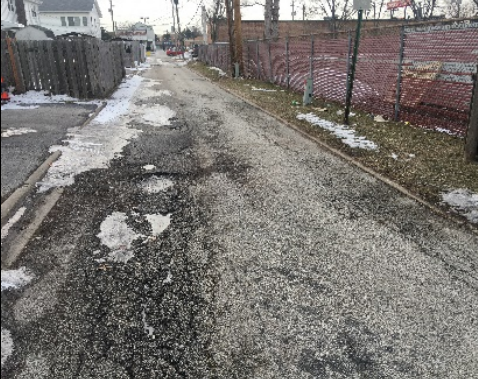
<p>Alley <i>Between Shermer Road and North Harlem Avenue</i>  <i>Last Major M&amp;R unknown</i></p>	<p>15</p>	<p>Major M&amp;R <i>Reconstruction</i></p>

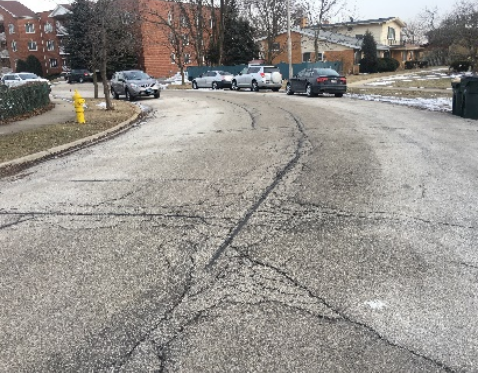
**Figure 8. Failure partially initiating along unsealed paving lane joint.**  
*Note: Visible sealant added post failure.*

A distress observed on several of the Village’s pavements was unsealed paving lane cracking that had progressed into alligator cracking, as shown in Figure 8. The impact of this distress on PCI values can be significant, and full-depth patching is required to fix this distress. By sealing and routinely re-sealing paving lane seams immediately following paving, this type of deterioration may be prevented.

<p>West Carol Court <i>Cold mill and overlay in 1997</i></p>	<p>55</p>	<p>Major M&amp;R <i>Localized structural patching + cold mill and overlay <u>or</u> reconstruction</i></p>

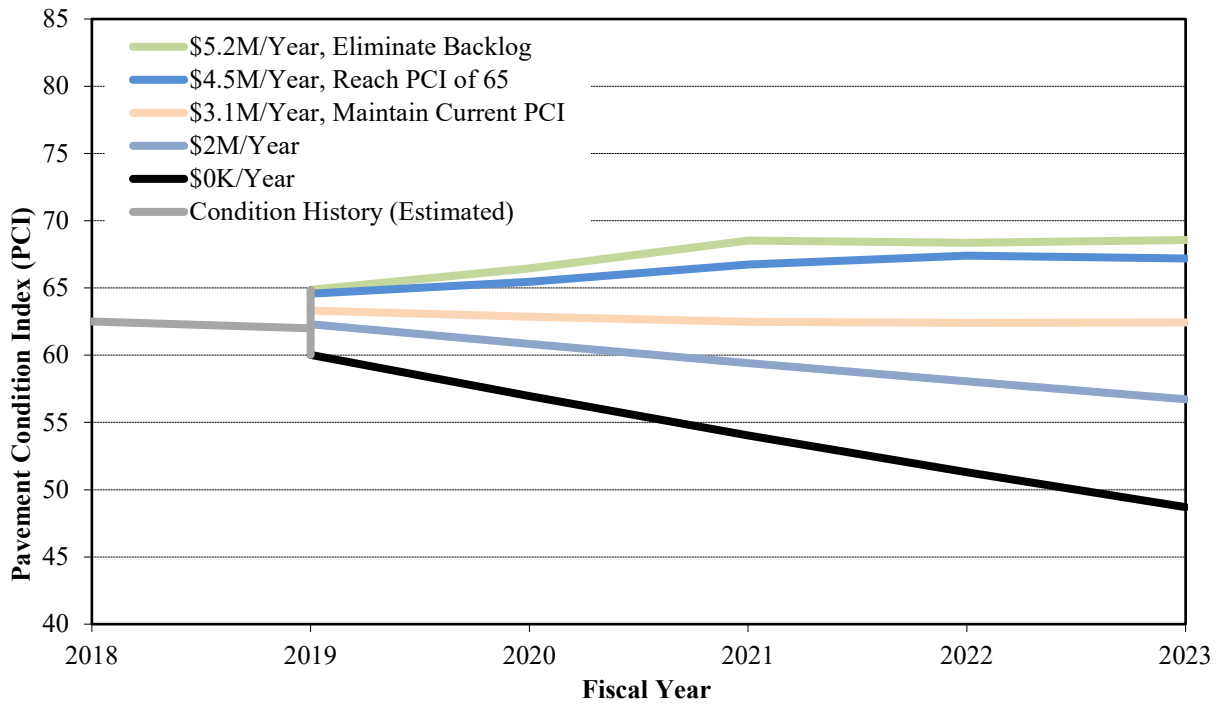
Figure 9: Effect of funding levels on overall pavement conditions by year.

Figure 9 illustrates the estimated five-year change in pavement condition resulting from the analyzed funding scenarios while Figure 10 depicts the estimated change in the Village’s Major M&R backlog for each funding scenario.

It was determined that a funding level of approximately \$3.1M/YR is needed to stabilize the Village’s network average PCI value of approximately 63 over the next five years. The \$3.1M/YR funding level keeps conditions relatively stable over the next five years and results in a modest decrease in the backlog of Major M&R.
