2018 “State of the Streets”

Final Report – 7/5/2019

Village of Riverdale, Illinois +
Chicago Metropolitan Agency for Planning

Gorrondona and Associates

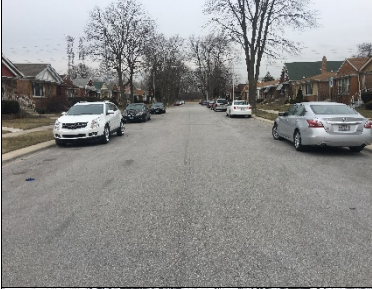
<p>Emerald Ave. <i>Between 142nd St. and 143th St.</i></p> <p><i>Last resurfacing date unknown</i></p>	94	<p>Preventive maintenance</p> <p><i>Seal paving lane seam + seal joints between pavement and curb and gutter</i></p>

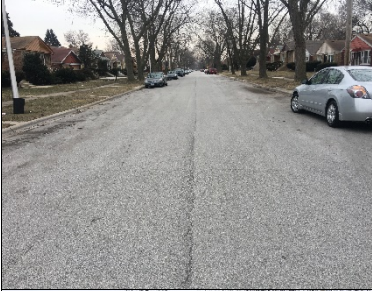
<p>S. Wallace St. <i>Between 142nd St. and 143th St.</i></p> <p><i>Last resurfacing date unknown</i></p>	85	<p>Preventive maintenance</p> <p><i>Seal paving lane seam + seal joints between pavement and curb and gutter</i></p>

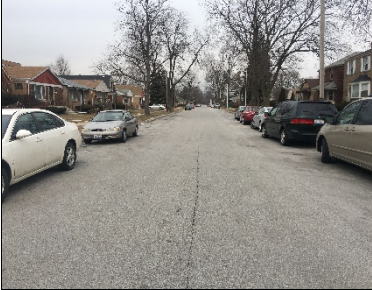
<p>Emerald Ave. <i>Between 144th St. and 145th St.</i></p> <p><i>Last resurfacing date unknown</i></p>	83	<p>Preventive maintenance</p> <p><i>Seal paving lane seam + seal joints between pavement and curb and gutter</i></p>

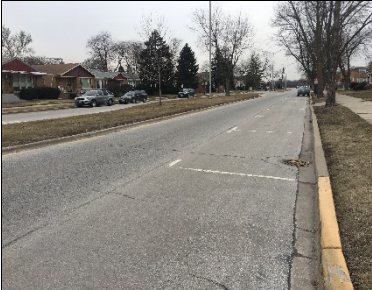
<p>W. 144th St. <i>Between S. Union Ave. to Lowe Ave.</i></p> <p><i>Last resurfacing date unknown</i></p>	63	<p>Major M&R</p> <p><i>Crack sealing + localized structural patching</i></p>

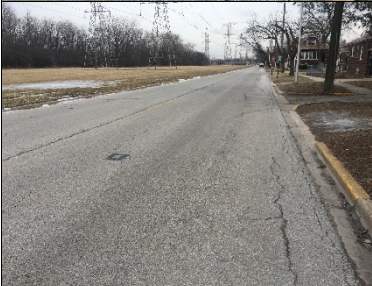
<p>W. 142nd St. <i>Between Emerald Ave. and S. Union Ave.</i></p> <p><i>Last resurfacing date unknown</i></p>	55	<p>Major M&R</p> <p><i>Localized structural patching + cold mill and overlay</i></p>

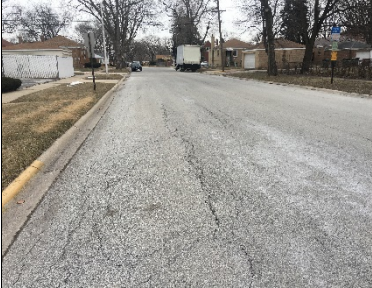
<p>143rd St. <i>Between Eggleston Ave. and Stewart Ave.</i></p> <p><i>Last resurfacing date unknown</i></p>	<p>53</p>	<p>Major M&R</p> <p><i>Localized structural patching + cold mill and overlay <u>or</u> reconstruction</i></p>

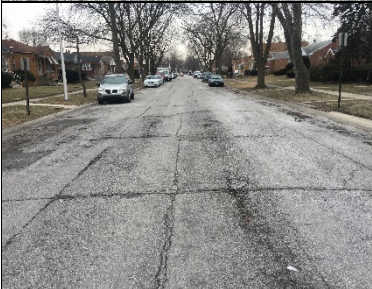
<p>Eggleston Ave. <i>Between 143rd St. and 144th St.</i></p> <p><i>Last resurfacing date unknown</i></p>	<p>43</p>	<p>Major M&R</p> <p><i>Localized structural patching + cold mill and overlay <u>or</u> reconstruction</i></p>

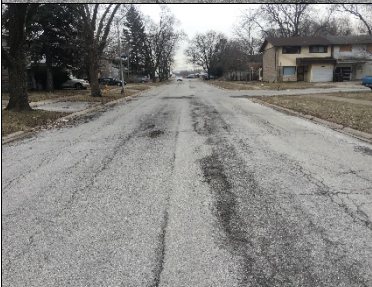
<p>Eggleston Ave. <i>Between 137th St. and 137th Pl.</i></p> <p><i>Last resurfacing date unknown</i></p>	<p>29</p>	<p>Major M&R</p> <p><i>Localized structural patching + cold mill and overlay <u>or</u> reconstruction</i></p>

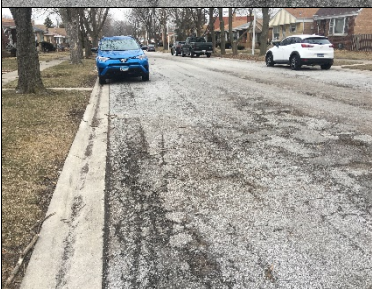
<p>South Lowe Ave. <i>Between 144th St. and 145th St.</i></p> <p><i>Last resurfacing date unknown</i></p>	<p>26</p>	<p>Major M&R</p> <p><i>Reconstruction</i></p>

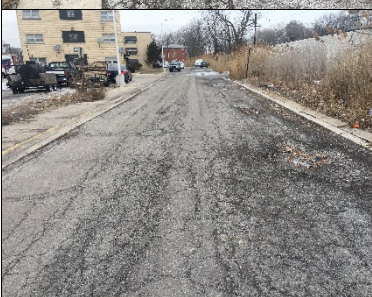
<p>Highlawn Ave. <i>Between 141st St. and 142nd St.</i></p> <p><i>Last resurfacing date unknown</i></p>	<p>20</p>	<p>Major M&R</p> <p><i>Reconstruction</i></p>

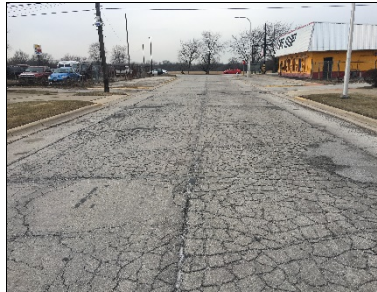
<p>145th St. <i>Halsted St. and Emerald Ave.</i></p> <p><i>Last resurfacing date unknown</i></p>	<p>12</p>	<p>Major M&R <i>Reconstruction</i></p>
---	--	-----------	---

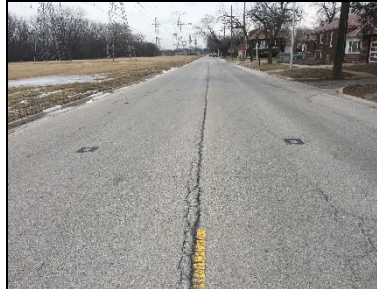
A distress observed on some of the Village’s pavements was unsealed paving lane cracking, as shown in Figure 7. The impact of this distress on PCI values can be significant if the cracking progresses into alligator cracking, and full-depth patching is required to fix this distress. By sealing and routinely re-sealing paving lane seams immediately following paving, this type of deterioration may be prevented.

<p>W. 142nd St. <i>Between Emerald Ave. and S. Union Ave.</i></p> <p><i>Last resurfacing date unknown</i></p>	<p>55</p>	<p>Major M&R <i>Localized structural patching + cold mill and overlay</i></p>

Figure 7. Failure partially initiating along unsealed paving lane joint.

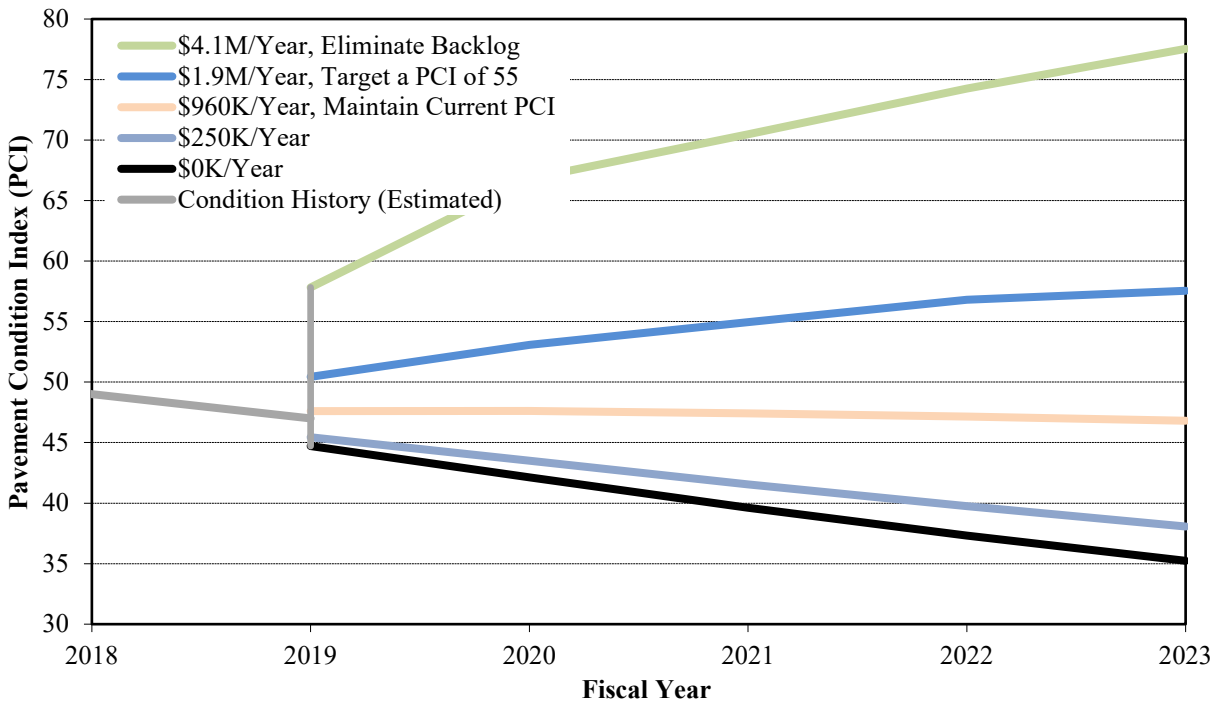
Figure 8 illustrates the estimated five-year change in pavement condition resulting from the analyzed funding scenarios while Figure 9 depicts the estimated change in the Village’s Major M&R backlog for each funding scenario.

Figure 8: Effect of funding levels on overall pavement conditions by year.

It is estimated that a funding level of approximately \$960K/YR is needed to stabilize the Village’s network average PCI value of approximately 50 over the next five years. The \$960K/YR funding level keeps conditions relatively stable over the next five years but results in a modest increase in the backlog of Major M&R.

An estimated funding level of approximately \$1.9M/YR is required to raise the Village’s overall PCI value from 50 to 55. In addition to raising the overall average condition of the Village’s roadways, the \$1.9M/YR funding level results in a stabilized Major M&R backlog over the five years.

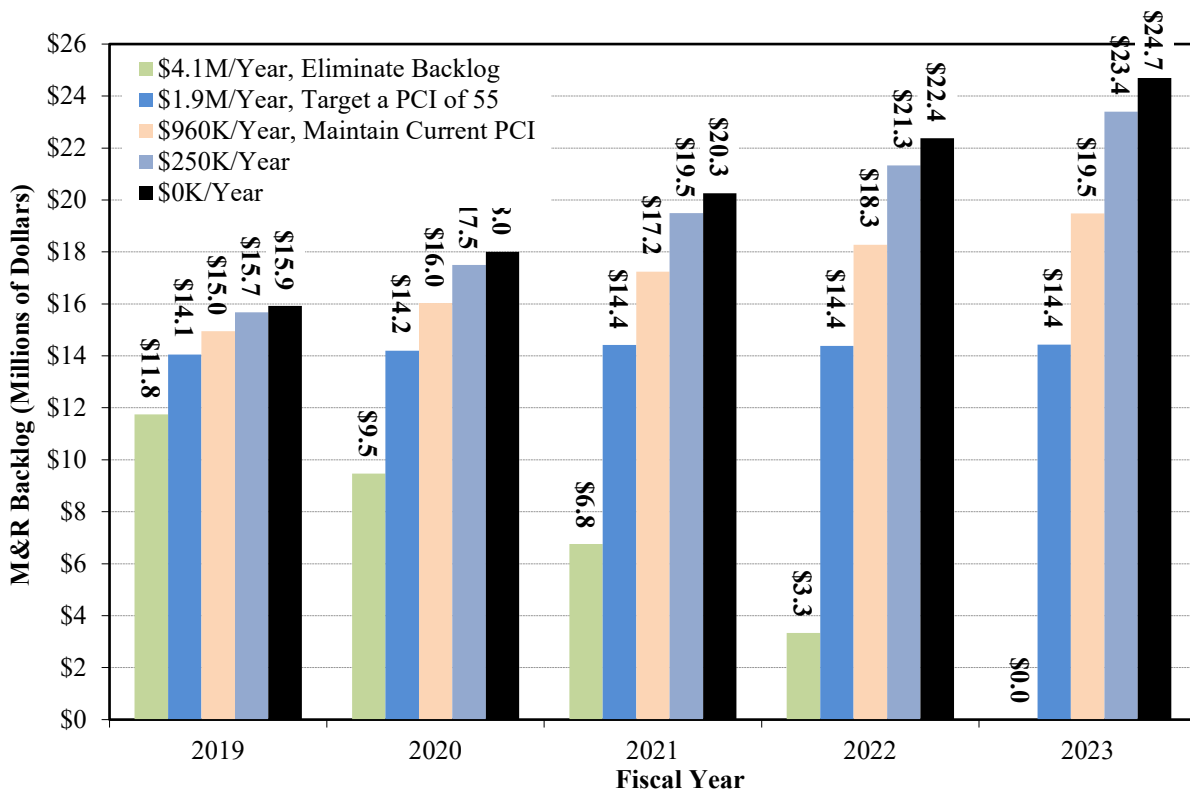
Figure 9: Effect of funding levels on pavement M&R backlog by year.
