PEDESTRIAN/BICYCLIST WARNING DEVICES AND SIGNS AT HIGHWAY- RAIL AND PATHWAY-RAIL GRADE CROSSINGS

Research Report FHWA-ICT-13-013

A report of the findings of
ICT-R27-96
**Pedestrian/Bicyclist Warning Devices and Signs at
Highway-Rail and Pathway-Rail Grade Crossings**

April 2013

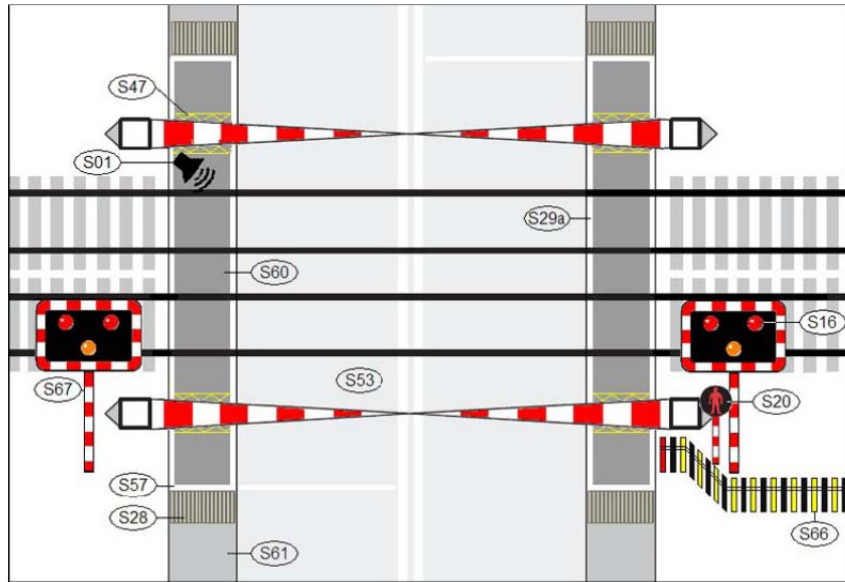
Figure 1. Solutions for key deficits in accessibility at grade crossings.
(Source: Delmonte and Tong 2011)

In the United Kingdom, Delmonte and Tong (2011) conducted a comprehensive analysis to identify solutions for improving safety and accessibility at level crossings for disabled pedestrians. They recommended the following 12 key solutions to address key deficits in accessibility at grade crossings. These solutions are mapped in the accompanying diagram, which is also taken from the same report (Figure 1).

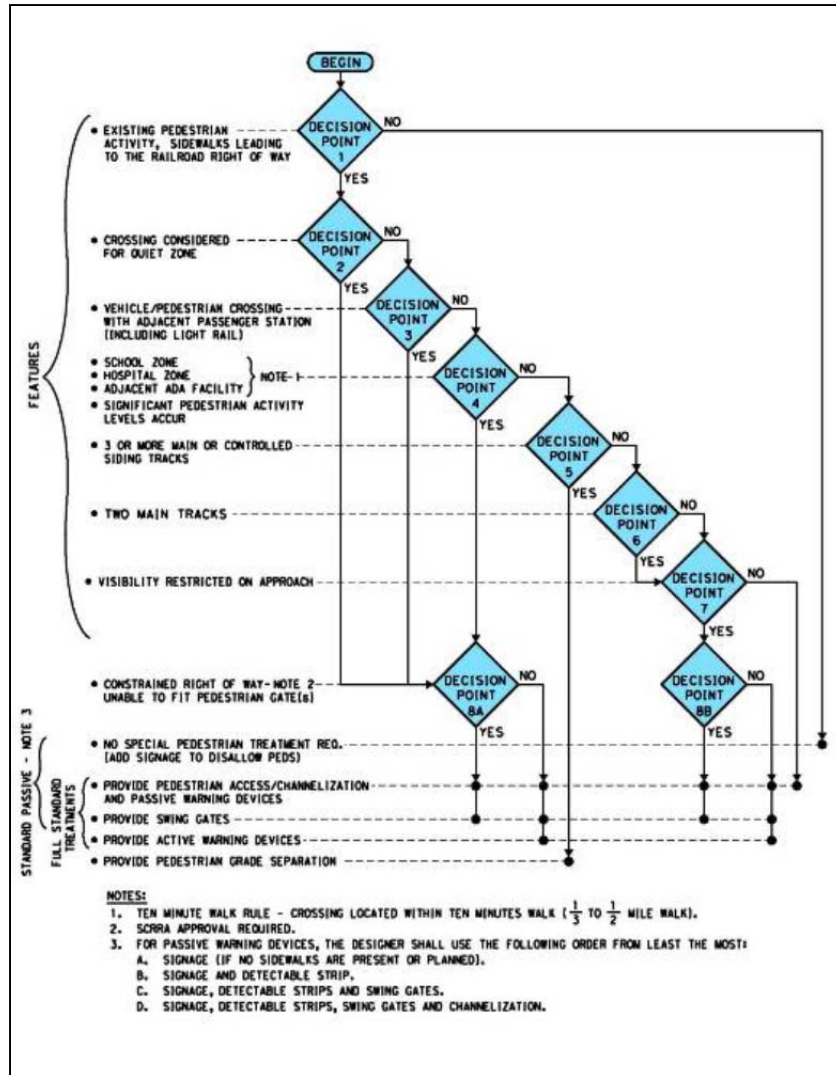
Figure 2. Pedestrian controls decision tree (Source: Korve et al. 2001, Figure 3-38).

In addition, also in California, the Southern California Regional Rail Authority (SCRRA, aka Metrolink) *Highway-Rail Grade Crossings Recommended Design Practices and Standards Manual* (SCRRA 2009) is a comprehensive single document that incorporates current and applicable highway-rail and pedestrian-rail grade crossing design standards and recommended design practices. The areas of interest for pedestrian-rail grade crossings include (1) pedestrian-grade separations; (2) 10-minute walk rule (proximity to schools, hospitals, and other high-density locations); (3) ADA issues; (4) refuge areas; (5) type and configuration of warning devices; (6) channelization; and (7) number of tracks. The manual notes that pedestrian treatments work well with proper channelization and signs, as well as sidewalks on either side of tracks and/or through the track area. Moreover, pavement striping continued across the track portion of roadway is an effective visual. The manual also states the importance of extra pedestrian treatments near stations for riders running to catch trains. Finally, the manual provides the decision tree shown in Figure 2 for use in determining the designs of pedestrian-rail grade crossings and appropriate warning treatments.

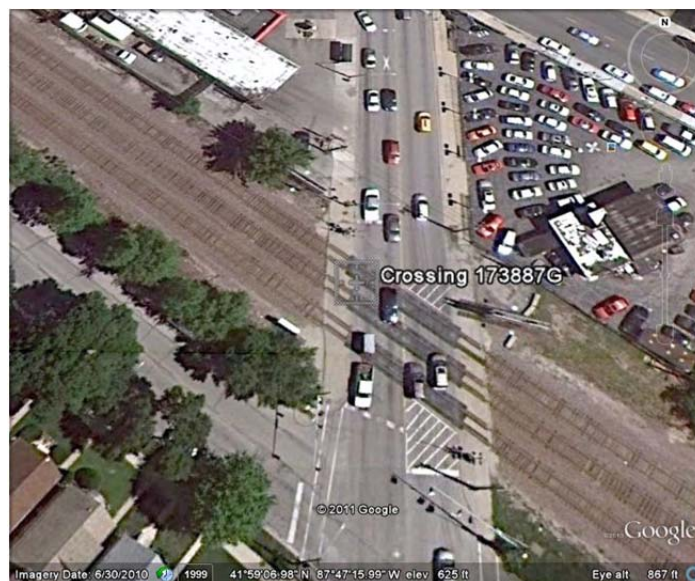
Figure 5. Crossing 173887G—A view above ground.
(Source: Google Earth 2010)

Crossing 173887G (Figure 5) is a triple-track highway-rail grade crossing on Nagle Avenue (see Appendix H for a ground view). There are pedestrian approaches on both sides of Nagle Avenue that continue on the other side of the tracks. There are pedestrian gates on all four quadrants of the attached sidewalks.

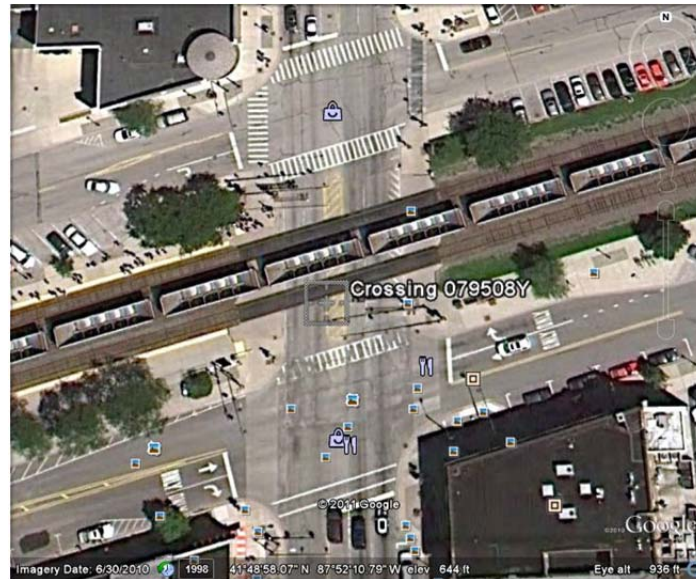
Figure 6. Crossing 079508Y—A view above ground.
(Source: Google Earth 2010)

Crossing 079508Y (Figure 6) is a triple-track highway-rail grade crossing on South La Grange Road. There are pedestrian approaches on both sides of La Grange Road that continue on the other side of the tracks. There are pedestrian gates on all four quadrants of the attached sidewalks.

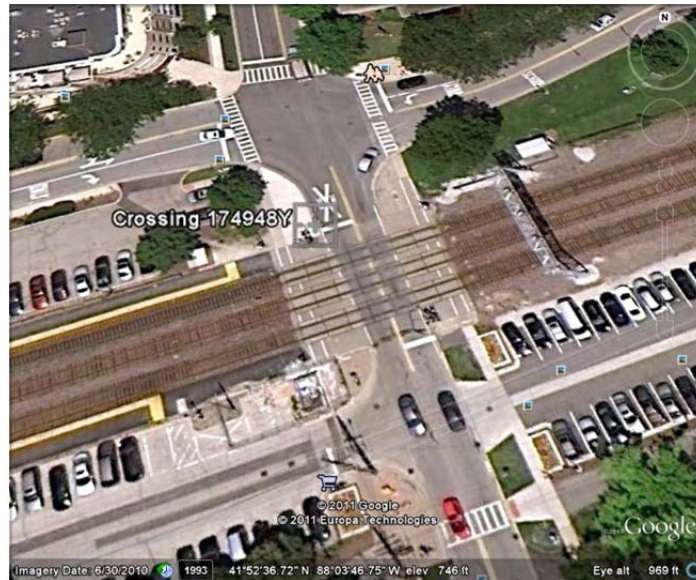
Figure 7. Crossing 174948Y—A view above ground.
(Source: Google Earth 2010)

Crossing 174948Y (Figure 7) is a triple-track highway-rail grade crossing on North Park Boulevard in Glen Ellyn. There are pedestrian approaches on both sides of the roadway that continue on the other side of the tracks. There are pedestrian gates on all four quadrants of the attached sidewalks, as well a “second train coming” audio-visual warning device.

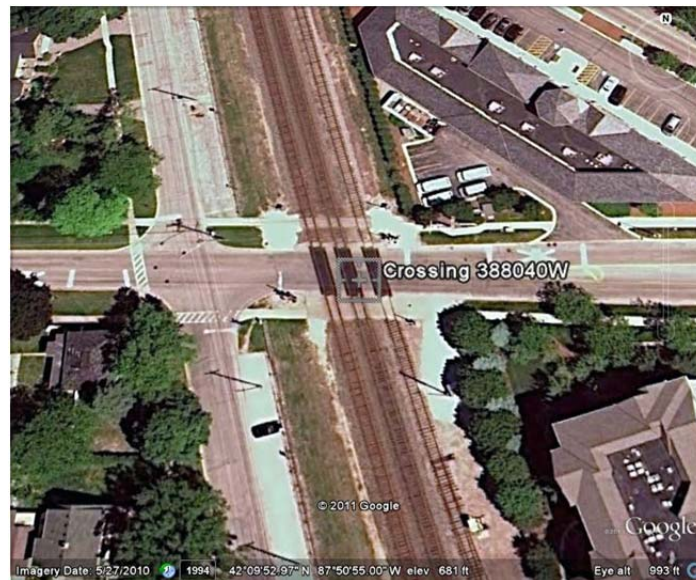
Figure 9. Crossing 388040W—A view above ground.
(Source: Google Earth 2010)

Crossing 388040W (Figure 9) is a triple-track highway-rail grade crossing on Osterman Avenue in Deerfield. There are pedestrian approaches on both sides of the roadway that continue to the other side of the tracks (see Appendix H for a ground view). There are pedestrian gates on all four quadrants of the attached sidewalks.

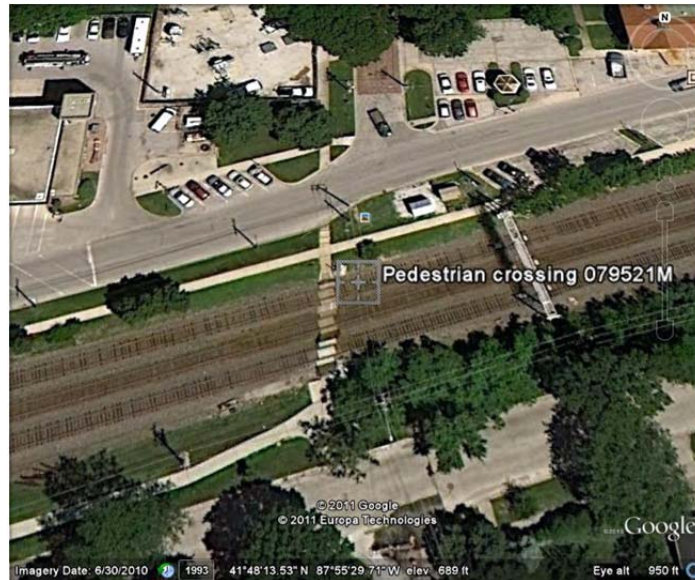
Figure 10. Crossing 079521M—A view above ground.
(Source: Google Earth 2010)

Dedicated pedestrian crossing 079521M (Figure 10) is several hundred yards east of the Hinsdale Metra station near the road intersection of N.M. Symonds Drive and Park Avenue. The facility crosses a triple-track rail line. There are pedestrian gates on both sides of the tracks (see Appendix H for a ground view).

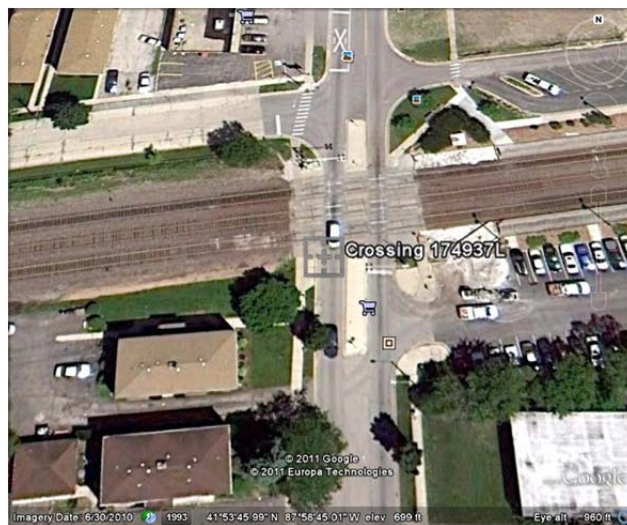
Figure 11. Crossing 174937L—A view above ground.
(Source: Google Earth 2010)

Crossing 174937L (Figure 11) is a triple-track highway-rail grade crossing on Ardmore Street in Villa Park. There are pedestrian approaches on both sides of the roadway that continue to the other side of the tracks. There are pedestrian gates as well as “another train coming” audio-visual devices on all four quadrants of the attached sidewalks (see Appendix H for a ground view). There is also pedestrian fencing and channelization designed to direct Metra patrons away from the tracks and back to the proper approach in order to cross the crossing.

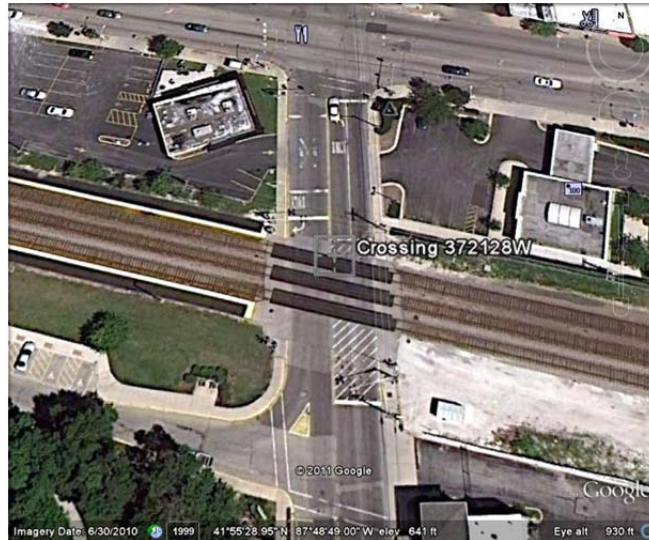
Figure 12. Crossing 372128W—A view above ground.
Source: Google Earth 2010)

Crossing 372128W (Figure 12) is a triple-track highway-rail grade crossing on 75th Avenue in Elmwood Park with pedestrian approaches on both sides of the roadway that continue to the other side of the tracks. There are no pedestrian gates on the attached sidewalks (see Appendix H for a ground view).

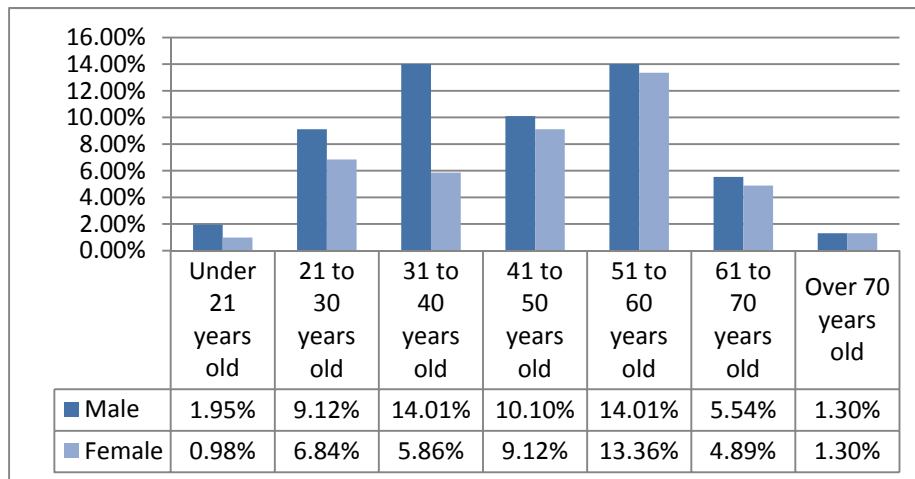
Figure 13. Distribution of survey respondents by gender and age group.

The distribution by age category is shown in Figure 13 (see Table 29 for age frequencies). More than twice as many male respondents 31 to 40 years old compared with their female counterparts participated in the survey. The other age categories were more evenly distributed between genders.

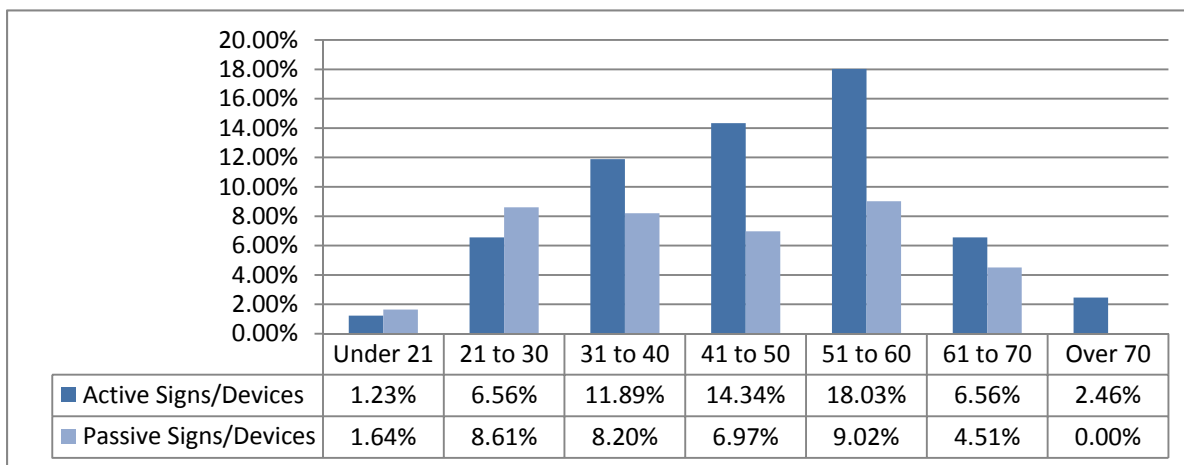
Figure 14. Active/passive signs/devices detection by age.

The warning signs and devices listed in Tables 10 and 11 were additionally categorized into two groups, active and passive, to further investigate visibility differences. Sixty-one percent of respondents noticed the active warning devices compared with 39% of the respondents who noticed the passive warning signs. This was virtually true independently of the mode of crossing. Interestingly, more users 31 years of age and older noticed the active warning devices, while more users 30 years of age and younger noticed the passive warning signs (Figure 14).

In addition, 62% of the male and 58% of the female respondents were more aware of active warning devices than passive warning signs. Finally, 60% of regular crossing users and 68% of respondents who rarely used a crossing noticed the active warning devices.

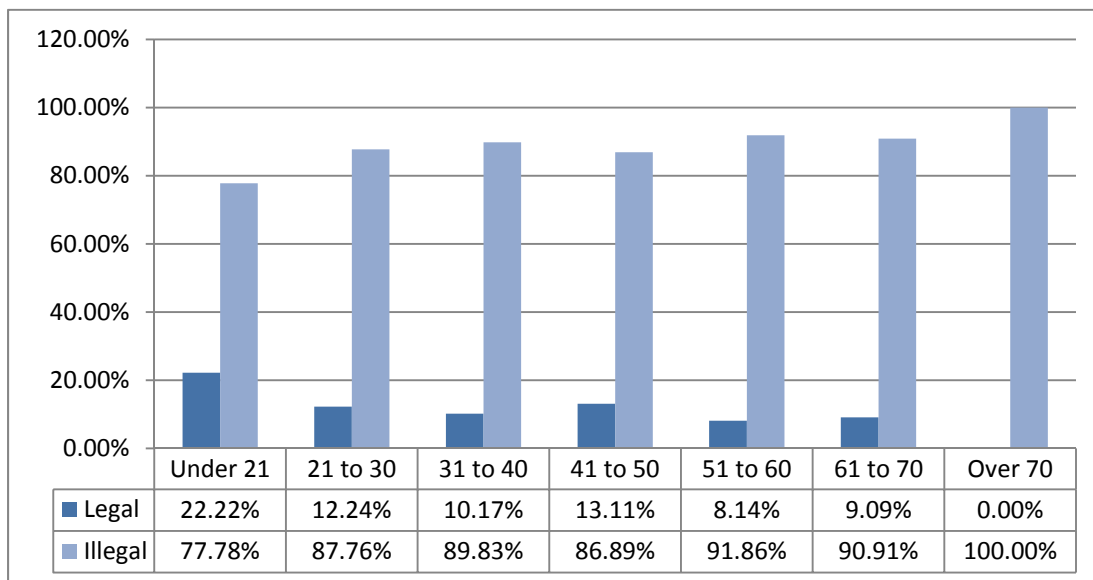
Figure 15. Legality of crossing tracks against activate signals by age.

The distribution of the two groups by age is shown in Figure 15. Generally speaking, perceptions of illegality when crossing against activated signals/devices increase with age.

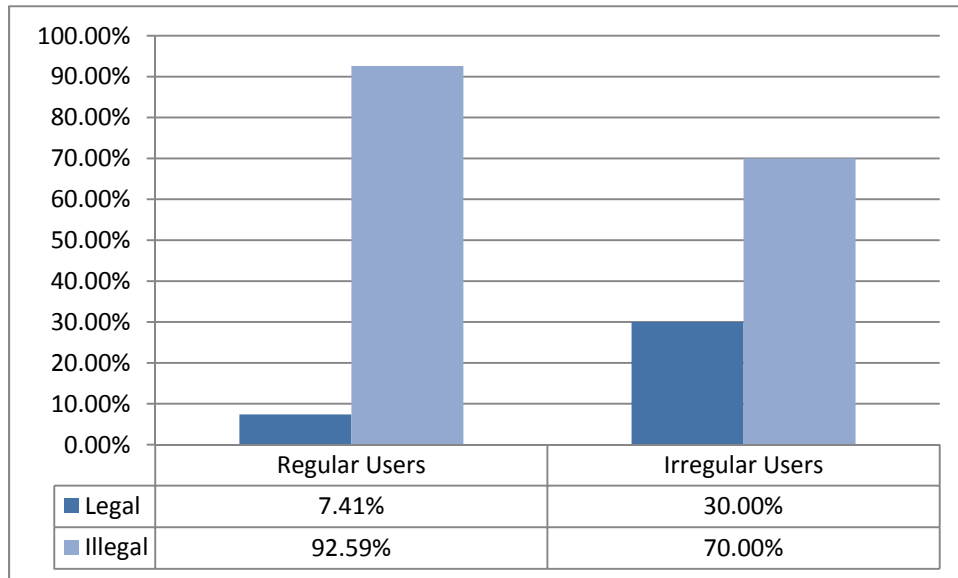
Figure 16. Perceptions of legality of crossing tracks between regular/irregular users.

There is a difference in the perception of legality between regular and irregular users (Figure 16). Thirty percent of irregular users compared with only seven percent of regular users believe it is legal to cross the tracks when the signals/devices are activated.

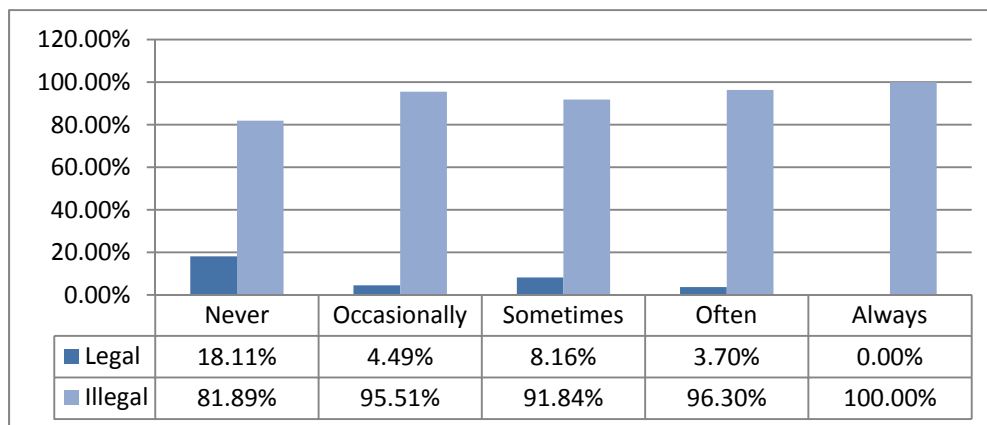
Figure 17. Perceptions of legality and level of general awareness.

Moreover, respondents' own perceptions about legally/illegally crossing against activated safety devices affect their awareness of the crossing behavior of other users. For example, 82% of respondents who believe it is illegal to cross against activated safety signals/devices have never seen other pedestrians doing so (Figure 17). Overall, the more likely a user perceives it is illegal to cross against activated safety signals/devices, the more frequently he/she will observe others doing so.

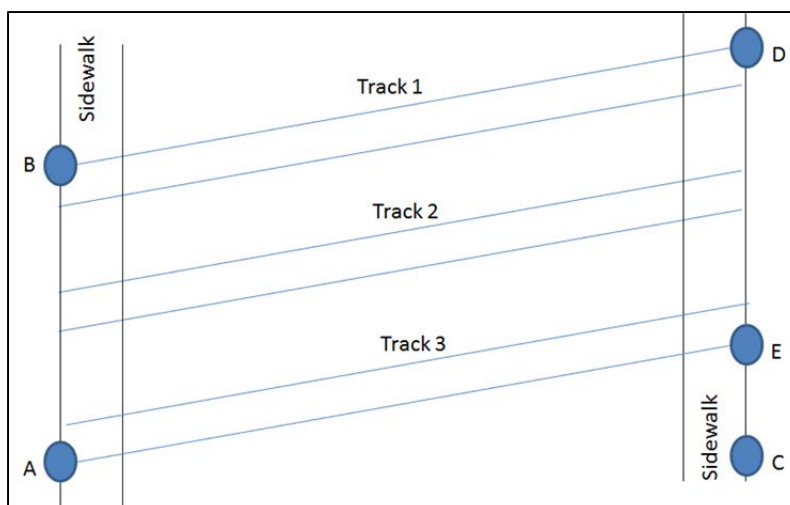
Figure 18. Crossing distances measured.

Considering that the vast majority of users observed were walkers, we expected that the literature about walking speeds would be relevant in our analysis once reasonable estimates for crossing times and distances were developed. The crossing time recorded in the video database was defined to be the time to traverse the distance between the outer rail at the near side and the outer rail at the far side of the crossing. To obtain reasonable speed estimates, we used Google Maps to measure the distances A–B, A–C, A–D, and B–E at each crossing, as shown in Figure 18 for a three-track crossing. We also observed the direction of travel (straight or diagonally) for each user. An estimate of the crossing speed was then obtained by the ratio of the crossing distance and the crossing time.

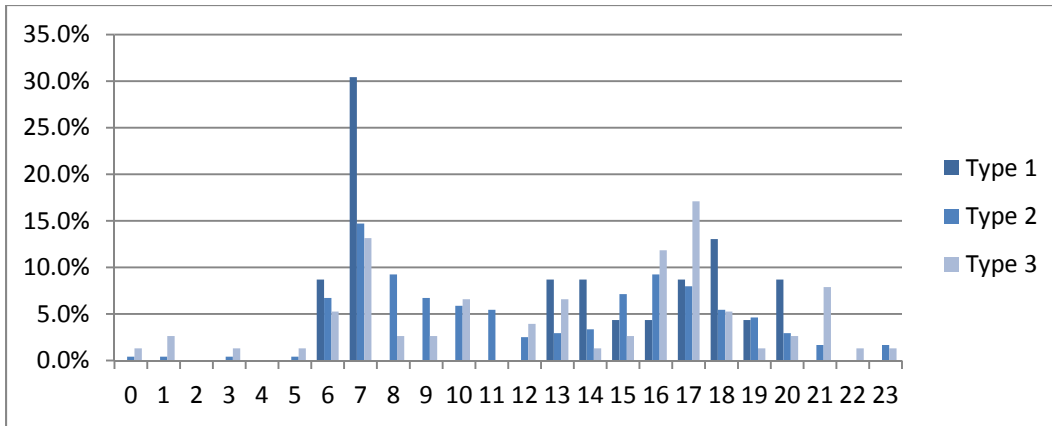
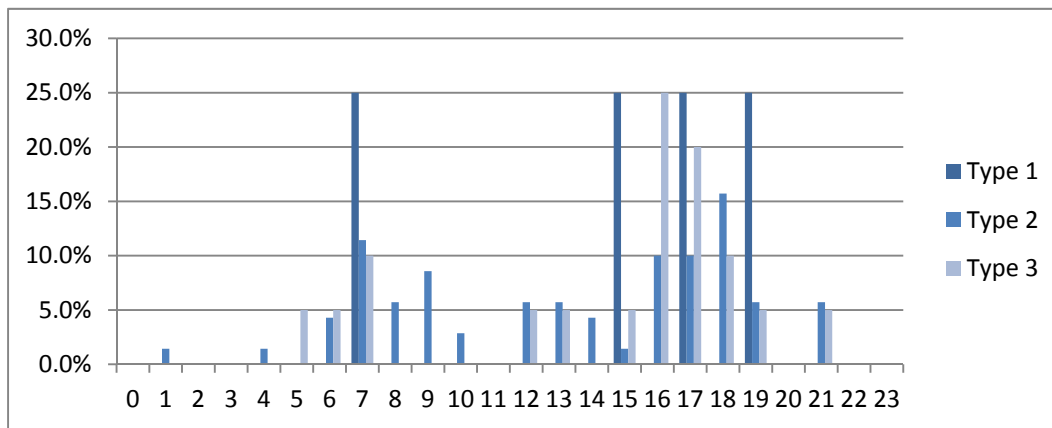
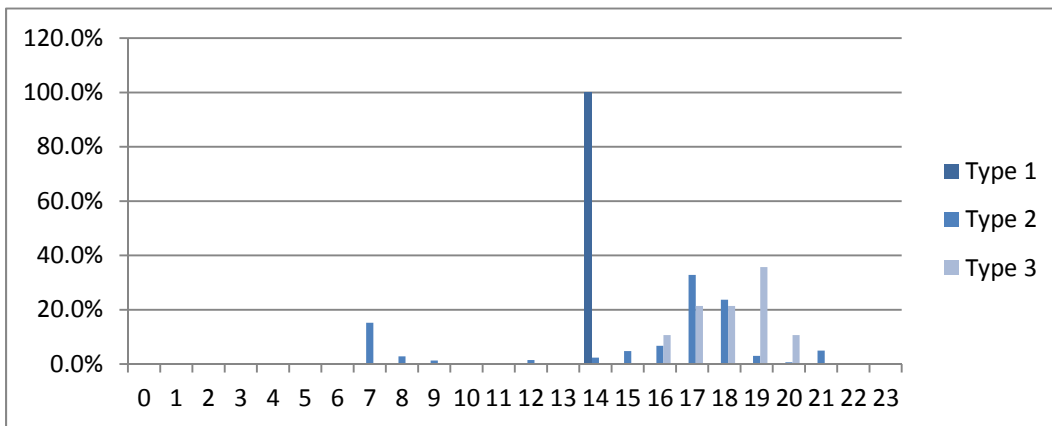
Figure 19. Hourly distribution of violation types for solo pedestrians.

Figure 20. Hourly distribution of violation types for groups of two pedestrians.

Figure 21. Hourly distribution of violation types for groups of more than two pedestrians.

More specifically, violations expectedly follow the patterns of pedestrian traffic during the day, i.e., a morning and an evening peak for all platoon sizes. Additionally, a rather pronounced spike of violation activity for groups of two or more pedestrians seems to coincide with the midday/early afternoon school release.

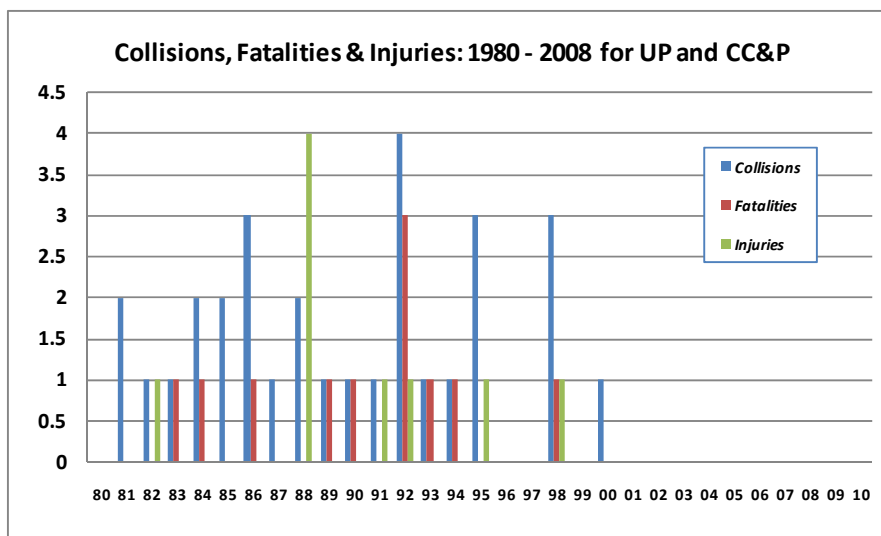
Figure 22. 1980-2010 Collisions, Fatalities & Injuries for UP and CC&P.
(Source: Elmhurst Police Department)

The effectiveness of such OL activities is verified by collision statistics (Figure 1). The community was experiencing about two to three fatalities per year prior to the program and only one fatality in the 17 years the program has been in place. Overall, the agency estimates that during this period a total of 32 lives have been saved (based on an average fatality rate prior to the program). The agency believes that this estimate is not affected by the impact of safety upgrades of warning devices at crossings during that time.

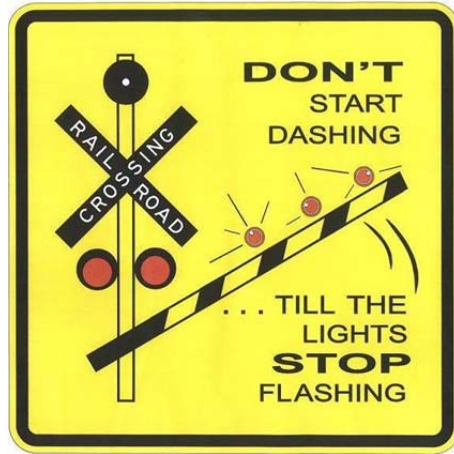
Figure 23. A pedestrian crossbuck sign used by the NJDOT.

In New Jersey, there are 1,652 public grade crossings including pedestrian crossings adjacent to rail-highway crossings and approximately 30 pedestrian only crossings. Of all public grade crossings 513 have flashing lights and gates. The New Jersey Department of Transportation (NJDOT) has utilized various types of signs (the design in Figure 2 has also been in use in Elmhurst, Illinois), pavement markings, channelizing devices and gates. A 'second train coming' sign has been used twice in places with pedestrian incidents. One of the most used signs is a large sign that says 'warning: trains approach from both directions' (Figure 3). One of the audible tone verbal messages being used is 'incoming train, stand behind the yellow line' for passenger stations.

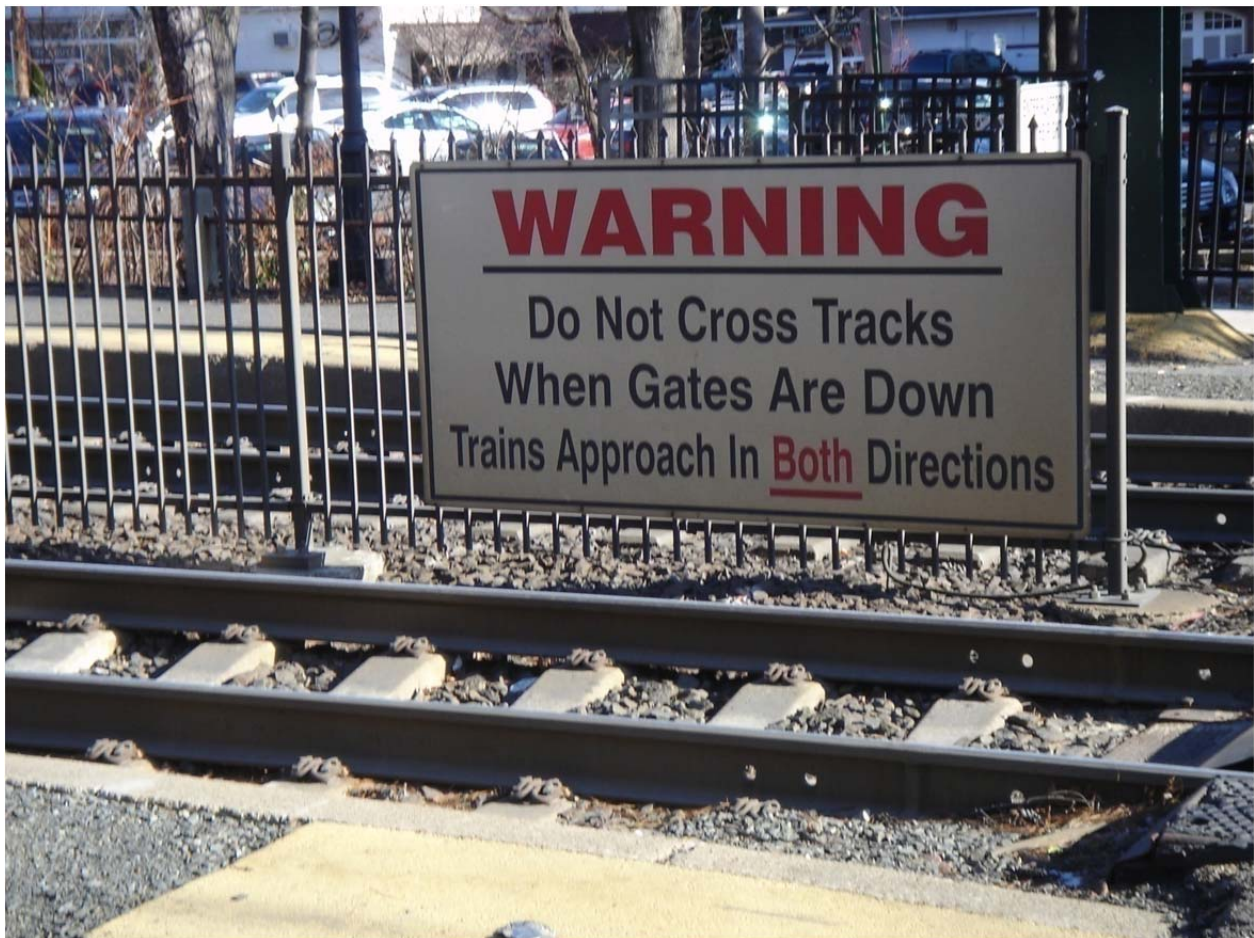
Figure 24. A common sign for trains approaching in both directions.

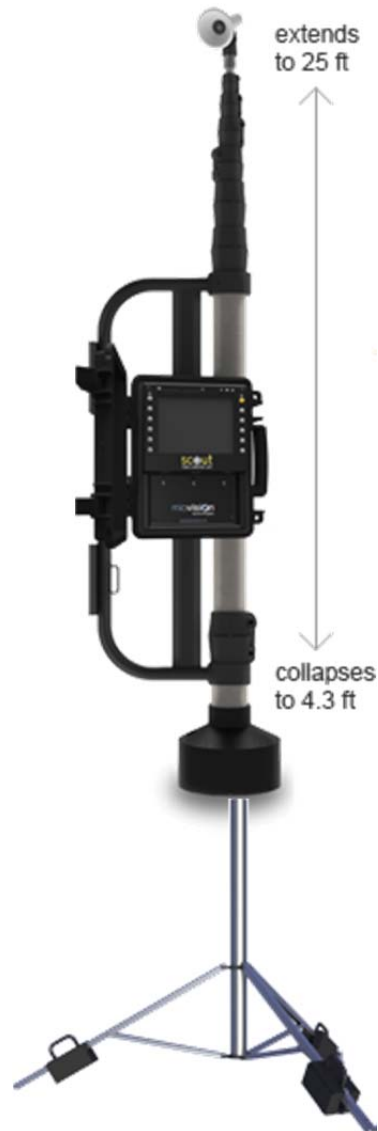
Figure 1. Video camera and tripod - (http://greenway-consulting.com/images/ScoutVCU_Spec_Sheet.pdf - Accessed 9/14/2011.)

Technical Specifications of the Video Monitoring Equipment
