Transportation Technology and Operations Coalition

May 2, 2024

OPTIMUM TRAFFIC SIGNAL CONDITION ASSESSMENT AND STRATEGIC MAINTENANCE PLANNING (ICT R27-251)

Progress Update, May 2024

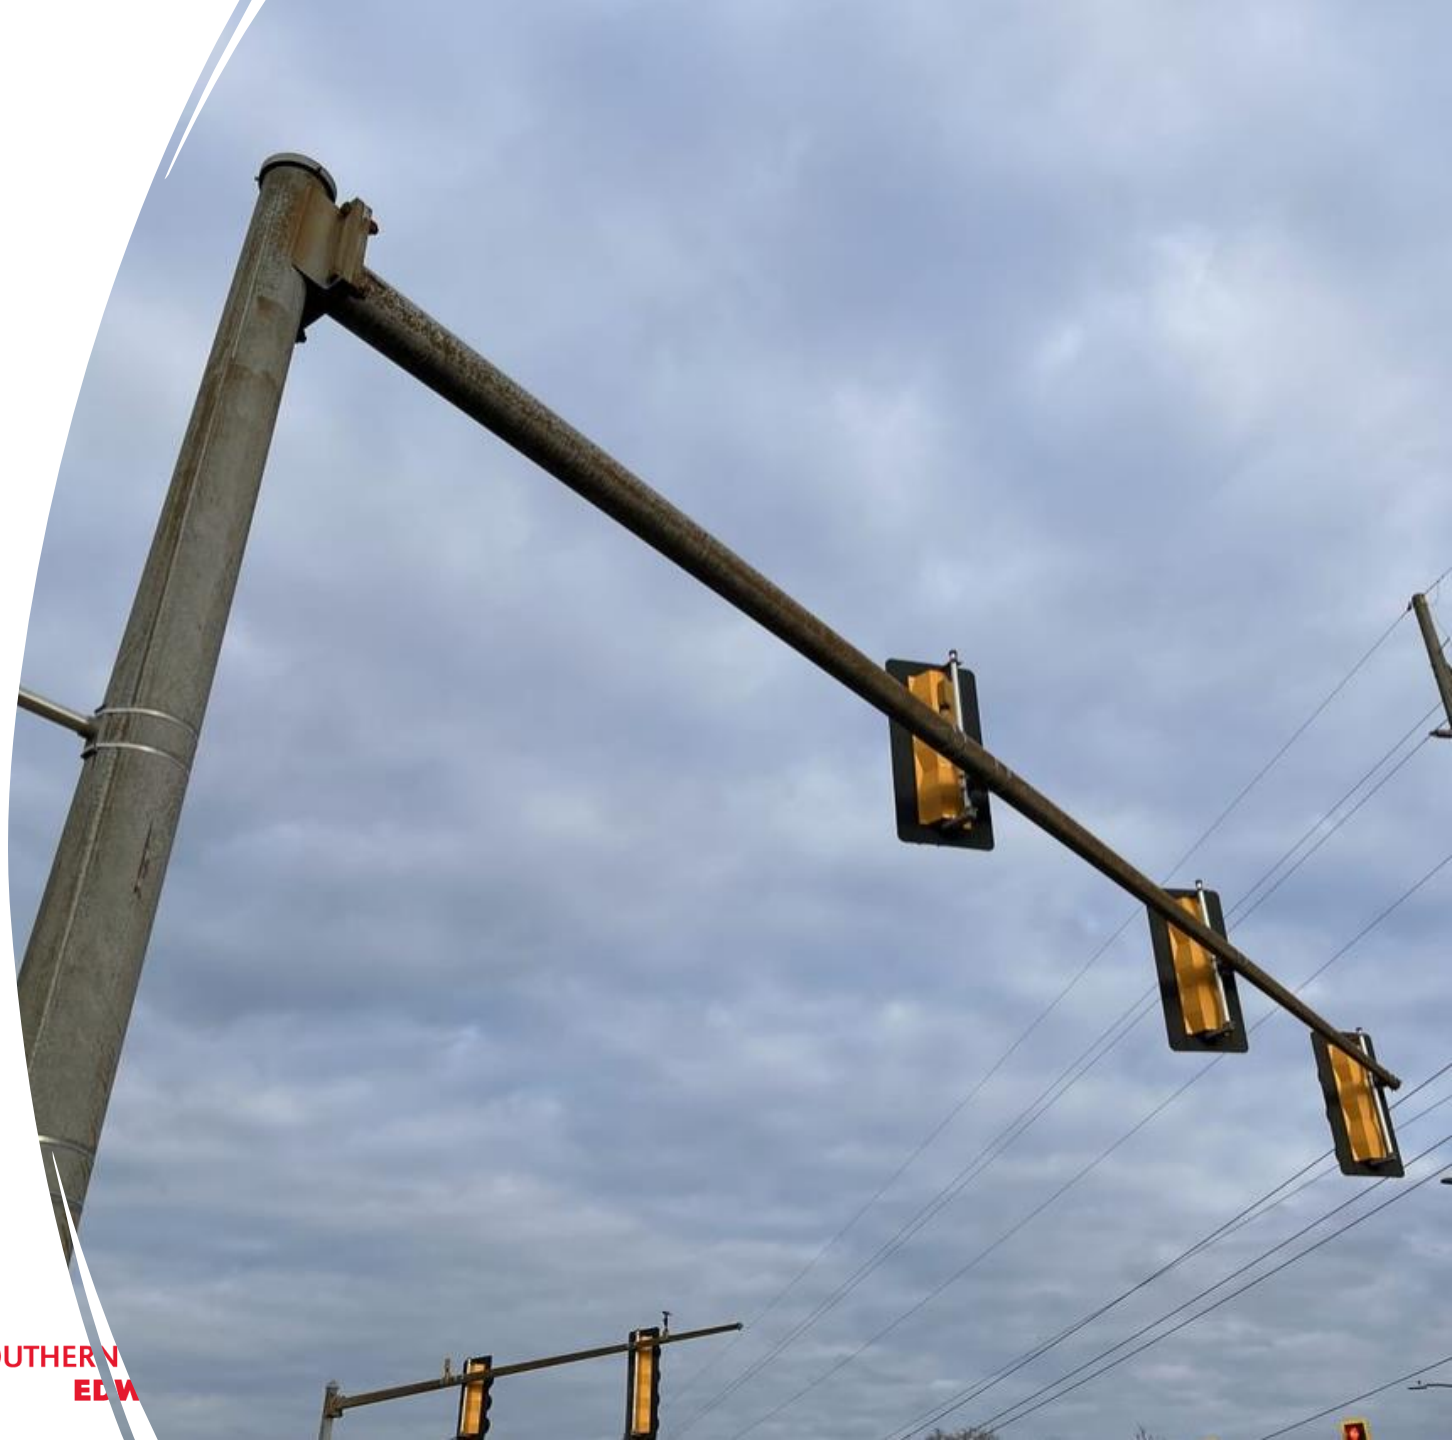
MAST ARM AGING CONSIDERATIONS

- Cantilever design
- Wind
 - Natural and truck-induced
 - Vortex shedding
 - Galloping

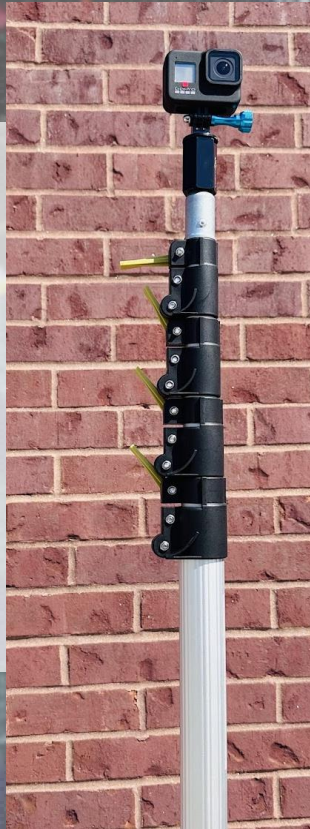
MAST ARM CONDITION ANALYSIS

- 96 Mast Arms
 - 24 Intersections
 - Southwestern Illinois
- Aged 10-25 years old
- Telescoping camera

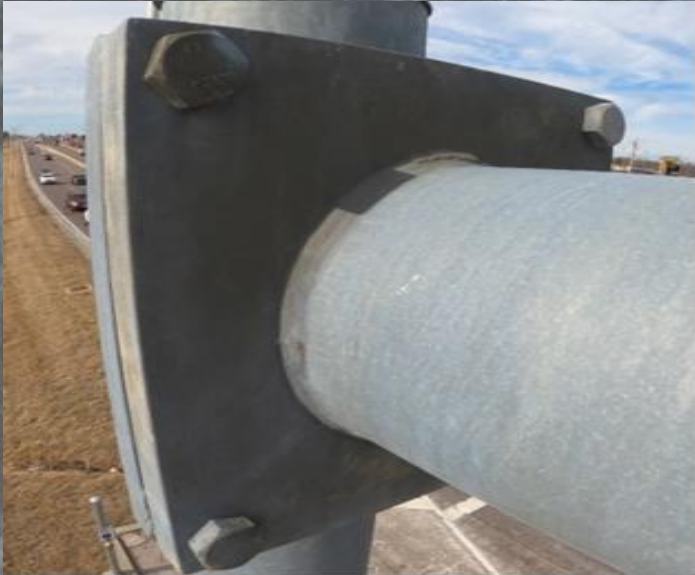
EXAMPLE WELD CONDITIONS OBSERVED

Categories What to inspect	Condition Rating		
	Good (1)	Poor (2)	Critical (3)
Cracks/Scars/Crater Pit (A)	Shall not have any cracks, scars, or crater pits.	Shall not have any cracks at weld's face or toe. May have small scars or crater pits on weld face.	Has one or more cracks at or near the weld's face or toe. May have scars or crater pits on or near weld.
Roughness/Porosity (B)	Should be smooth and clean, no roughness around the weld.	May have the presence of minor roughness around the weld, but not on the weld face.	Has minor roughness around weld toe and on weld face
Corrosion/Oxidation (C)	May have minor corrosion/oxidation around the weld.	May have moderate corrosion or oxidation around the weld.	May have severe corrosion or oxidation on or around the weld, causing section loss.

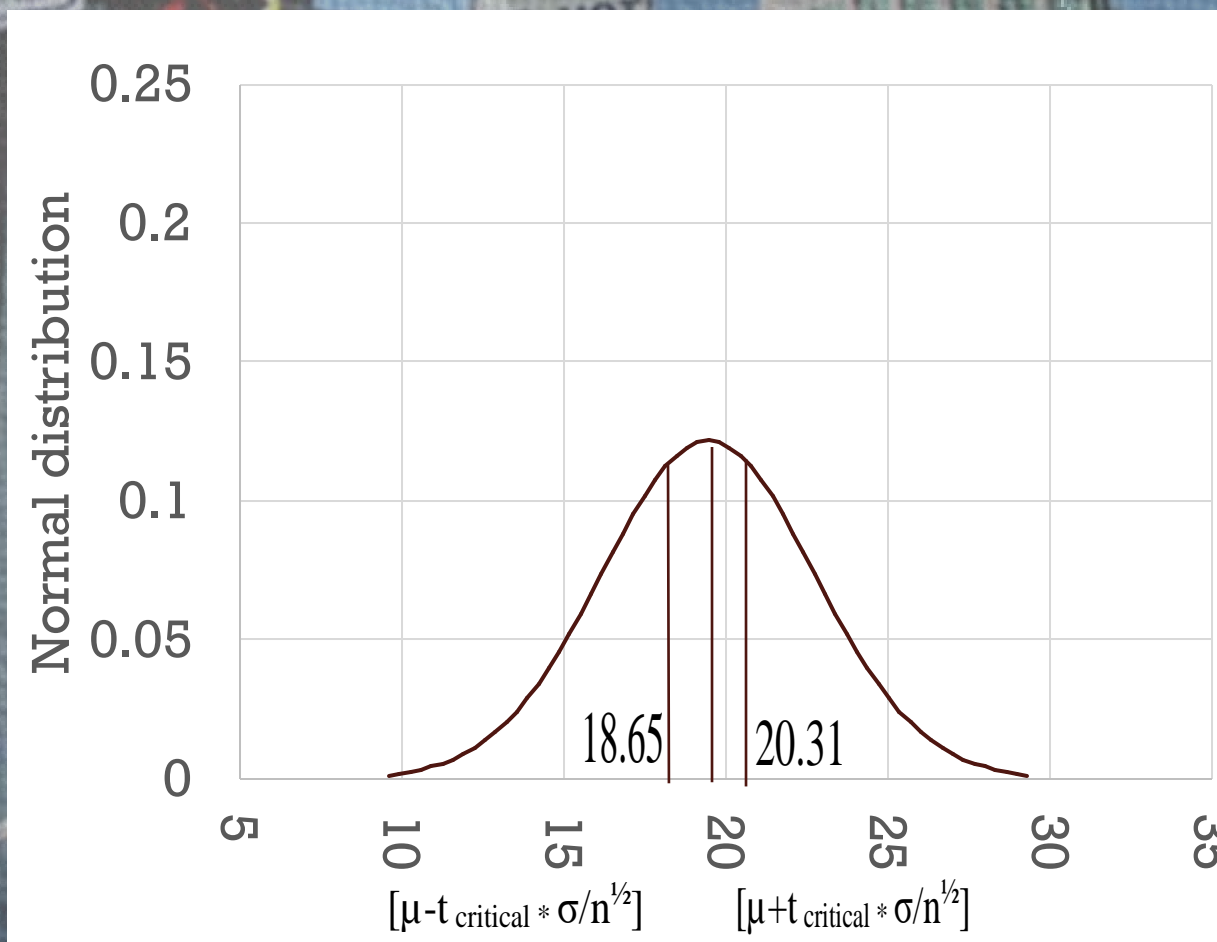
MAST ARM FINDINGS

Limiting State Analysis: Critical Condition

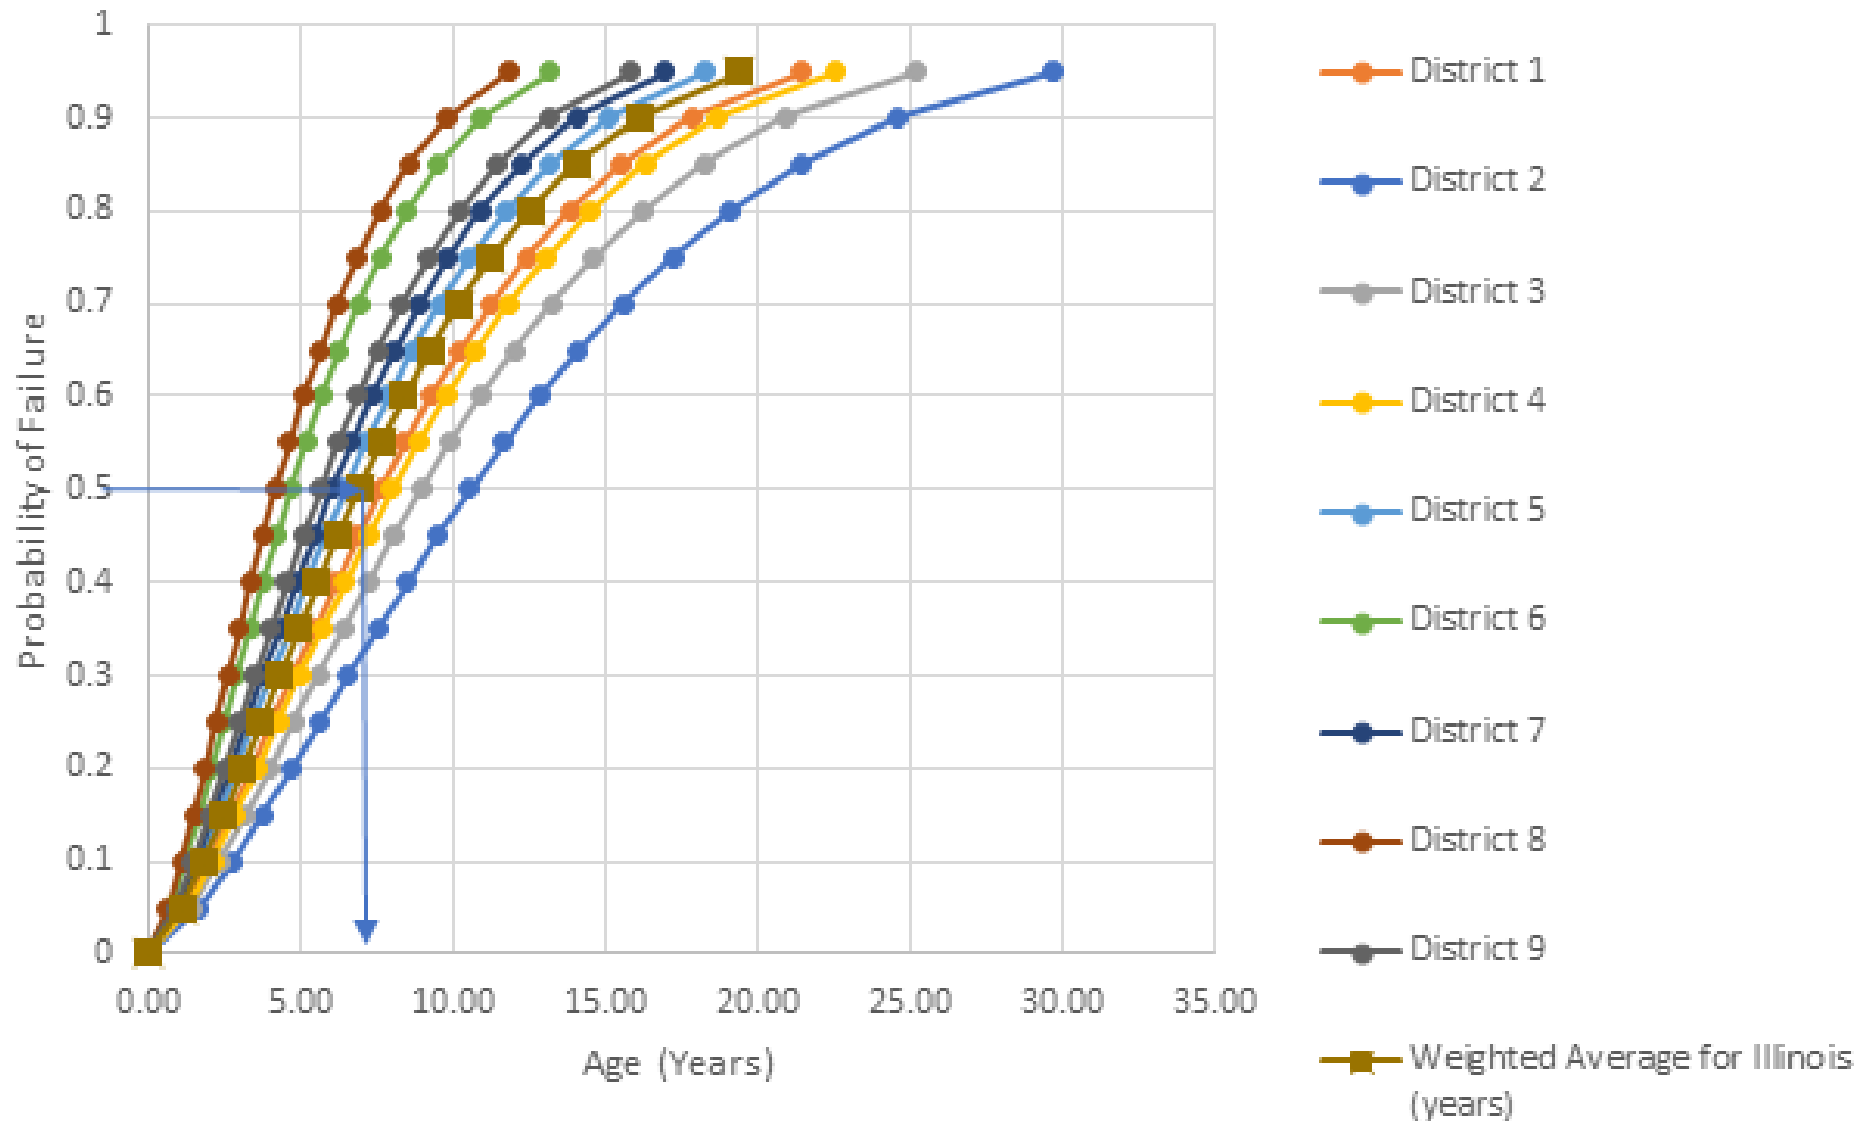
ENVIRONMENTAL MODELING FINDINGS

SIGNAL CONTROLLER ENVIRONMENTAL MODELING

$$y(g) = e^{-\left(\frac{g}{\alpha}\right)^{\beta}}$$

$$\alpha = \exp(9.343 - 0.101 * (\text{average wind speed in mph}) \\ - 0.108 * (\text{average annual temperature in } ^{\circ}\text{F}) \\ + 0.139 * (1 \text{ if pre-timed or semi-actuated signal, } 0 \text{ otherwise}) \\ - 0.288 * (1 \text{ if on a city street, } 0 \text{ otherwise}) \\ - 0.583 * (1 \text{ if supported by a mast arm, } 0 \text{ otherwise}) \\ + 0.352 * (1 \text{ if part of a closed loop or hardwire interconnected}) \\ - 0.319 * (1 \text{ if fiber-optic cables, } 0 \text{ otherwise}))$$

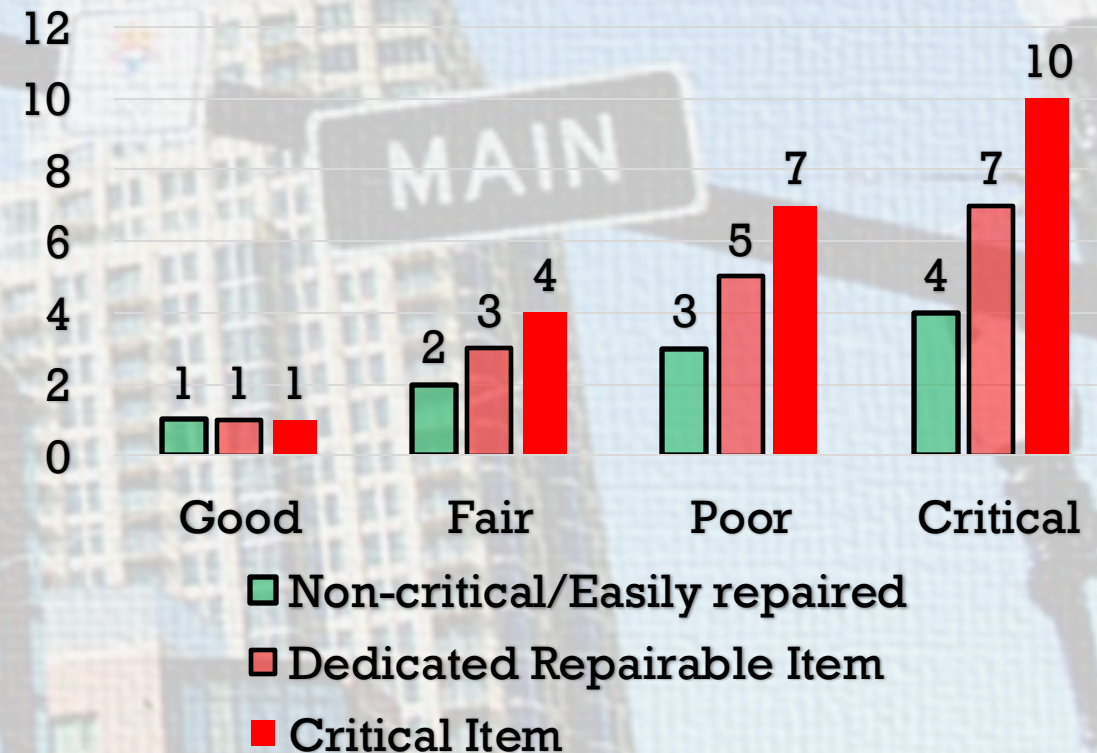
Proposed Scoring Levels

CONDITION SCORING

- Scoring absent from review sheet
- Three categories of components
 - Non-critical/Easily repaired
 - Dedicated Repairable Item
 - Critical Item
- Scores vary by category
