2018 “State of the Streets”

Final Report – 4/18/2019

Village of Park Forest, Illinois +

Pavement Engineering and Management Division

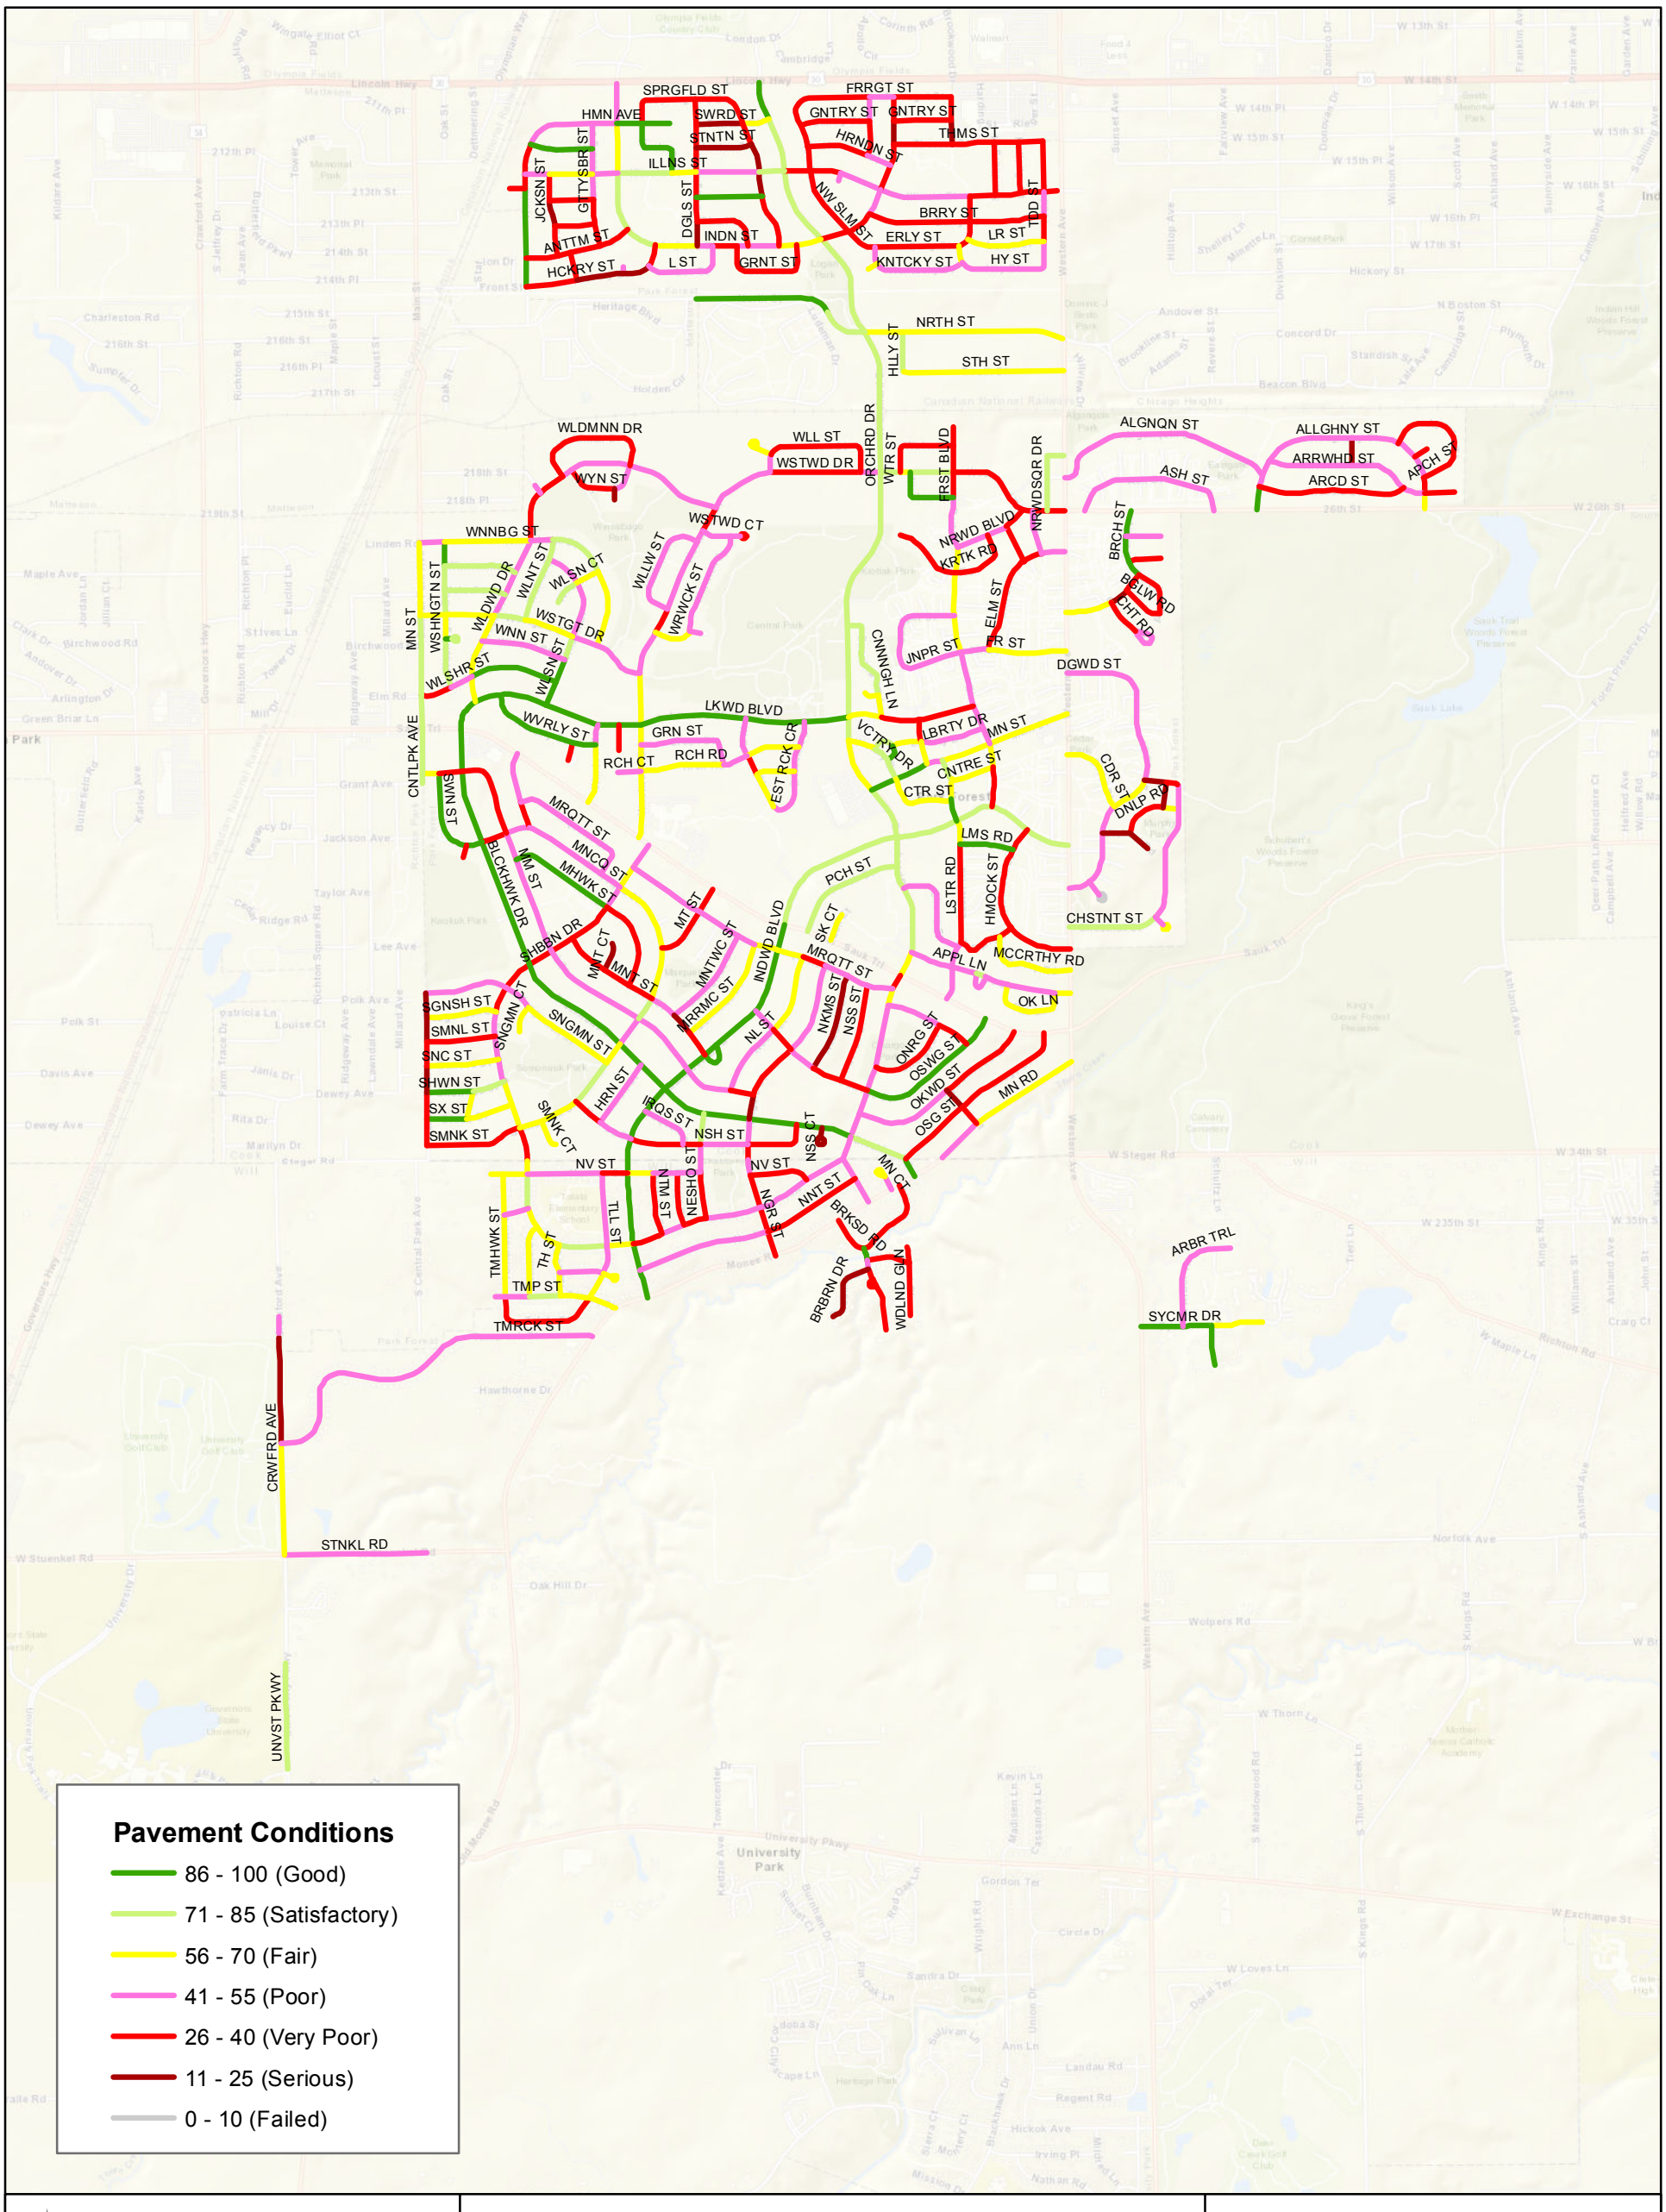
Pavement Conditions

At the time of G&AI's November 2018 inspection, the Village's pavements were found to be in overall "Fair" condition, with an average PCI of 56. The condition distribution of the Village's pavements at the time of inspection is shown in Figure 5, and detailed condition maps can be found in Appendix A.

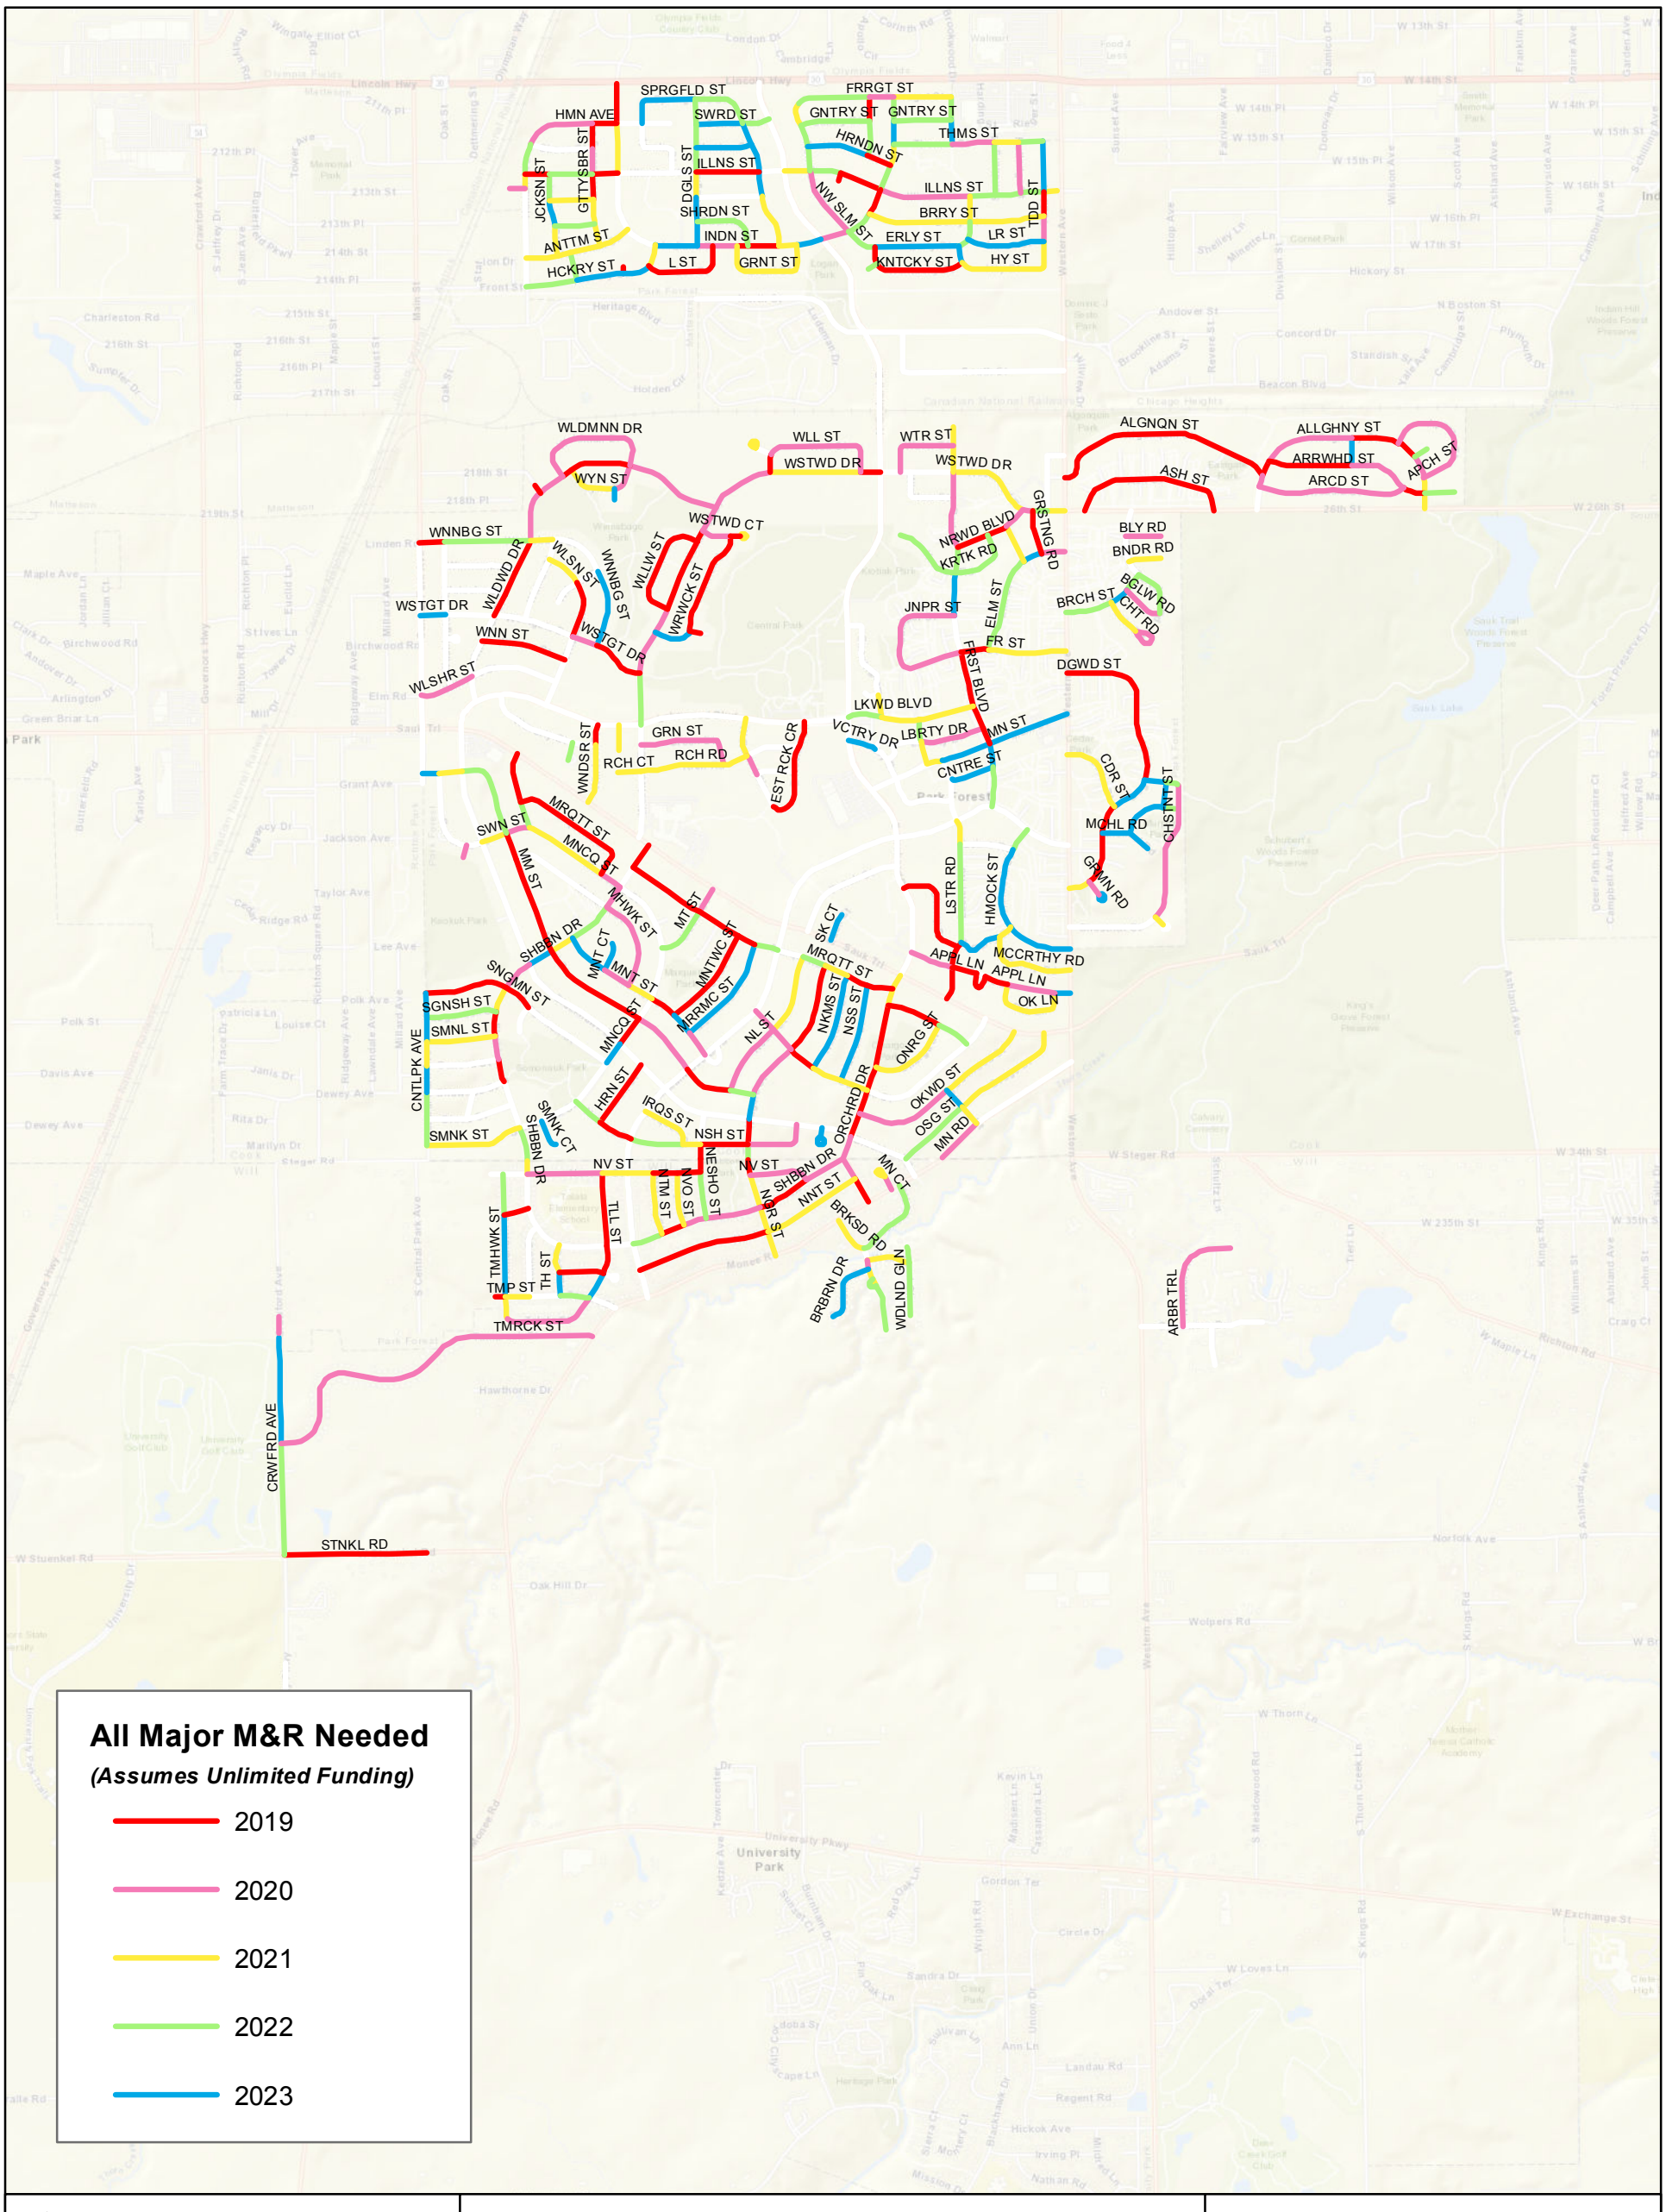
TH ST
TMP ST
BRBRN DR
WDLND GLN
ARBR TRL
TMRCK ST
CRWFRD AVE
STNKL RD
All Major M&R Needed
(Assumes Unlimited Funding)
2019
2020
2021
2022
2023
N
0
1,500
3,000
Feet
Major M&R Needs
Village of Park Forest, Illinois
Pavement Assessment
Gorrondona & Associates, Inc.
Urban GIS
your world, your way
