# Pavement Data Collection and Pavement Management System Implementation for City of Crystal Lake, IL

Prepared for  
**City of Crystal Lake, Illinois**  
In Association with  
**Chicago Metropolitan Agency for Planning**

Prepared by  
**Applied Research Associates, Inc.**

## FINAL REPORT

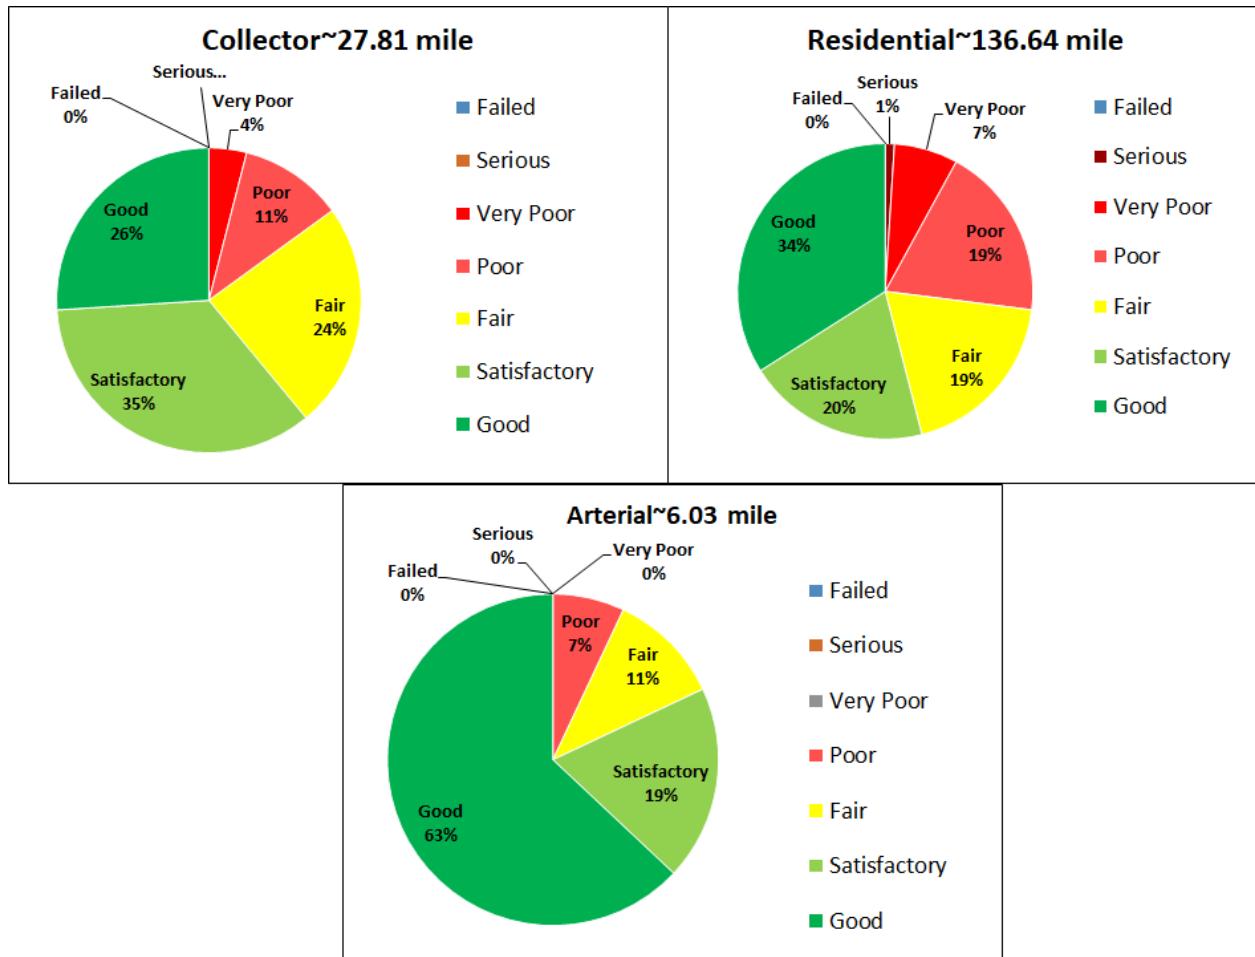
**Figure 9. Pavement condition distribution based on functional class.**

Figure 8 shows the distribution of network pavement area based on pavement current conditions. In Figure 8, it can be observed that only 1% of the pavement network is in ‘serious’ condition. It is observed that about 23% of the network is in ‘poor’ or ‘very poor’ condition whereas about 57% of the network is in ‘satisfactory’ or ‘good’ condition. Figure 9 shows the detail distribution of pavement conditions based on the functional class of the streets.

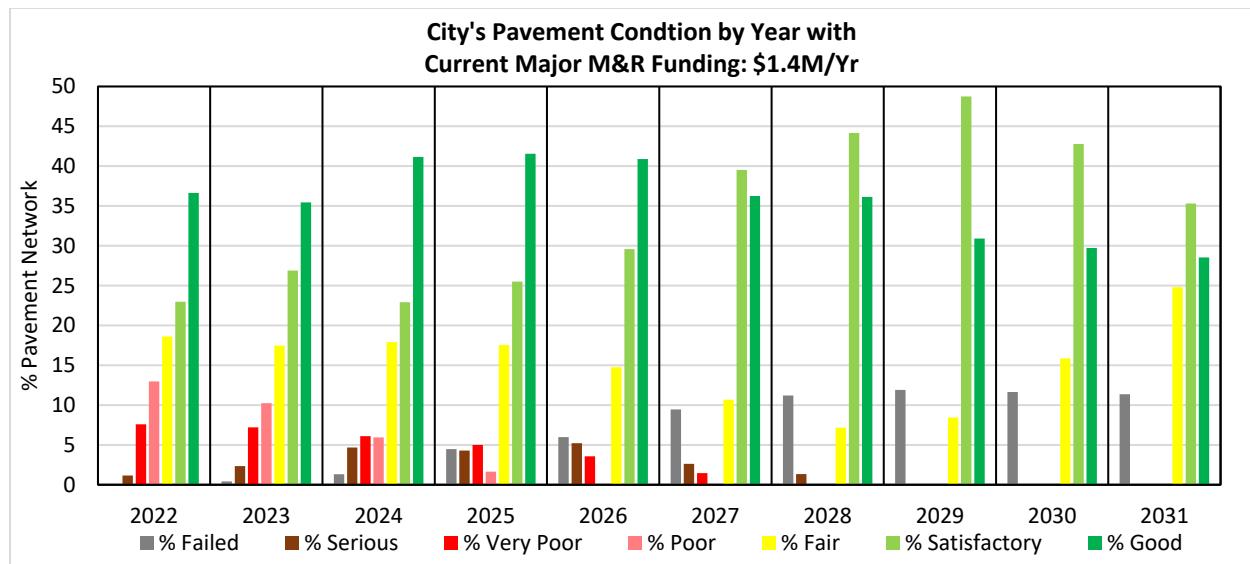
**Figure 18. Pavement condition by year with current major M&R funding.**

The 10-Year major M&R plan based on the current funding and 2021 localized distress maintenance plans are provided in Appendix A. Figure 18 shows the network condition distribution for the next ten years with the current funding level. Currently, about 7% of the pavement network is in ‘very poor’ or ‘serious’ condition and about 77% in “Fair” or better condition. With current funding, the average PCI of the network is expected to be 70.2 in 2031. Although the network PCI is predicted to decline slightly, 89% of the network will still be in “Fair” or better condition by 2031 with the City’s current major M&R and pavement preservation funding. PAVER™ recommends projects by adhering to the principles of achieving the best possible outcomes within budgetary limitations.
