2019 “State of the Streets”

Final Report

**Village of Dixmoor, Illinois &
Chicago Metropolitan Agency for Planning**

Gorrondona and Associates, Inc.
Pavement Engineering Division

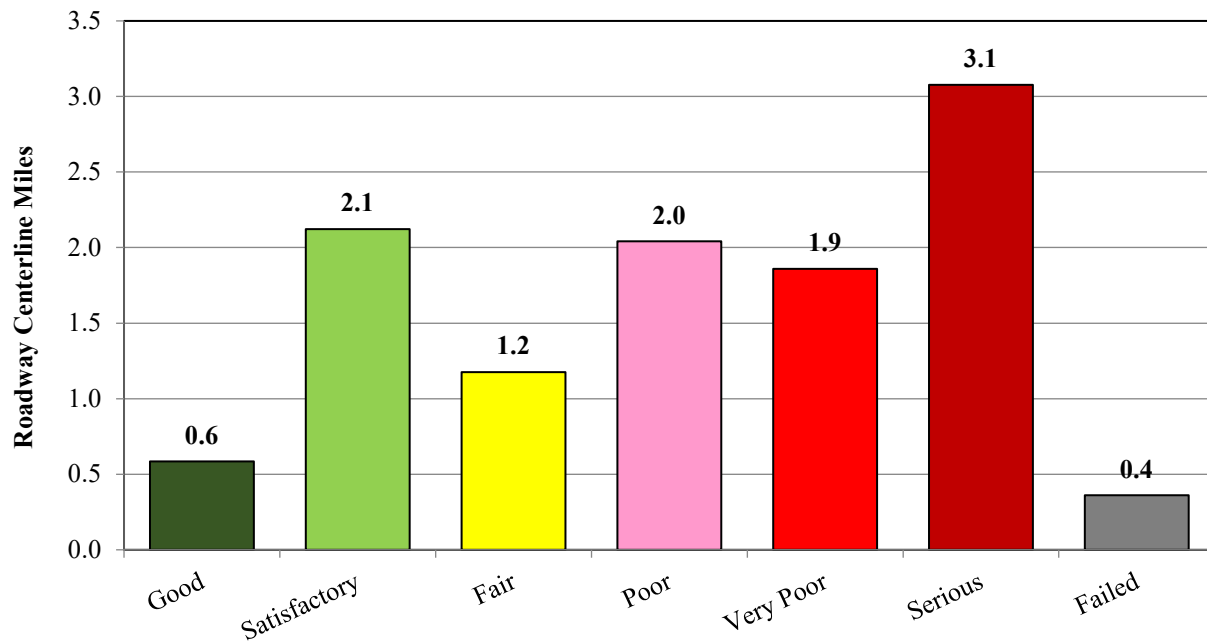
Figure 10. Village's roadway pavement condition distribution by PCI category.
 (Note: Excludes gravel roadways.)

At the time of G&AI’s June 2019 inspection, the Village’s pavements were found be in overall “poor” condition and have an average PCI of 46. The condition distribution of the Village’s pavements at the time of inspection is shown in Figure 10, and detailed condition maps can be found in Appendix A.
