2020 “State of the Streets”

Final Report

**Village of River Grove, Illinois &
Chicago Metropolitan Agency for Planning**

Gorrondona and Associates, Inc.
Pavement Engineering Division

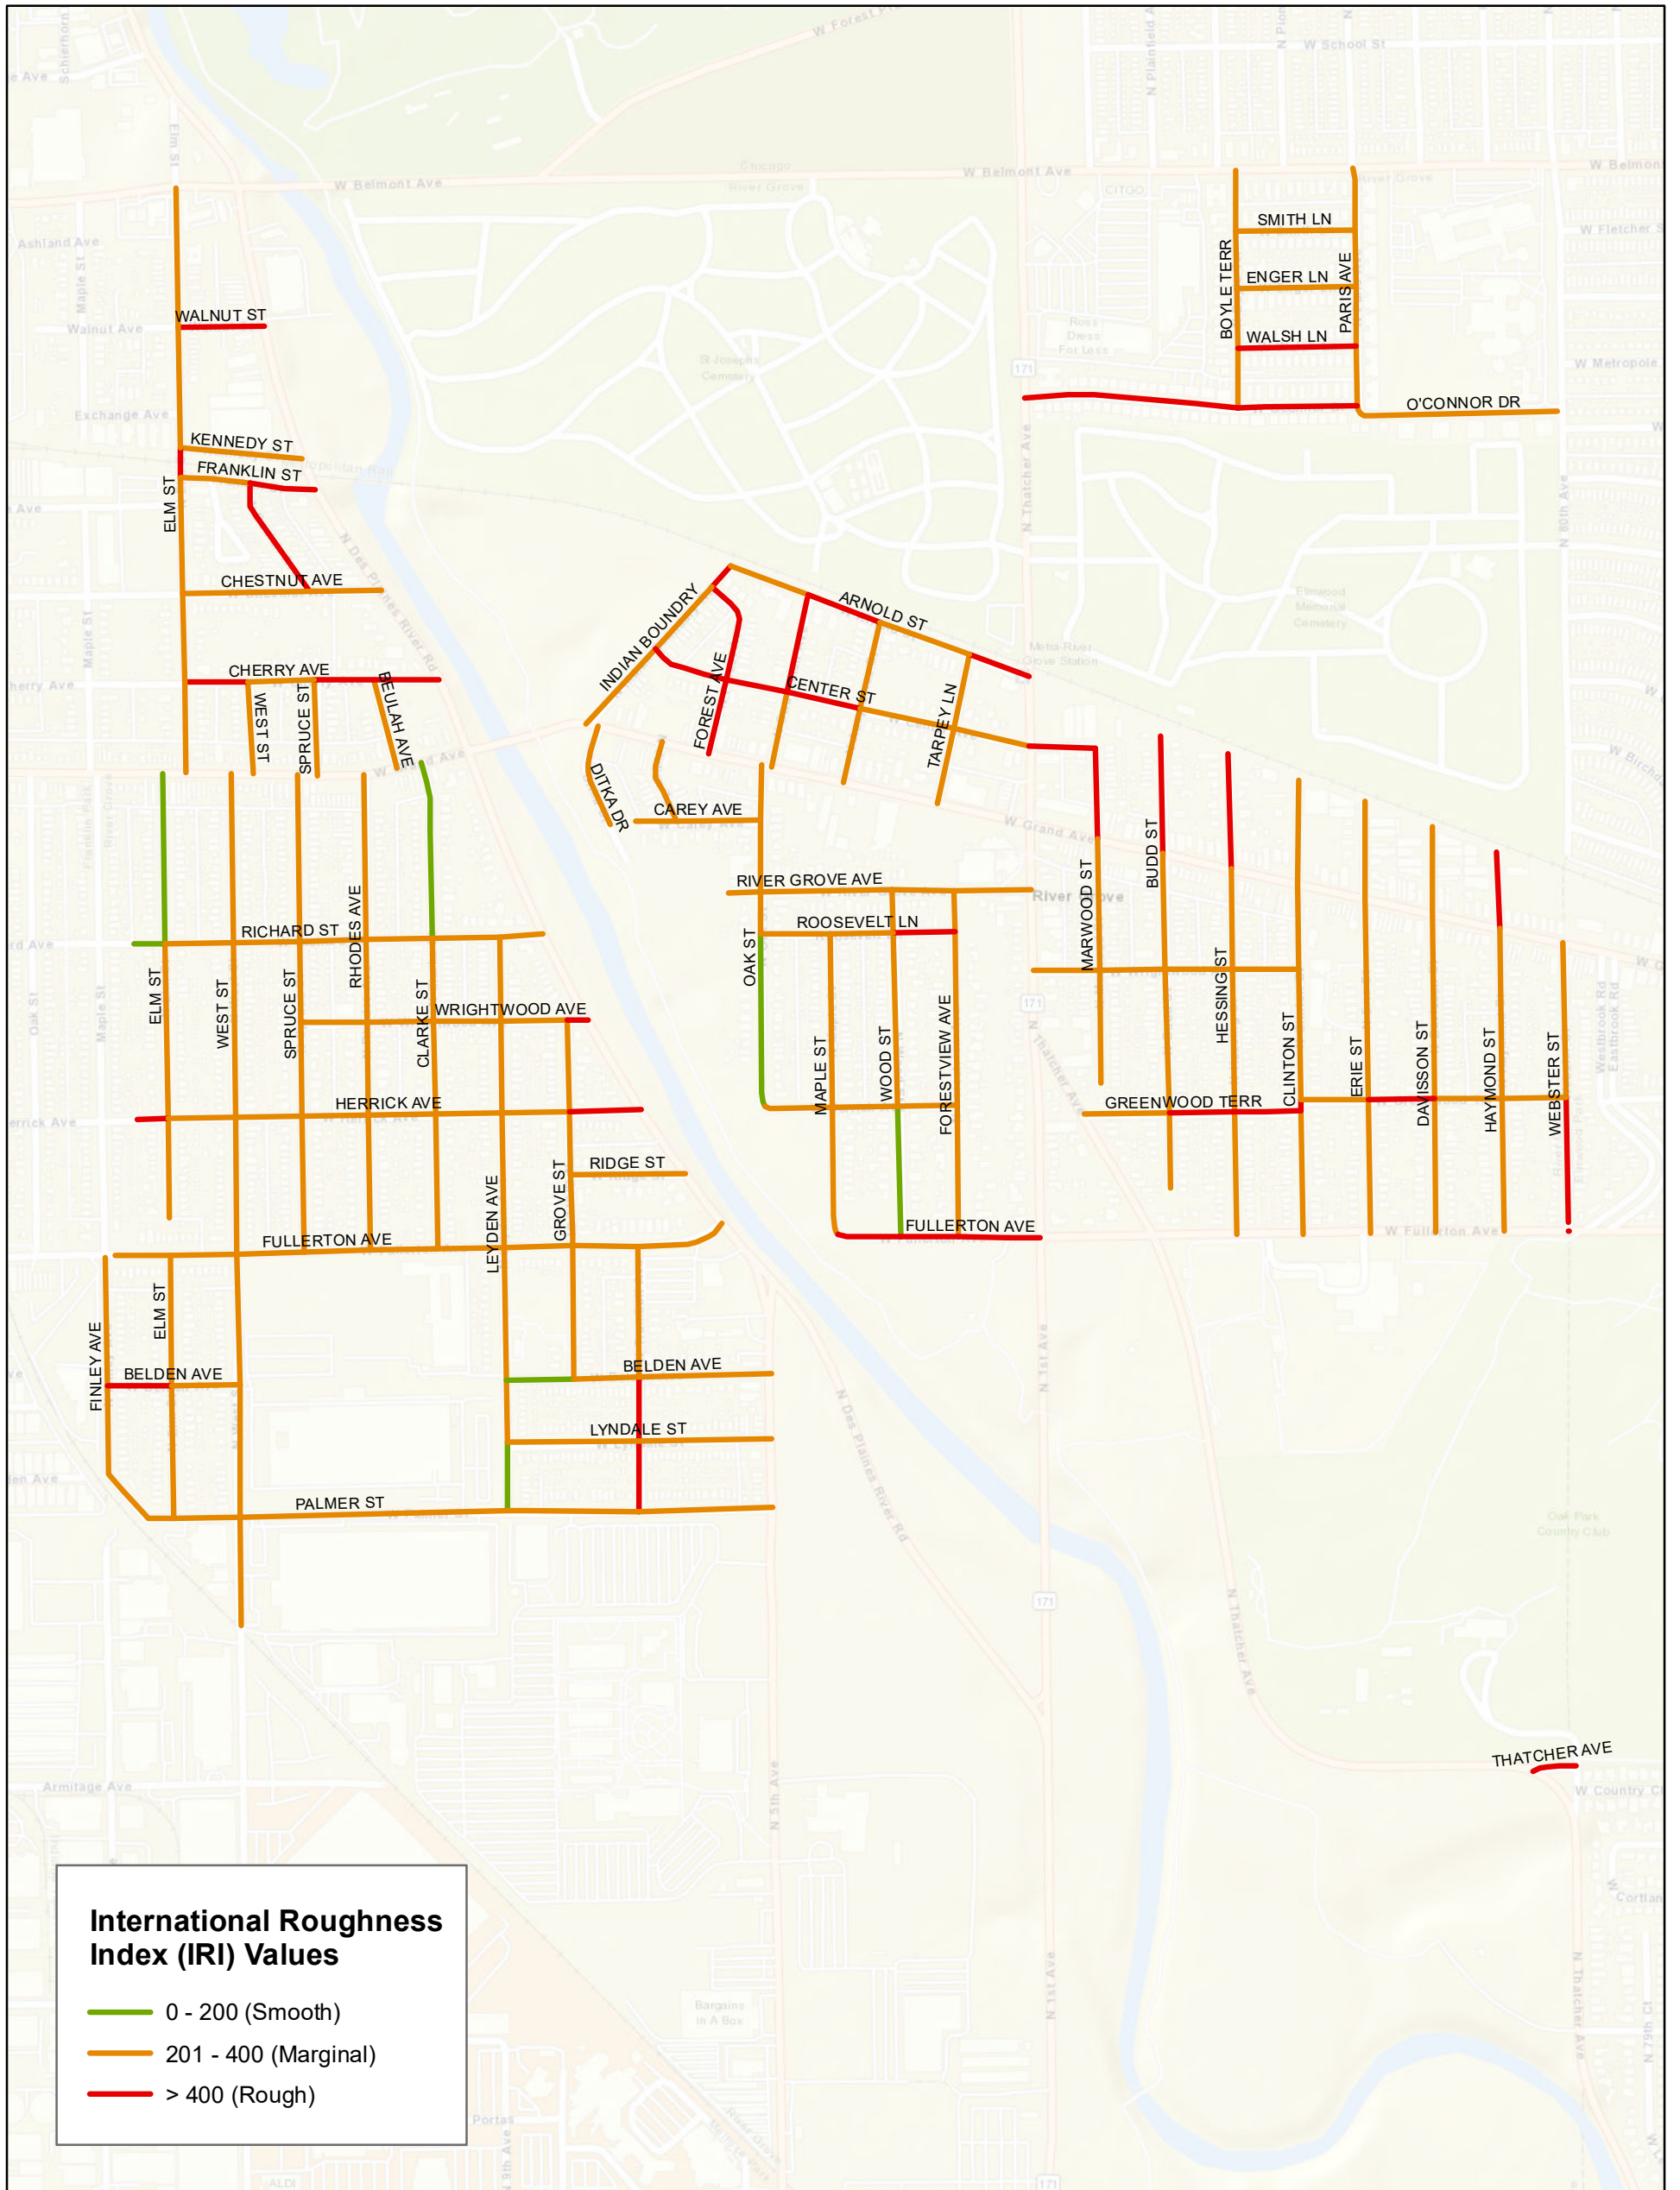
Map 2:
International Roughness
Index (IRI) Values

The Village’s roadways were found to have an average IRI value of 316 inches/mile, which indicates overall “marginally rough” pavement.

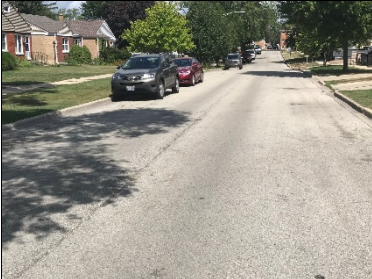
Figure 11. Pavement conditions observed during PCI inspection.

Figure 11 illustrates a variety of pavement conditions observed throughout the Village during the pavement condition survey. The figure includes PCI and IRI values for each pavement section along with observed distress types and recommended M&R.

Location + History	PCI (IRI)	Recommended M&R Activity (Typical)
