VILLAGE OF BELLWOOD:
TECHNICAL ASSISTANCE
SAFETY PLANNING

25th Avenue
and Illinois Prairie Path

EXISTING
CONDITIONS
REPORT

Chicago Metropolitan Agency for Planning
and Village of Bellwood

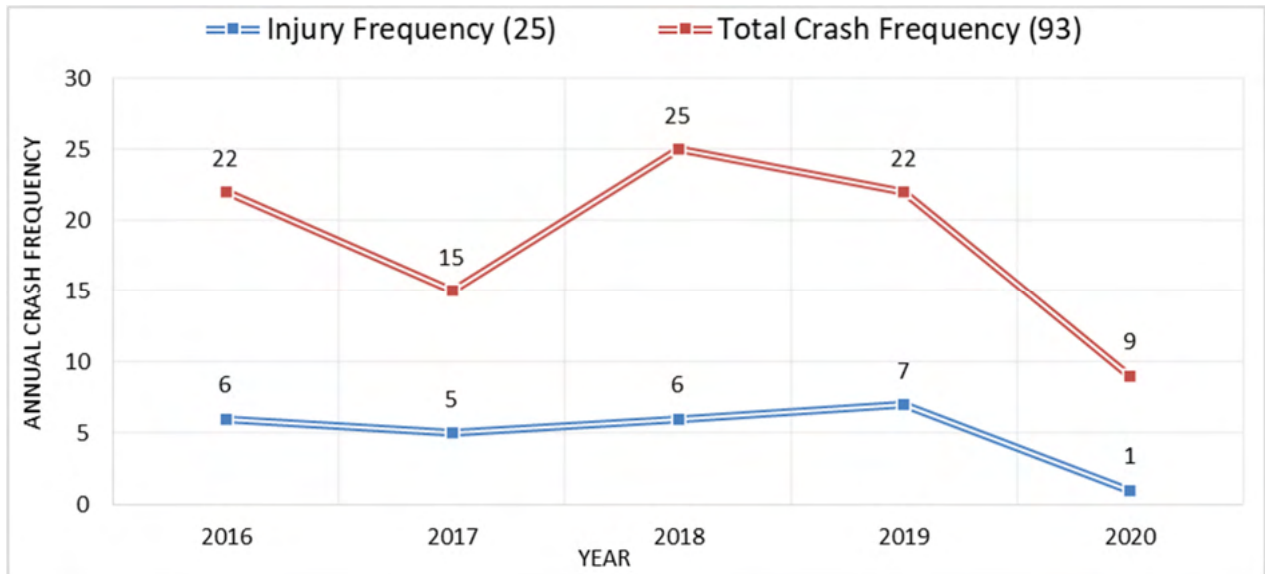
Figure 2-3. Bellwood Project Study Area: Crash History Trendline

While Figure 2-1 and Figure 2-2 show the crashes in a spatial manner, Figure 2-3 displays the fairly consistent annual crash frequency for injury crashes, other than the year 2020. The drop in 2020 is likely due to the reduced travel demand as a result of the COVID-19 pandemic and associated stay-at-home order. It is important to study the nature of these crashes to determine where the greatest potential for safety improvement (i.e., reducing crashes) may lie. The following sections further detail current safety conditions of the intersection of 25th Avenue and the IPP.

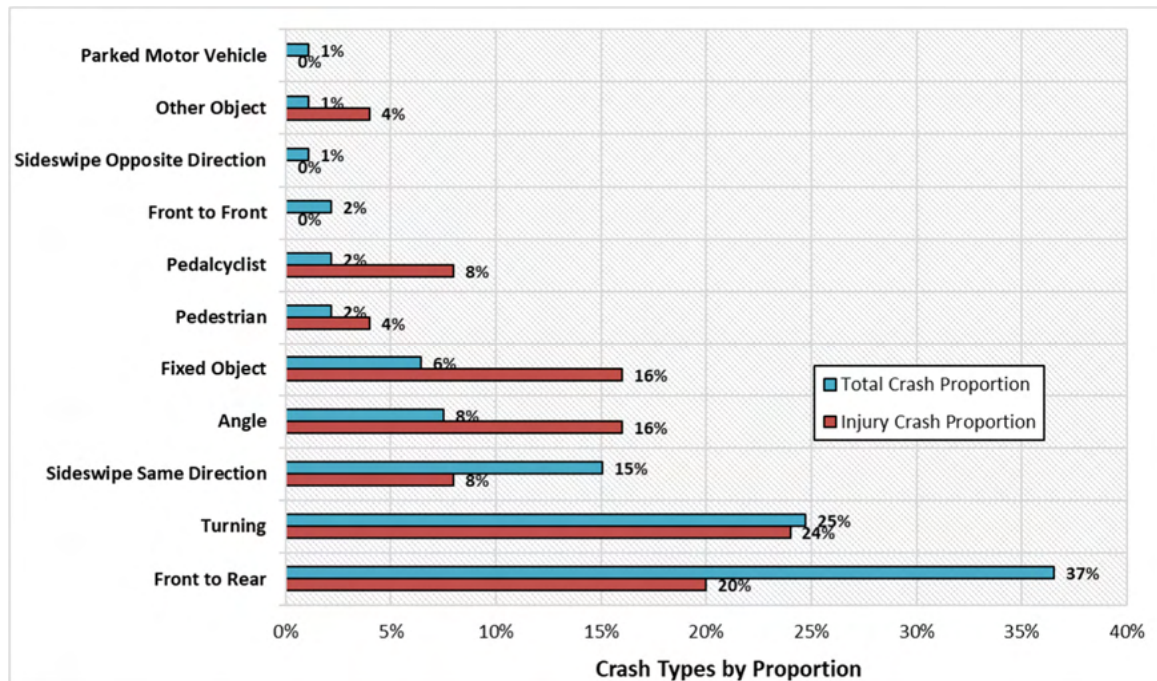
Figure 2-4. Bellwood Project Study Area: Crash Type Distribution

Figure 2-4 presents the distribution of crashes by crash type. This figure illustrates several key features of the safety study’s traffic safety performance profile. As expected, the majority of crashes at the safety study location are crash types commonly associated with intersections (e.g., front to rear, turning, and angle). Additionally, though front to rear crashes are generally lower severity than some other prominent crash types, they represent a large proportion of all injury crashes. These insights together may indicate safety concerns related to congestion at the intersection, where the potential for severe front to rear crashes is elevated.

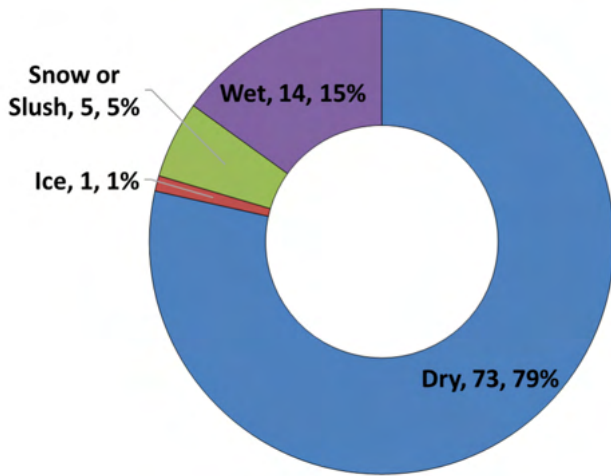
Figure 2-7. Bellwood Project Study Area: Crash Distribution by Surface Condition

As any motorist in the Village of Bellwood can attest, driving when roads are covered in snow, slush, or ice can be challenging due to reduced vehicle traction among other things. Roads can also be difficult to maneuver during rain or when roads are otherwise wet, requiring additional time to react to hazards or other vehicles by breaking or evading. For this reason, it is helpful to understand the extent to which such factors influence crash frequency and how they may be mitigated through infrastructure or other traffic safety treatments. Figure 2-7 breaks down of the number of total crashes that occurred under different roadway conditions throughout the study period. Most crashes occurred on dry roadways, with about 20 percent occurring on roadways with ice, snow, or wet conditions. This indicates that surface condition is not a major contributing factor for crashes across the Village but could be addressed with countermeasures like high-friction surface treatments.

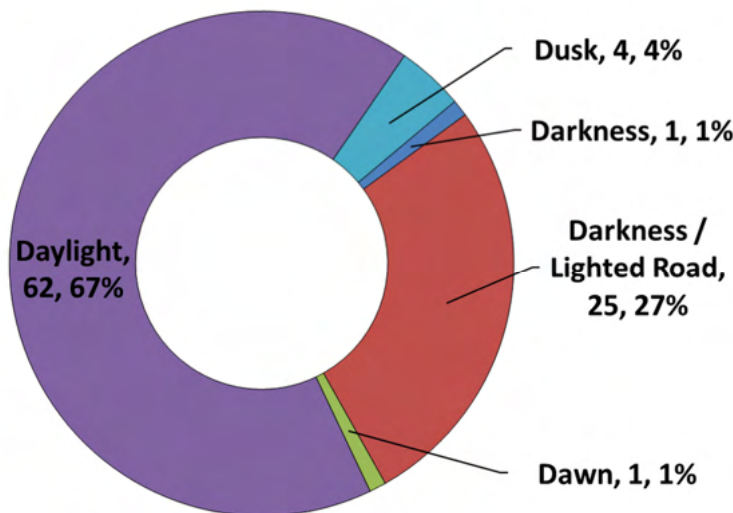
Figure 2-8. Bellwood Project Study Area: Crash Distribution by Lighting Condition

Similar to roadway surface condition, lighting condition is a common focus when assessing the safety performance of a specific site. Under dark conditions, many things like pavement markings, signs, and roadway features may be more difficult to see, making it challenging to react and maneuver effectively. Additionally, low lighting may make it difficult for motorists to see pedestrians or bicyclists, increasing the probability of a crash. Around the hours of sunset and sunrise, the sun may create glare, impairing the vision of some road users and creating another conditional hazard. Figure 2-8 breaks down total crashes by roadway lighting condition, indicating that a two-thirds of crashes occurred during daylight, with almost 30 percent occurring under dark conditions. This indicates a concern for street lighting as a contributing factor for some crashes, with a potential safety treatment involving upgrades of lighting at the intersection and along the legs of the intersection.

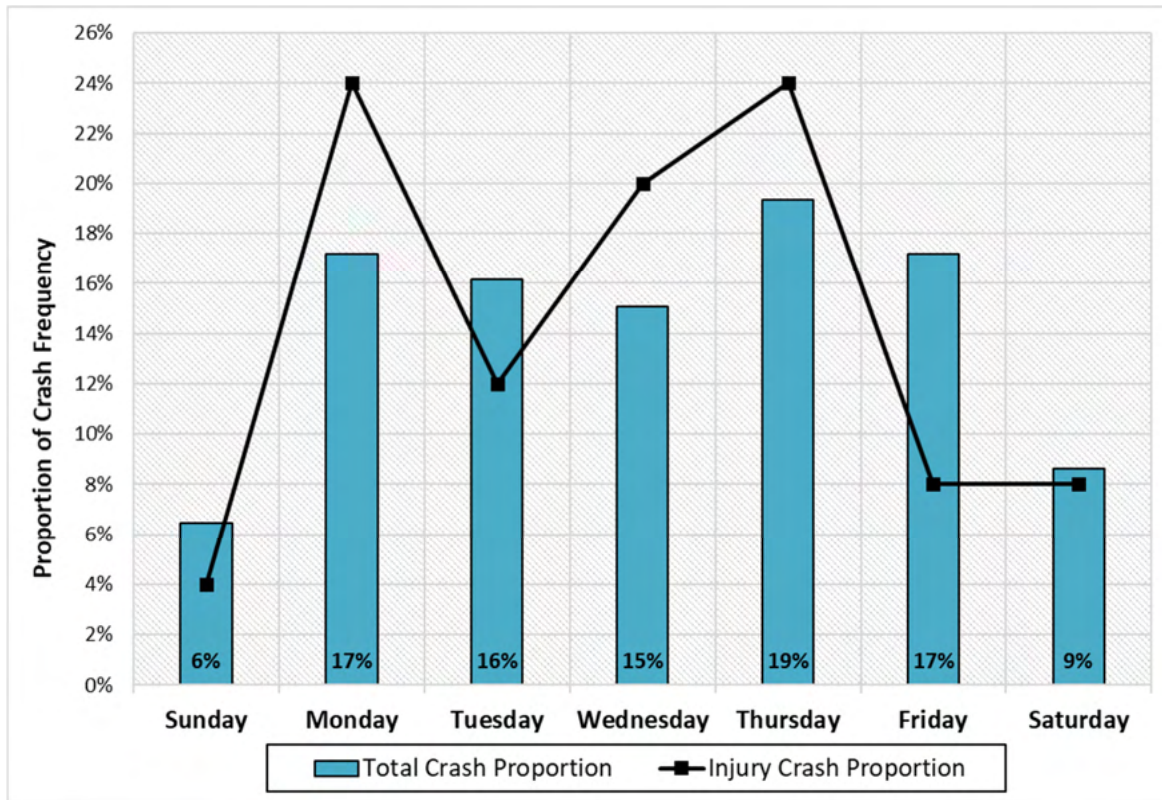
Figure 2-10. Bellwood Project Study Area: Crash Distribution by Day of Week

As shown in Figure 2-10, crash data is fairly consistent across days of week with no extreme fluctuations. There is, however, a moderate dip in both injury and total crash frequency on Saturdays and Sundays, perhaps related to lower traffic volumes or less general driving activity. Additionally, there is an unusual bump, even though small, of injury crashes on Mondays and Thursdays. Between this and the crash distribution by time of day, there appears to be a trend of higher-severity crashes occurs on evenings on Mondays and Thursdays.

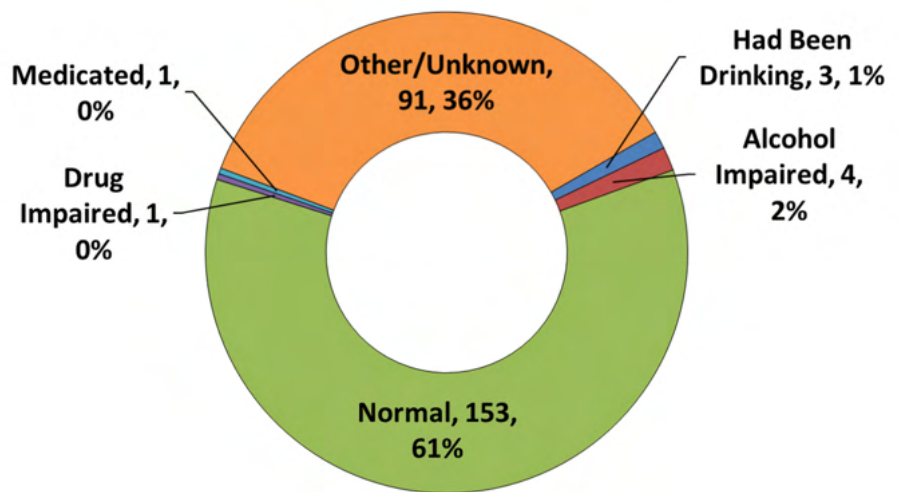
Figure 2-12. Bellwood Project Study Area: Distribution of Involved Drivers by Condition

Figure 2-12 visualizes the distribution of drivers involved in crashes by their physical conditions as noted by reporting officers. The data shows that though the majority of drivers involved in crashes were reported as being normal, a small portion (6) of these drivers were found to be impaired with alcohol, drugs, or other substances (e.g., medication) that can critically reduce a driver’s capacity to drive safely. These crashes also tend to be higher severity due to reduced inhibitions often resulting in higher speed, riskier behavior, and poorer reaction times. Additionally, three drivers were noted by the responding officer as ‘had been drinking’.

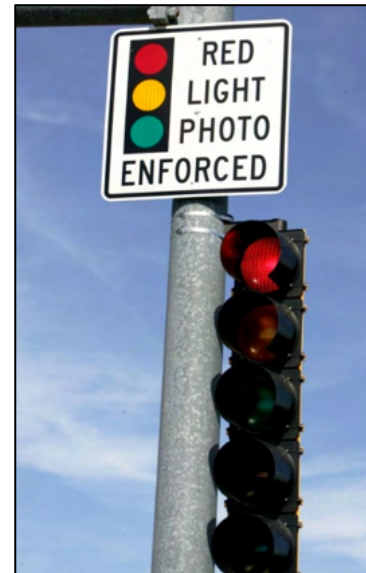
Figure 5-1. Example of Signage for Intersections with Red Light Photo Enforcement

There is a Red Light Running (RLR) Photo Enforcement System installed at the intersection of 25th Avenue and Madison Street/South Maywood Street on October 12, 2007. The RLR Photo Enforcement System monitors violations occurring on the southbound approach of the intersection. Figure 5-1 shows a sign similar to the “RED LIGHT PHOTO ENFORCED” sign that is located on all traffic poles facing each leg of the intersection. Data on citations was obtained from RedSpeed International for the years of 2017-2021.

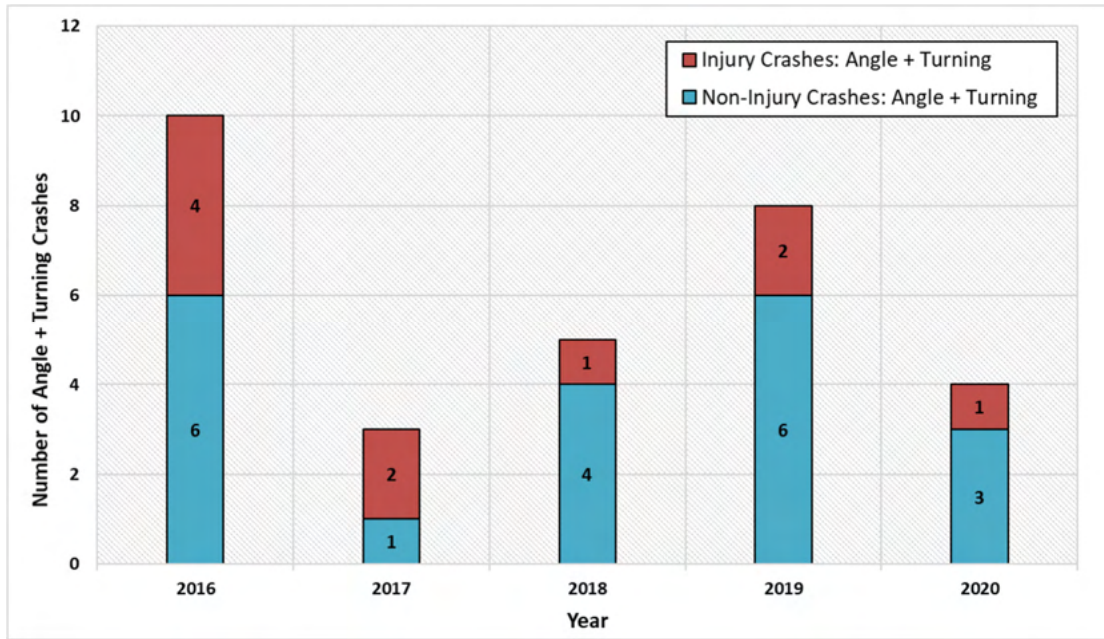
Figure 5-3. Bellwood Project Study Area: Turning and Angle Crashes by Year

Additional information associated with the citations like time of day, vehicle make and model was not available. However, we can compare the number of citations to the number of angle and turning crashes occurring from 2016 through 2020, as shown in Figure 5-3. When observing these two crash types – crash types that red-light cameras intend to decrease – we see that there is no apparent trend from 2016 to 2020.

The implementation of the red-light running cameras at the intersection does not appear to be having the desired impact of crash reductions and decreasing citations year over year. Ideally, the number of turning and angle crashes displayed in Figure 5-3 would show minimal frequency or a relatively constant decrease in the trend. Additionally, the frequency of both injury and total rear-end crashes at the intersection of 25th Avenue and Madison Street/South Maywood Drive is shown in Figure 5-3.

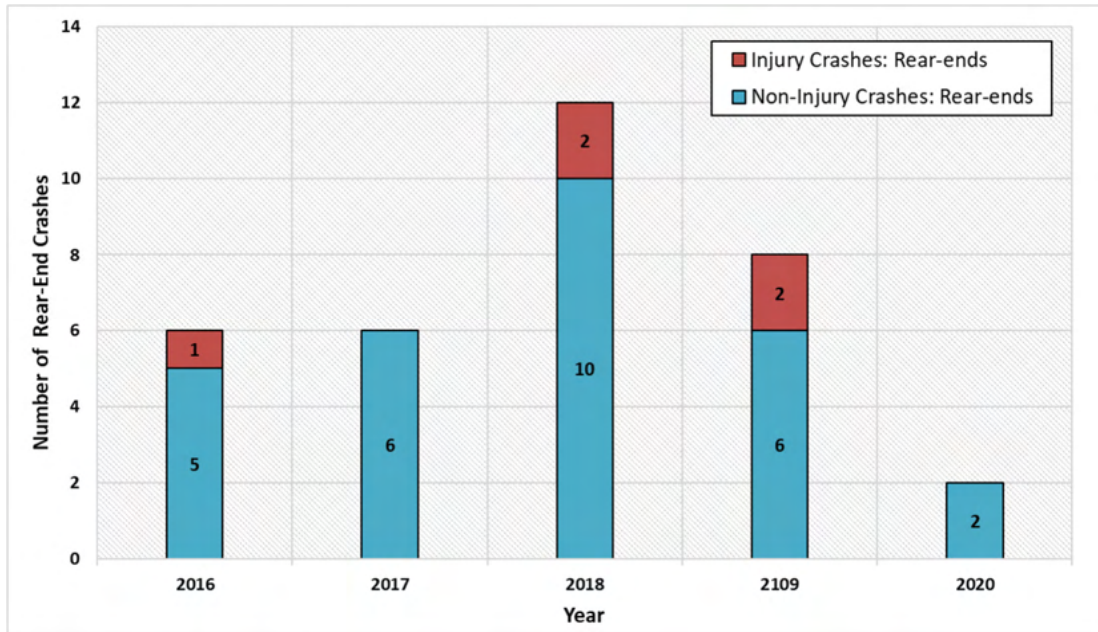
Figure 5-4. Bellwood Project Study Area: Rear-end Crashes by Year

With the addition of red-light running cameras at signalized intersections, the frequency of drivers disregarding the traffic signal generally decreases due to the fear of a monetary fine. The possibility of monetary fines causes more rear-end crashes to occur – the hard braking of the lead vehicle attempting to come to a stop when they observe a traffic signal changing from green to yellow catches the trailing vehicle off-guard, resulting in a rear-end crash if the trailing vehicle follows too closely.
