## Chicago Metropolitan Agency for Planning

**Project Name:** Long Lake Shoreline Stabilization Project

**Grant Recipient:** Round Lake Park District

**Project Location:** Round Lake Park, Grant and Avon Townships, Lake County, Illinois

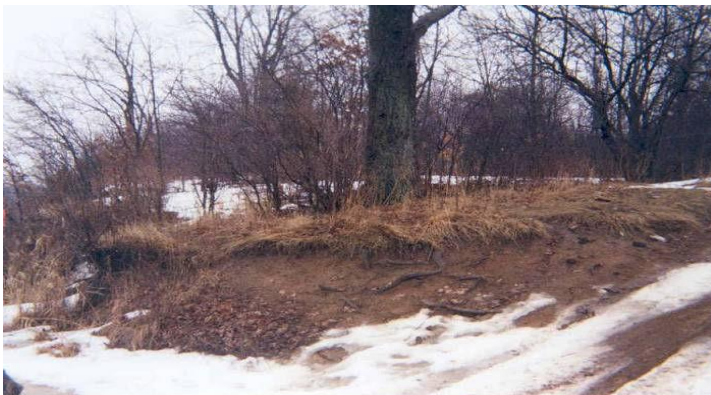
*Pre-construction shoreline conditions*

**Project Summary:** Long Lake is a 375 acre ( $\pm$ ) fresh water lake in the Squaw Creek Watershed, tributary to the Fox River. Long Lake, like many similar waterbodies in Illinois, has areas of severe shoreline erosion. The Round Lake Area Park District (District) owns a parcel on the southeastern side of the lake which was experiencing severe erosion and bank sloughing. The goals of this project were to stabilize the bank and to reduce the amount of eroded soil and associated nutrients delivered to Long Lake. The project was aimed at further mitigating the transport of solids, nutrients, and organic loading to Long Lake and the Fox River to improve water quality and the habitat for aquatic organisms. Design calculations determined that the significant wave action required hard armoring at the toe of the slope; therefore, a graded rock revetment was constructed to protect the shoreline from wave and ice action. Construction began with invasive species removal and slope regrading. The rock toe was then installed. Above the rock, native prairie vegetation was specified to stabilize and naturalize the slope. A turf reinforcement mat was utilized immediately above the rock to protect from wave splash and to strengthen the slope from potential foot traffic. Long term erosion control blankets were utilized on the upper slope to allow adequate time for native vegetation establishment. Additionally, emergent wetland vegetation was planted in a shallow, nearshore area at the southern project limit, where the lake bed slope and wave protection allowed. A split rail fence was added along the top of the slope, a wooden stairway was built from the top of the slope to the water's edge, and a wood chip trail was laid to help route pedestrian traffic and minimize trampling of the native vegetation.

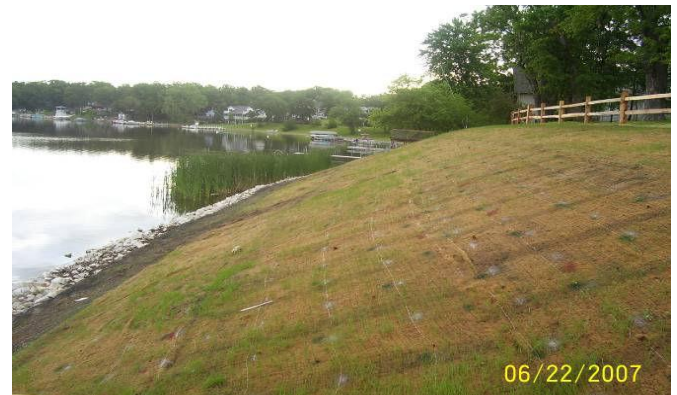
*Post-construction shoreline conditions*
