Pedestrian crossing beacons — overhead flashing beacon

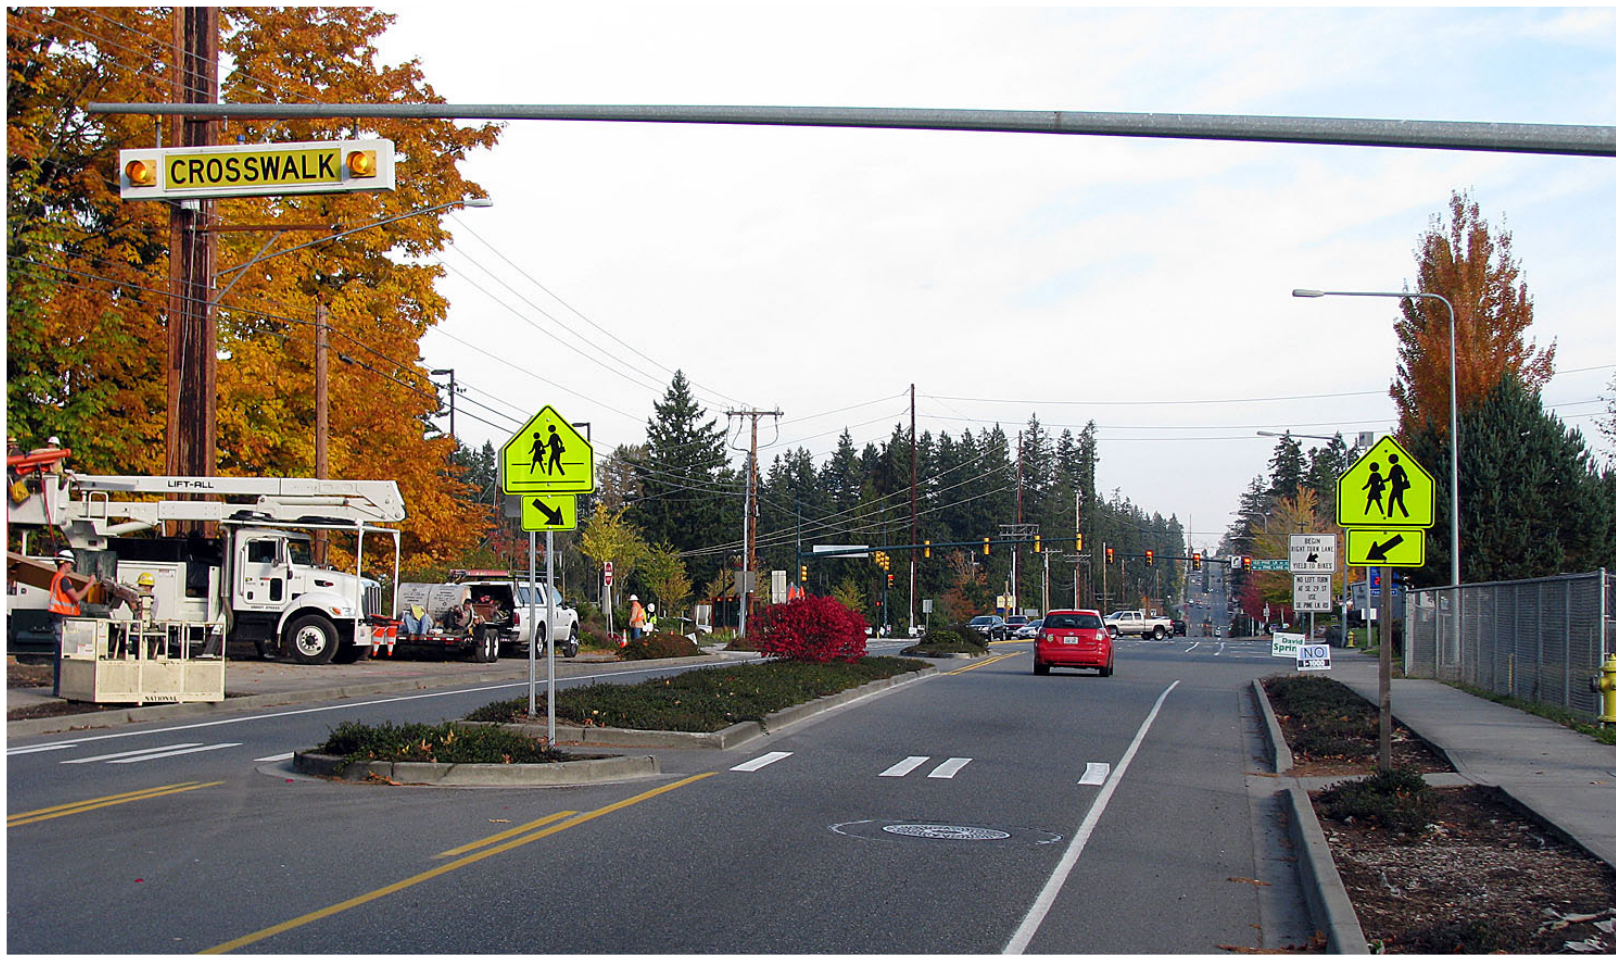
Example of an overhead flashing crosswalk beacon.
Source: Dan Burden.

Overhead flashing beacons are pedestrian-activated flashing amber beacons installed on traffic signal poles and mast arms at uncontrolled crossing locations, typically along with regulatory/warning signage.

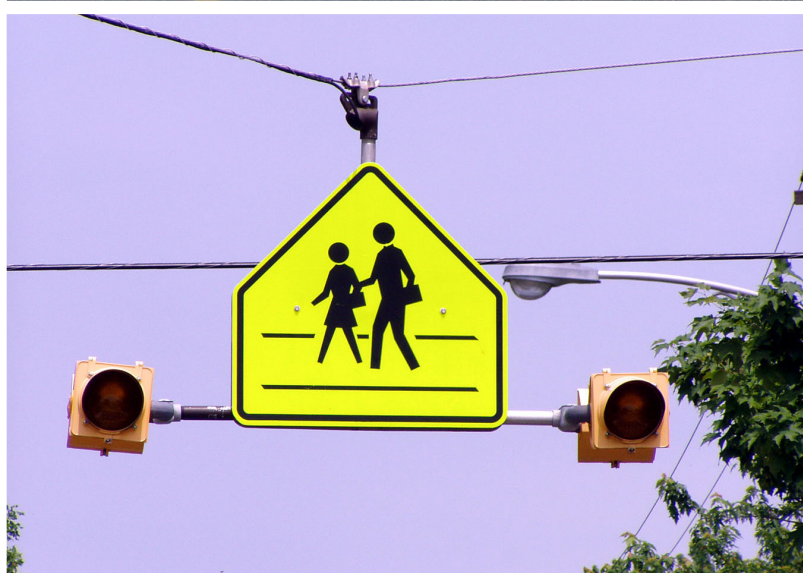
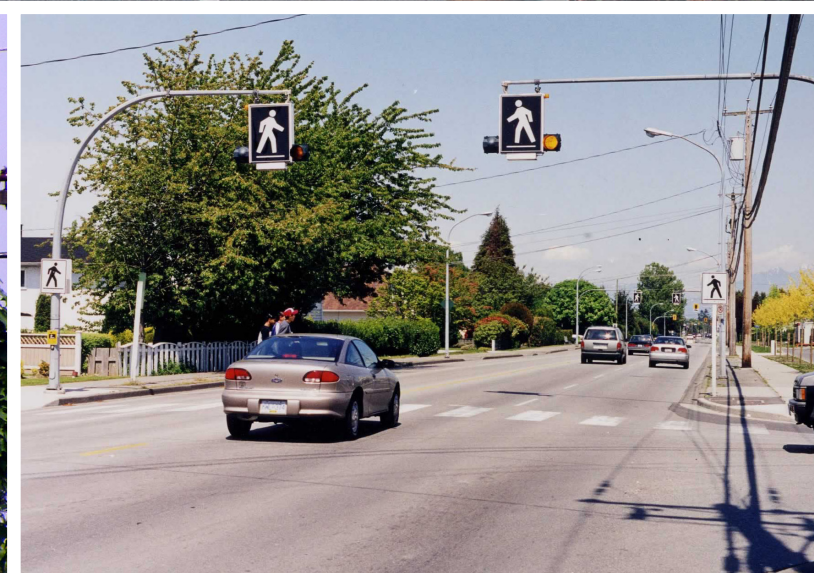
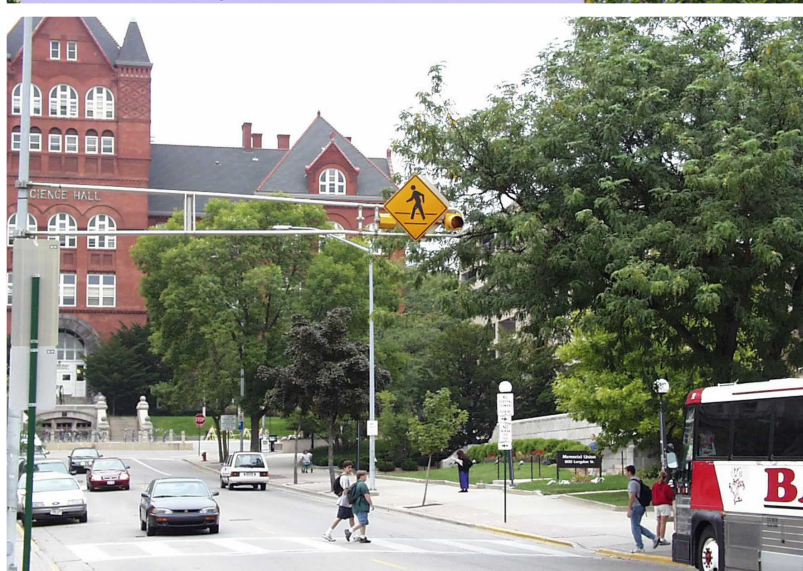
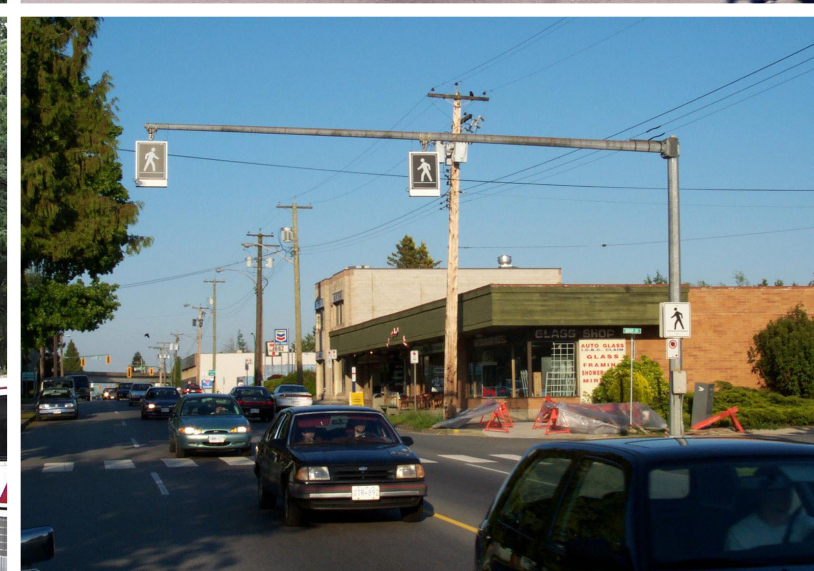
Additional examples:
Source: Dan Burden, pedbikeimages.org.
